PROJECT NUMBER: PNB041-0708

OCTOBER 2012

# Four year inspection of a comparative trial of accelerated H3 decay test method

**Laurie J. Cookson, David Page and Tripti Singh**

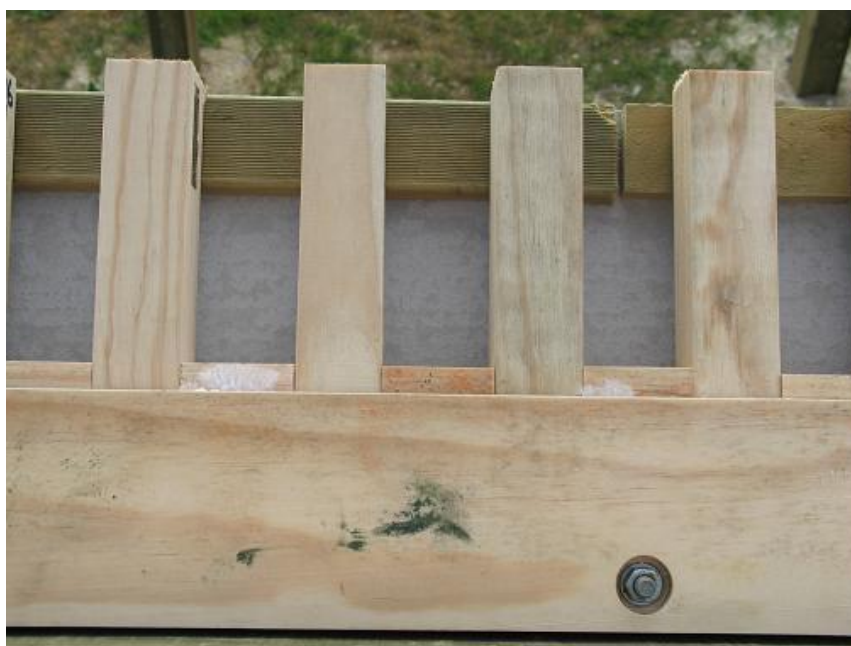
**Figure 21. Pre-inoculated embedded test at Rotorua AFS when installed for summer exposure in graveyard on 5 December 2007. Note mycelium from the pre-inoculated blocks spreading up over the surface of the holders.**

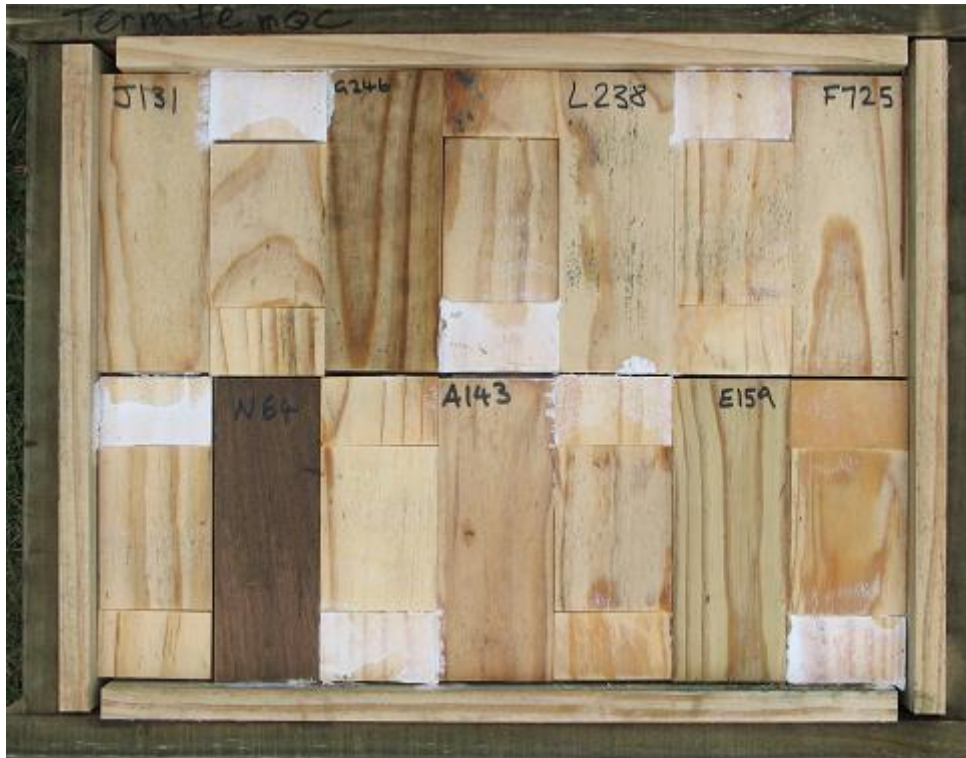
**Figure 29. Pre-inoculated rot box from the Rotorua AFS after moving to the graveyard for summer exposure. Mould patches and *O. placenta* mycelium have developed on untreated separators and some of the test specimens.**

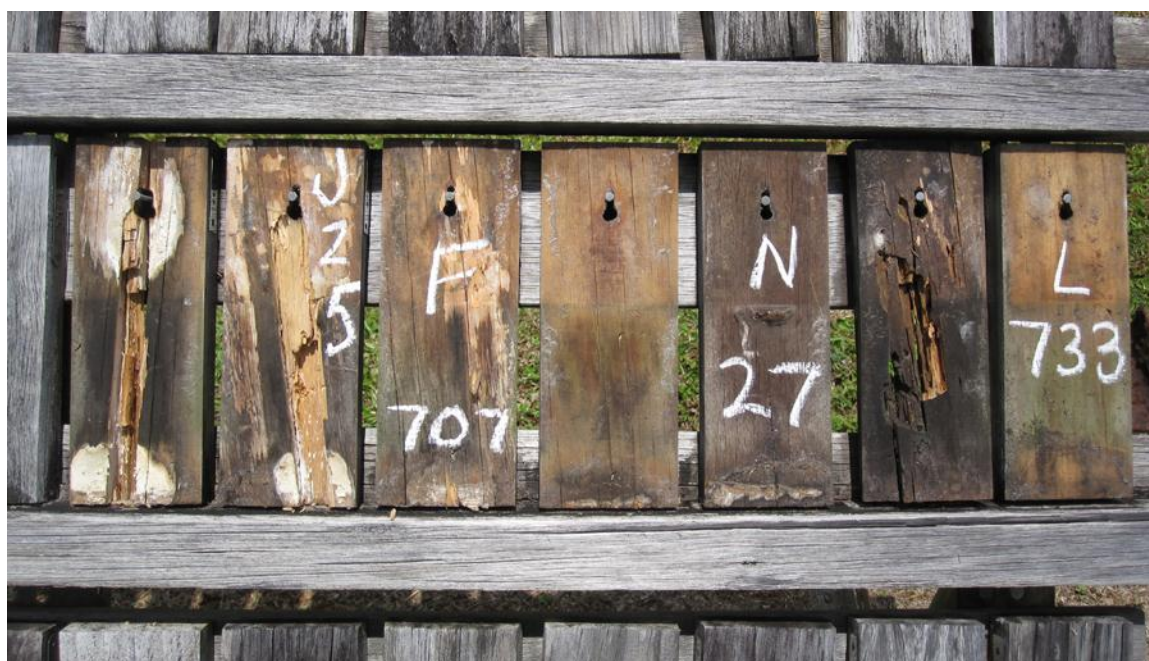
**Figure 43. Flat panel test on new frame at Innisfail after four years, underside. Left to right = E32 ACQ rating 0, J25 HFK rating 0, F707 TBTN rating 4, G30 CCA rating 7, N27 *C. maculata* rating 8, A38 water rating 0, L733 azoles rating 7.**

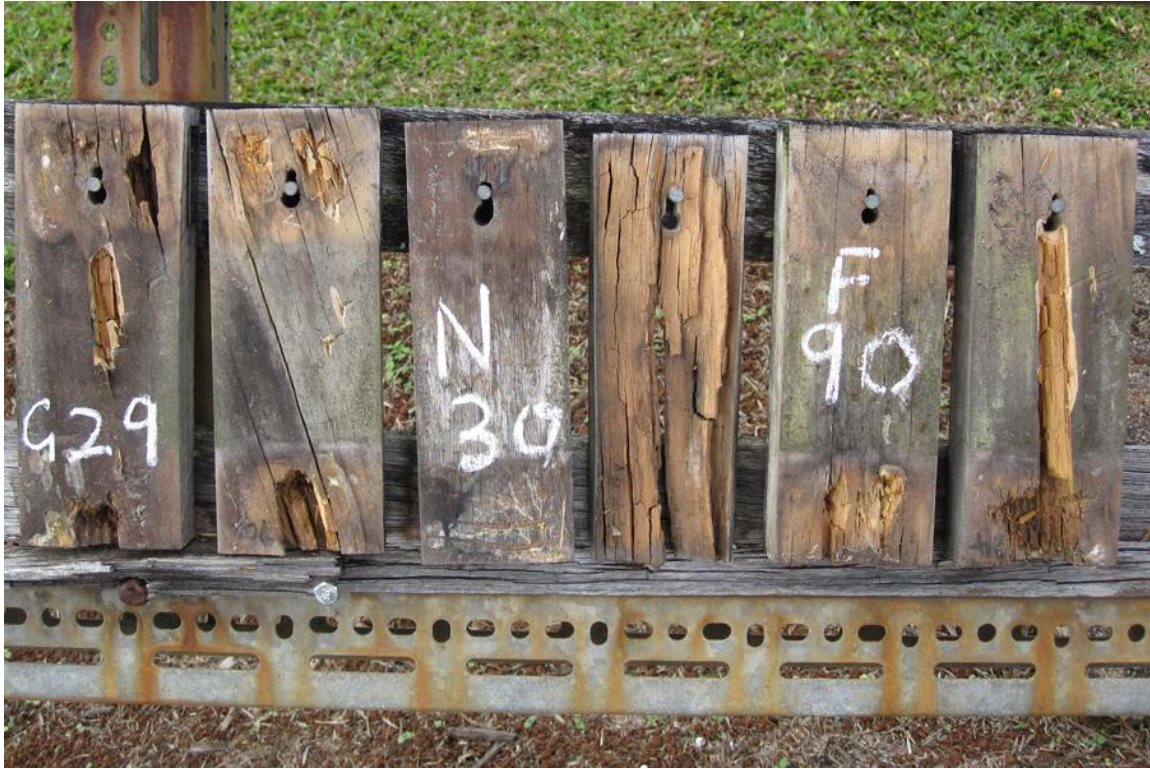
Figure 44. Flat panel test on old frame at Innisfail after four years, underside. Left to right = G29 CCA rating 0, L701 azoles rating 0, N30 *C. maculata* rating 8, J633 HFK rating 0, F90 TBTN rating 3, E24 ACQ rating 0.

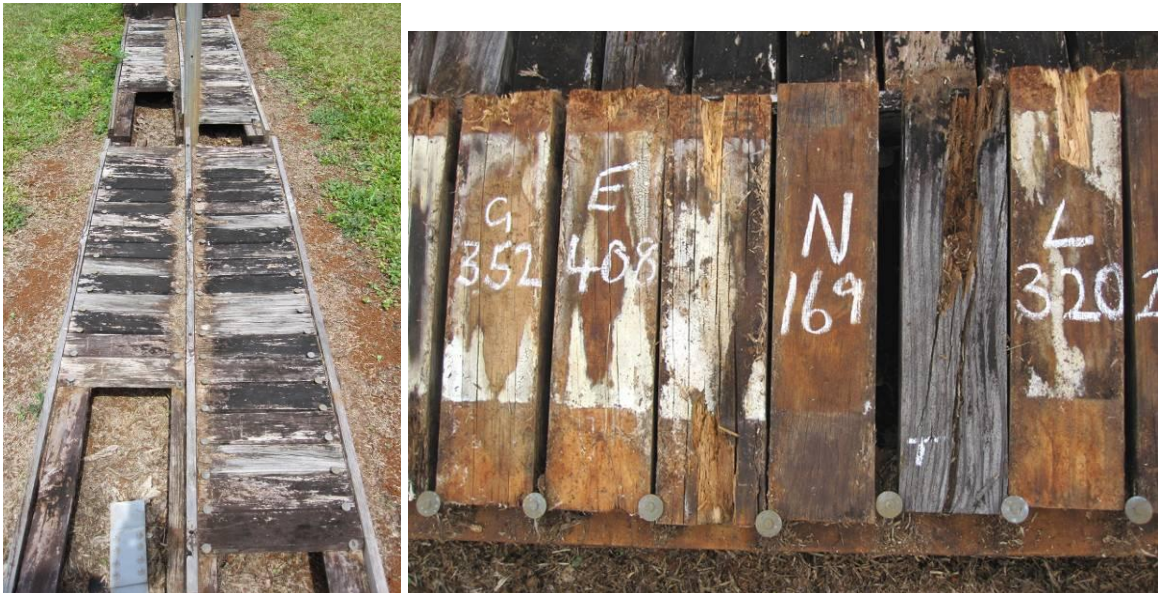
**Figure 46. Deck-on-grass at Innisfail after four years. Left photo, note dead grass accumulated along centre board on top of specimens. Right photo, left to right undersides = G352 CCA rating 0, E408 ACQ rating 1, F373 TBTN rating 0, N169 *C. maculata* rating 8, A230 (top side) rating 0, L320 azoles rating 0.**

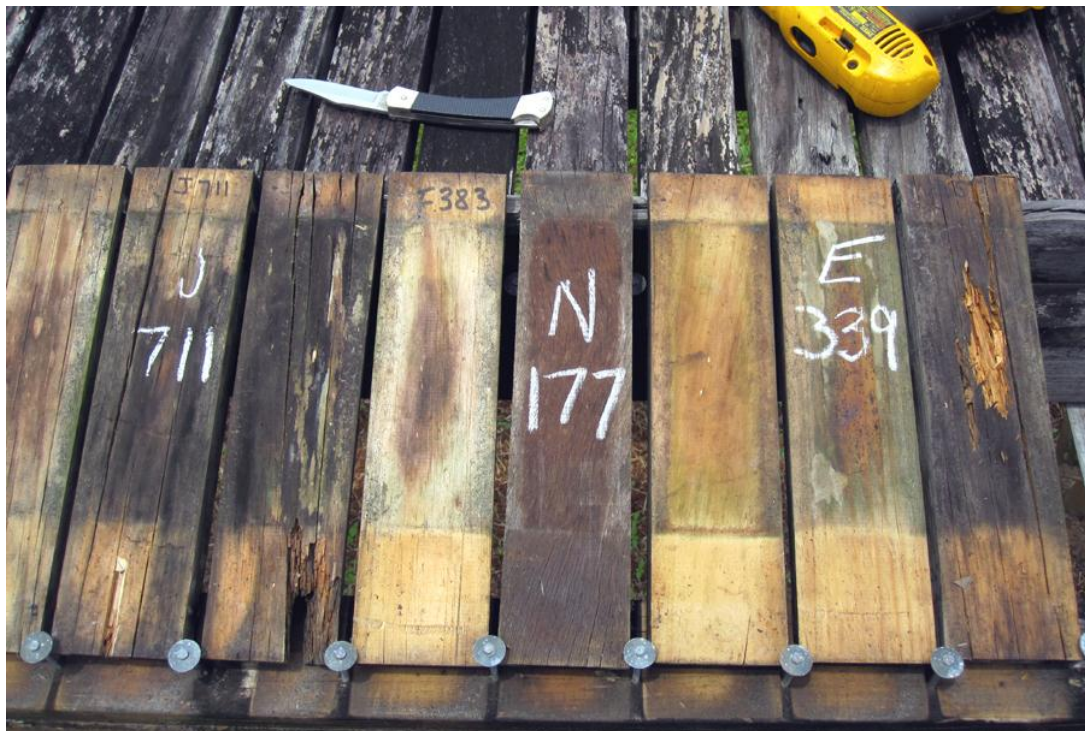
**Figure 47. Raised deck at Innisfail after four years, underside. Left to right = F343 TBTN rating 8, J711 HFK rating 1, A229 water rating 0, F383 TBTN rating 8, N177 *C. maculata* rating 8, G395 CCA rating 8, E339 ACQ rating 8, L357 azoles rating 0.**

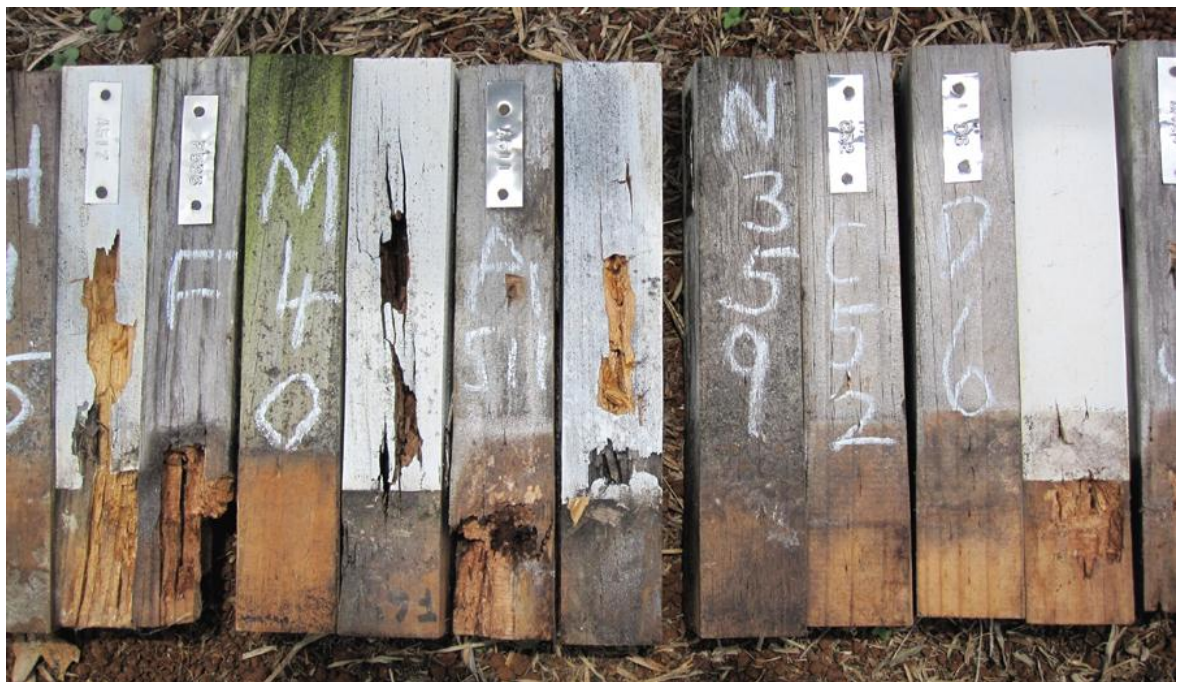
**Figure 49. Embedded test at Innisfail after four years, frame H. Left to right = H15 CCA (H3) rating 8, A517 water painted rating 0, F586 TBTN rating 0, M40 azoles (H3) rating 8, F650 TBTN painted rating 0, A511 water rating 0, J778 HFK painted rating 0, N359 *C. maculata* rating 8, C52 CuCr ('H3') rating 8, D6 ACQ (H3) rating 8, G547 CCA painted rating 6.**

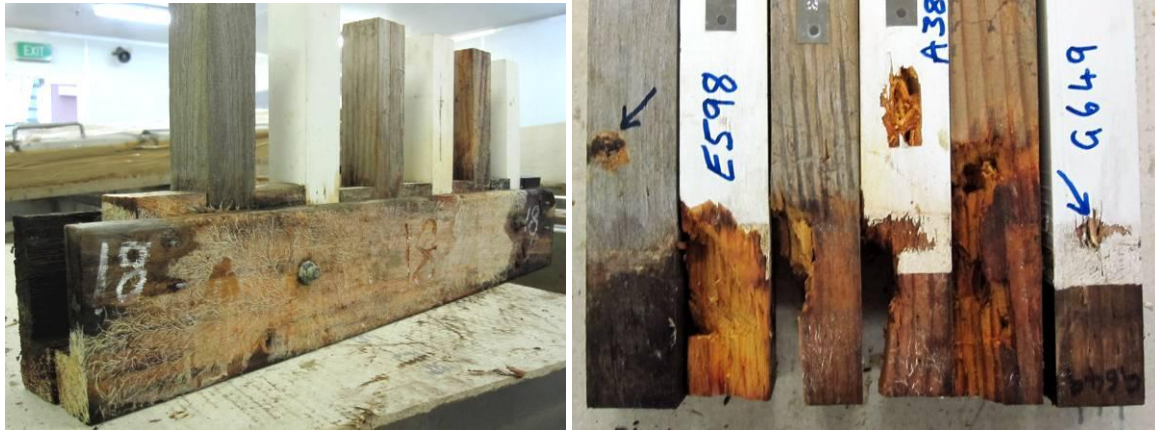
**Figure 50. Embedded test in AFS at Clayton after four years, frame 18. Left photo, showing mycelium growing over base holder (white areas). Right photo, left to right = N320 *C. maculata* rating 8 (with fruiting body on side), E598 ACQ rating 0, A323 water rating 0, A389 water rating 0, E690 ACQ rating 0, G649 CCA rating 6.**

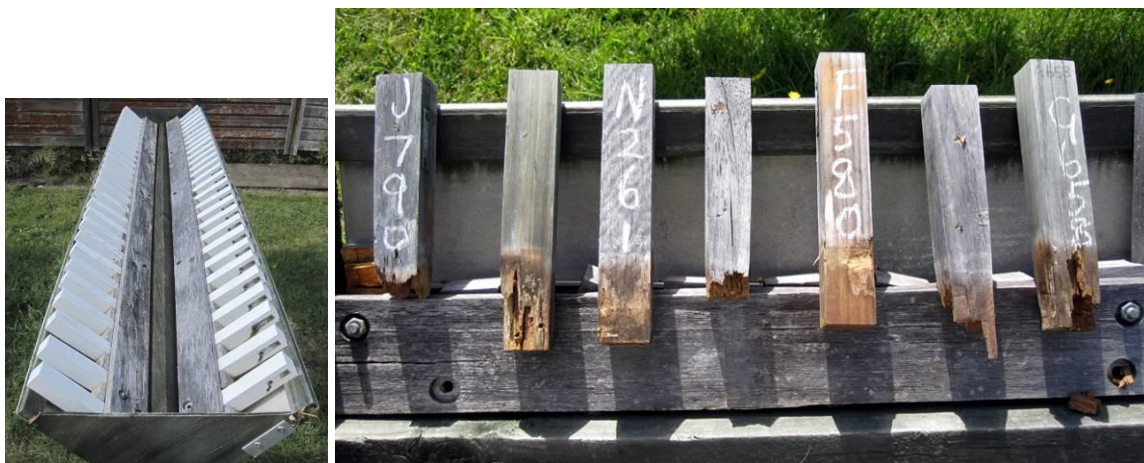
**Figure 51. Embedded tests at Rotorua after four years. Left photo, painted specimens. Right photo, frame No. 5 in AFS (not inoculated), left to right J790 HFK rating 0, E631 ACQ rating 0, N261 *C. maculata* rating 7, L630 azoles rating 0, F530 TBTN rating 7, A496 water rating 0, G659 CCA rating 0.**

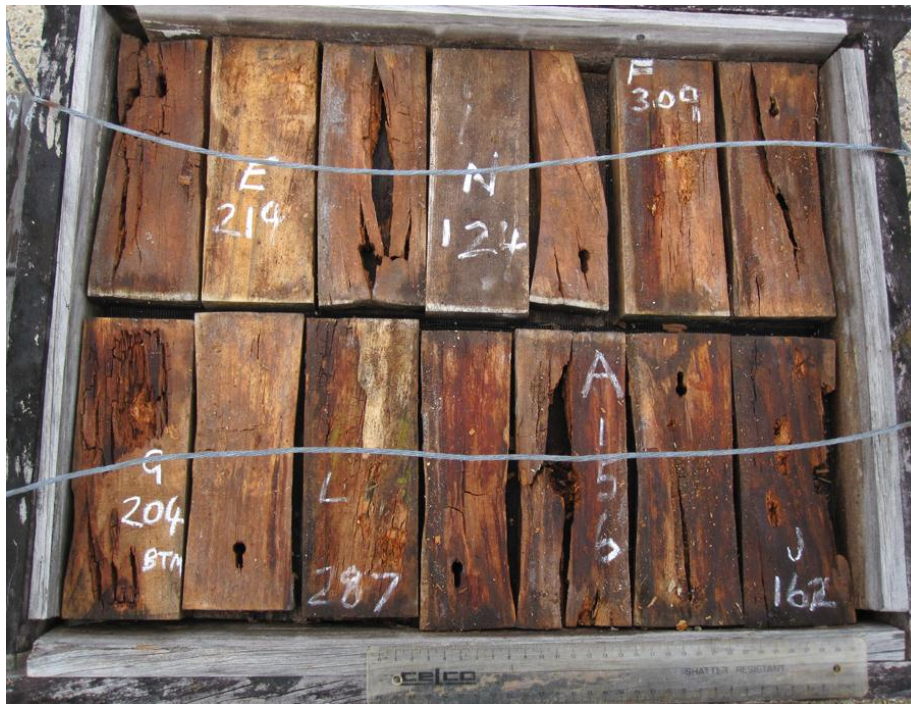
Figure 52. Rot box No 12 at Innisfail after four years, second top row, feeder bait blocks alternate with test specimens. Left to right = E219 ACQ rating 5, N124 *C. maculata* rating 7, F309 TBTN rating 4, G204 CCA rating 0, L287 azoles rating 3, A156 water rating 0, J162 HFK rating 0.

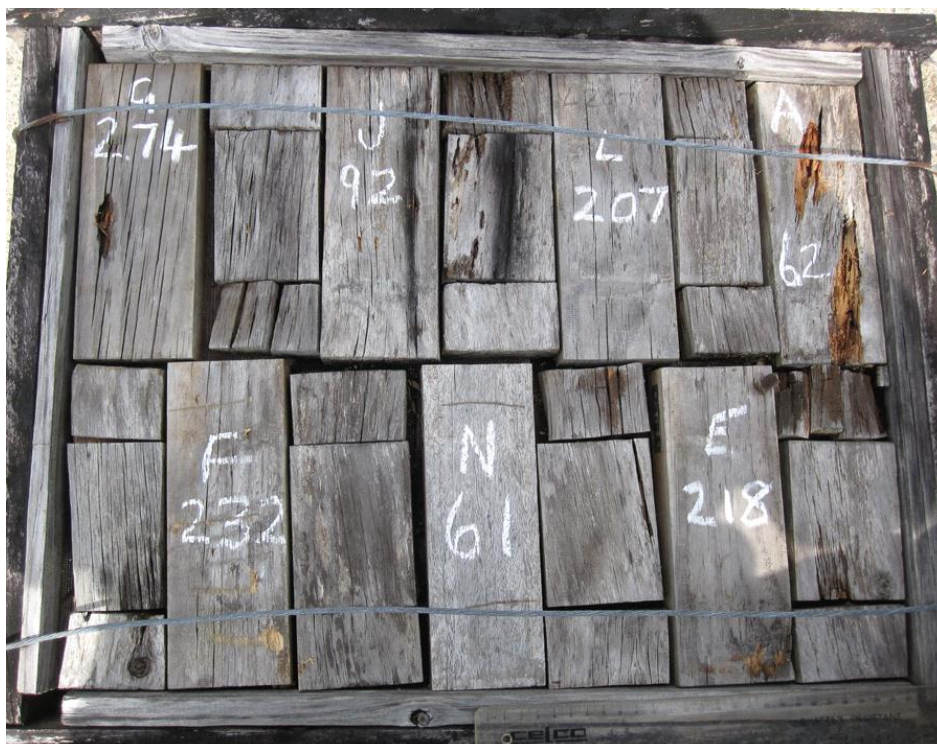
Figure 53. Inoculated rot box No. 14 at Innisfail after four years, top row, inoculated feeder bait blocks alternate with test specimens. Left to right = G274 CCA rating 4, J92 HFK rating 0, L207 azoles rating 7, A62 water rating 0, F232 TBTN rating 5, N61 *C. maculata* rating 7, E218 ACQ rating 6.

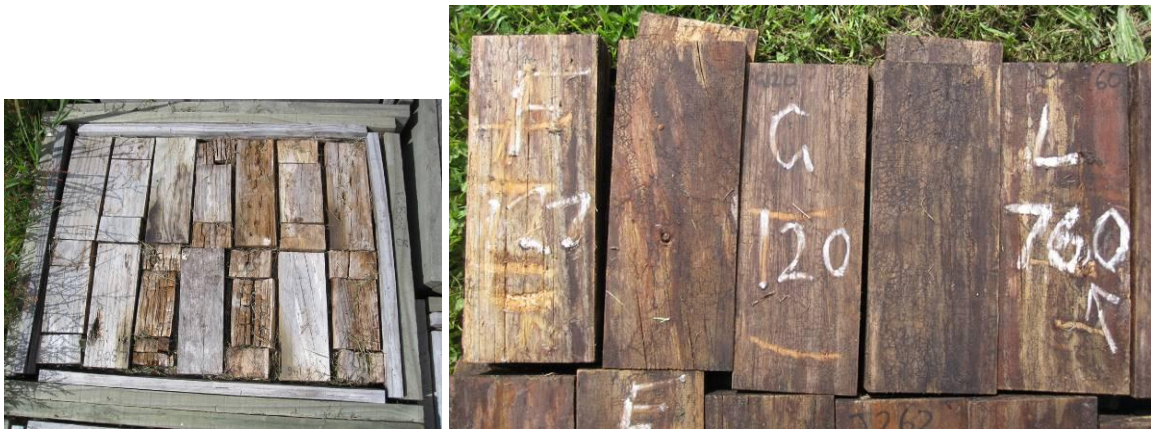
Figure 54. Rot boxes in AFS at Rotorua after four years (during summer exposure outdoors). Right Box No. 8 pre-inoculated showing brown rotted feeder blocks between test specimens. Left Box No. 5 not inoculated, left to right = F127 TBTN rating 7, feeder, G120 CCA sound, feeder, L760 azoles rating 6.

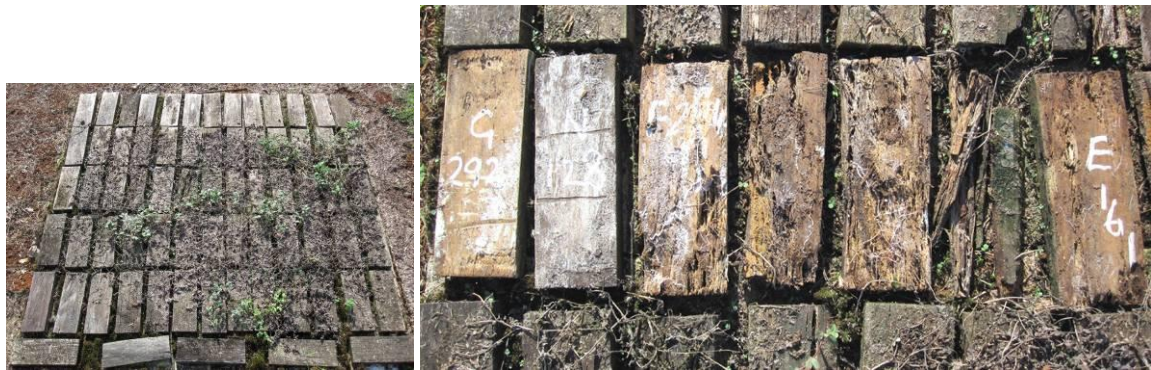
Figure 55. Ground proximity test at Innisfail after four years. Left to right = G292 CCA rating 6, N128 *C. maculata* rating 7, F224 TBTN rating 0, J224 HFK rating 0, L232 azoles rating 0, A122 water rating 0 (nearly disintegrated), E161 ACQ rating 0.

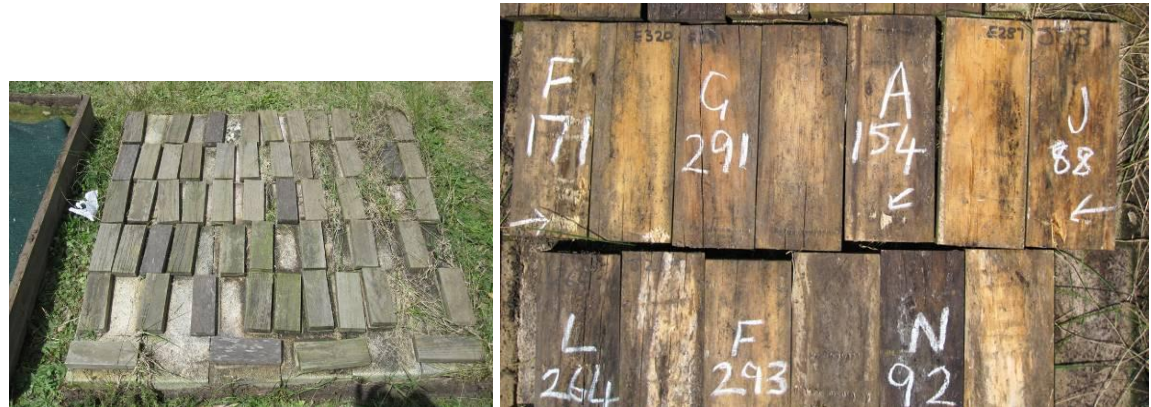
Figure 56. Ground proximity test at Clayton after four years. Left to right underside = F171 TBTN rating 7, E320 ACQ rating 7, G291 CCA rating 8, L790 azoles rating 8, A154 water rating 7, E287 ACQ rating 8, J88 HFK rating 4.

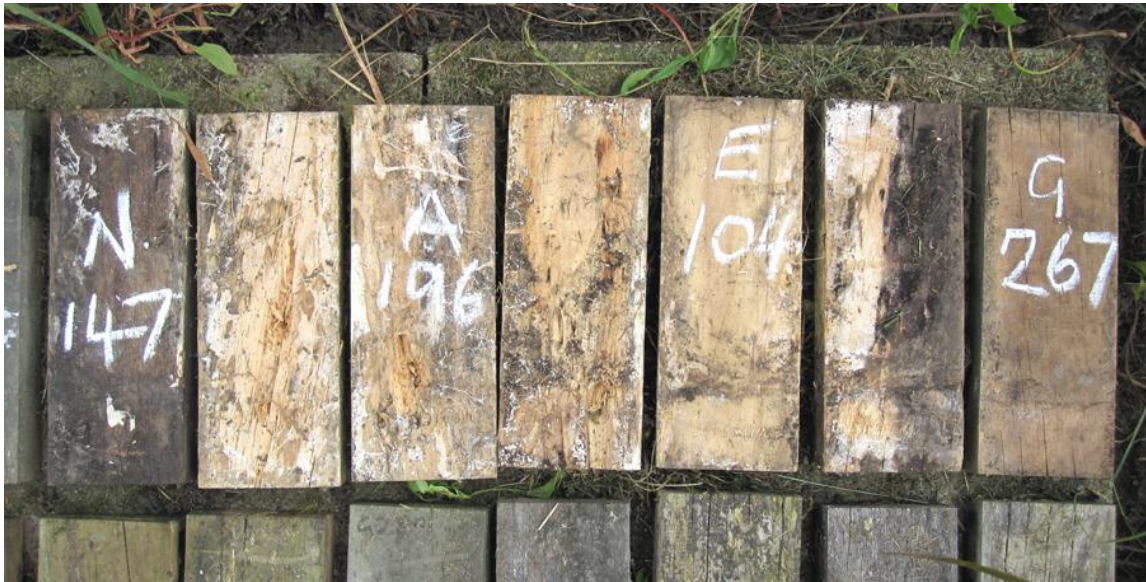
**Figure 57. Ground proximity test at Rotorua after four years, underside. Left to right = N147 *C. maculata* rating 7, F263 TBTN rating 2, A196 water rating 2, J276 HKF rating 1, E104 ACQ rating 7, J279 HFK rating 6, G267 CCA rating 8.**

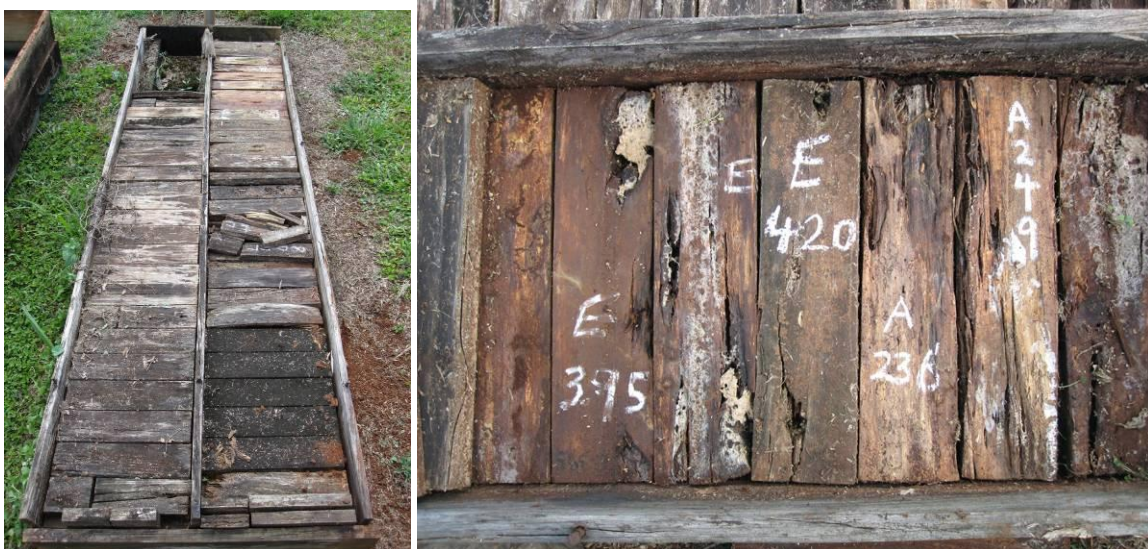
**Figure 58. Double layer test at Innisfail after four years. Right, bottom right column shows set of darker *C. maculata* specimens rating 7 or 8, middle right column azoles (jumbled) all rating 0. Left, bottom layer of E specimens (ACQ) all rating 0, and A specimens (water) all rating 0 (spare blocks separating treatments removed for photo).**

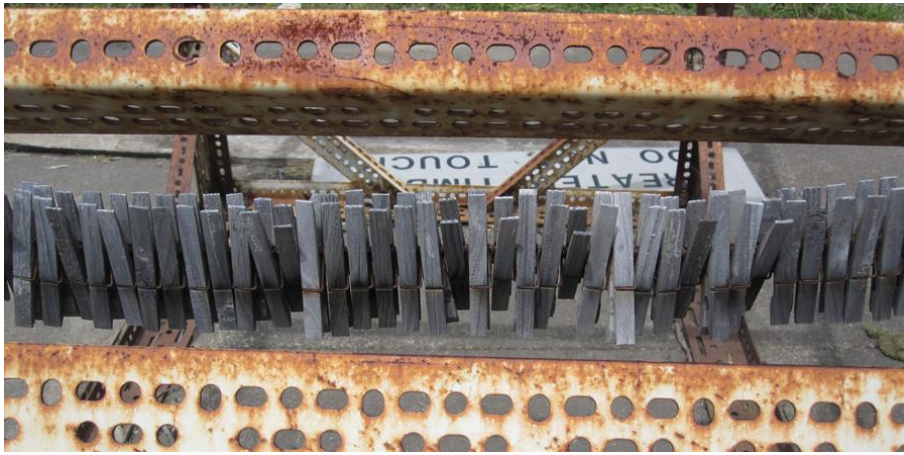
**Figure 59. Peg test at Clayton after four years, no peg would break when opened.**

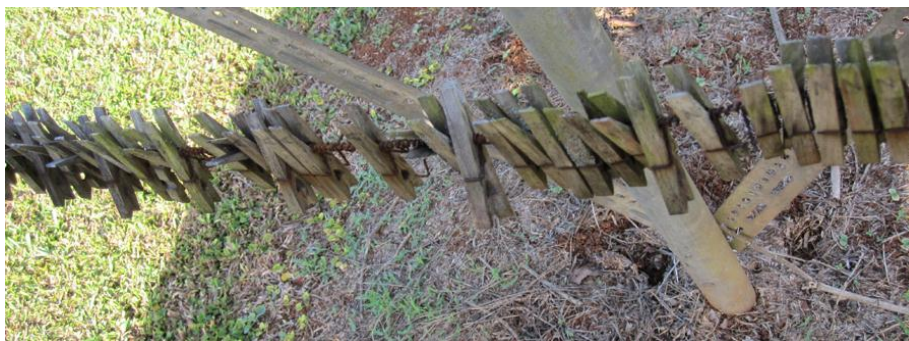
**Figure 60. Peg test at Innisfail after four years, some pegs broken or missing (except for their wire hinges).**

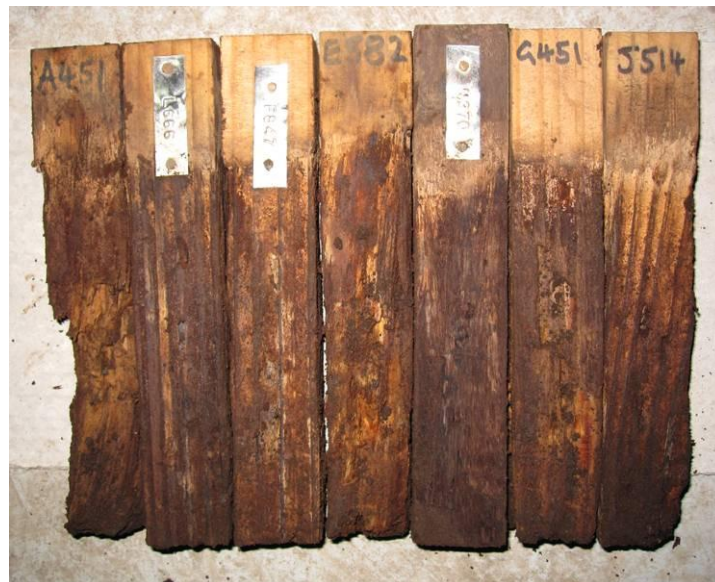
**Figure 61. In-ground stake in Clayton AFS after four years. Left to right = A451 water rating 0, L666 azoles rating 5, F847 TBTN rating 3, E582 ACQ rating 3, N370 *C. maculata* rating 7, G451 CCA rating 3, J514 HFK rating 0.**

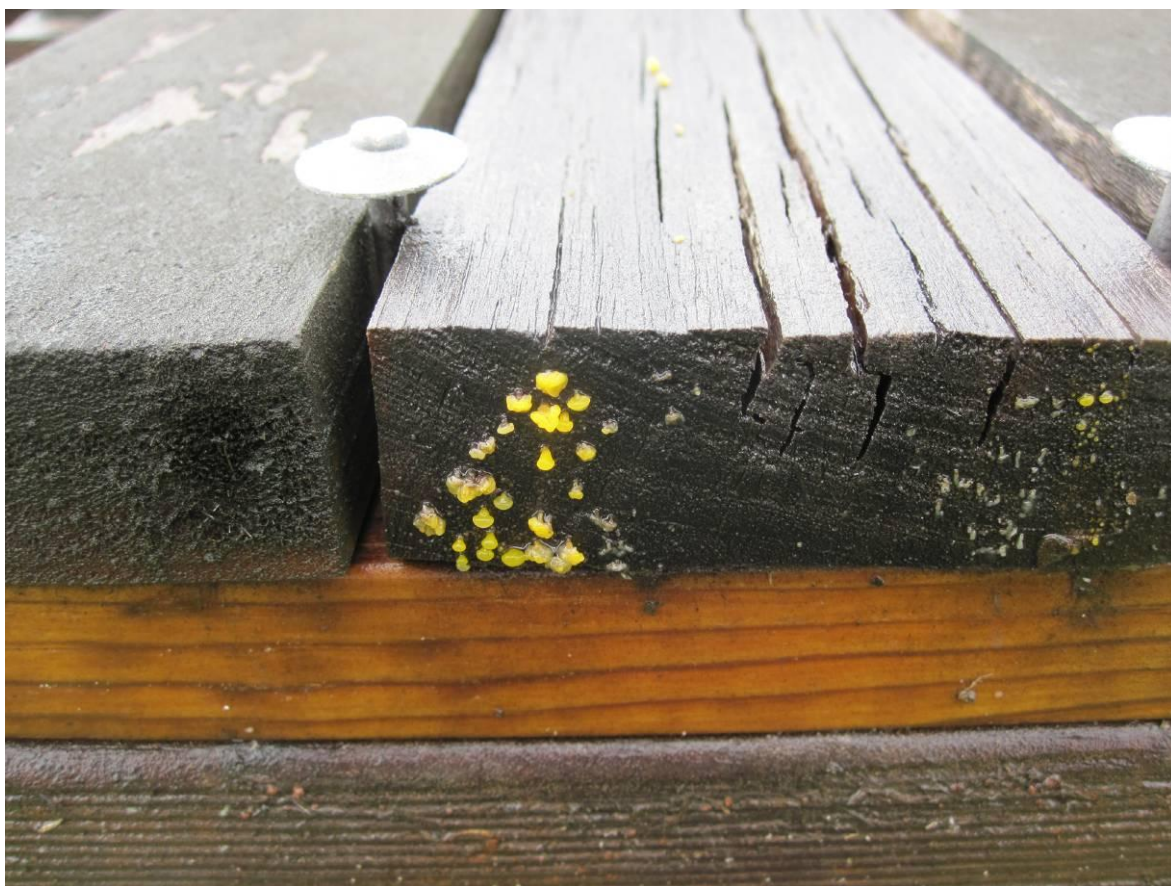
Figure 67. Fruiting bodies of the brown rotting fungus (*Heterotextus* sp.) responsible for extensive decay in quarter azole-treated *P. radiata* test specimens in the raised deck test at Innisfail after three years.
