Accelerated Testing of Window Joinery made from Eucalypts

Project no: PN98.702

D.K. Scown, L.J. Cookson, K.J. McCarthy & N. Chew **CSIRO FFP** Private Bag 10, Clayton South, Victoria 3169

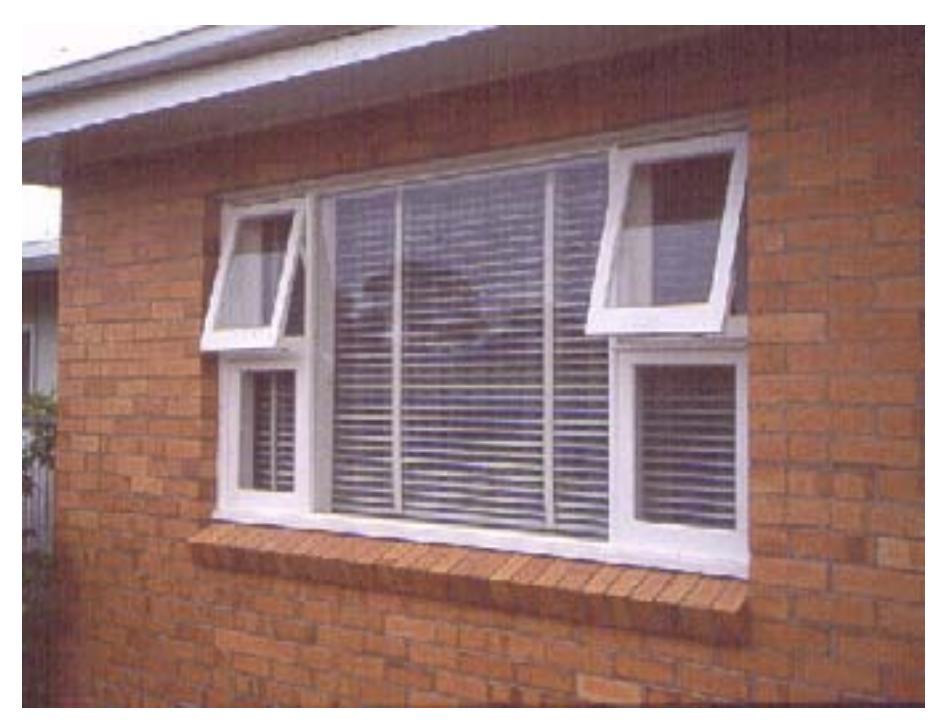
The survey incorporated a group of eucalypt windows in buildings at Bairnsdale. These windows were generally in excellent condition (Figure 1.1). The experience of the joinery supplier responsible for the manufacture of these windows was that sealing the end grain within the joints prior to assembly extended the service life of the joint considerably. He claimed that a poorly made joint would last only 15 years whereas a well made joint can be expected to last more than 40 years. He recommended the use of only oil based paints and a flexible sealant in major joints to protect the end grain of the timber from water ingress. Other tips were to fully paint prime the timber before assembly, including the underside of the timber beading to be used against the glass, and the outer frame and underside that would later be hidden against the brickwork after installation.

Figure 1.1: Eucalypt window 43 years old in Bairnsdale, with internal joints sealed prior to assembly, in excellent condition. For the purposes of the survey, this figure is considered to show one window.

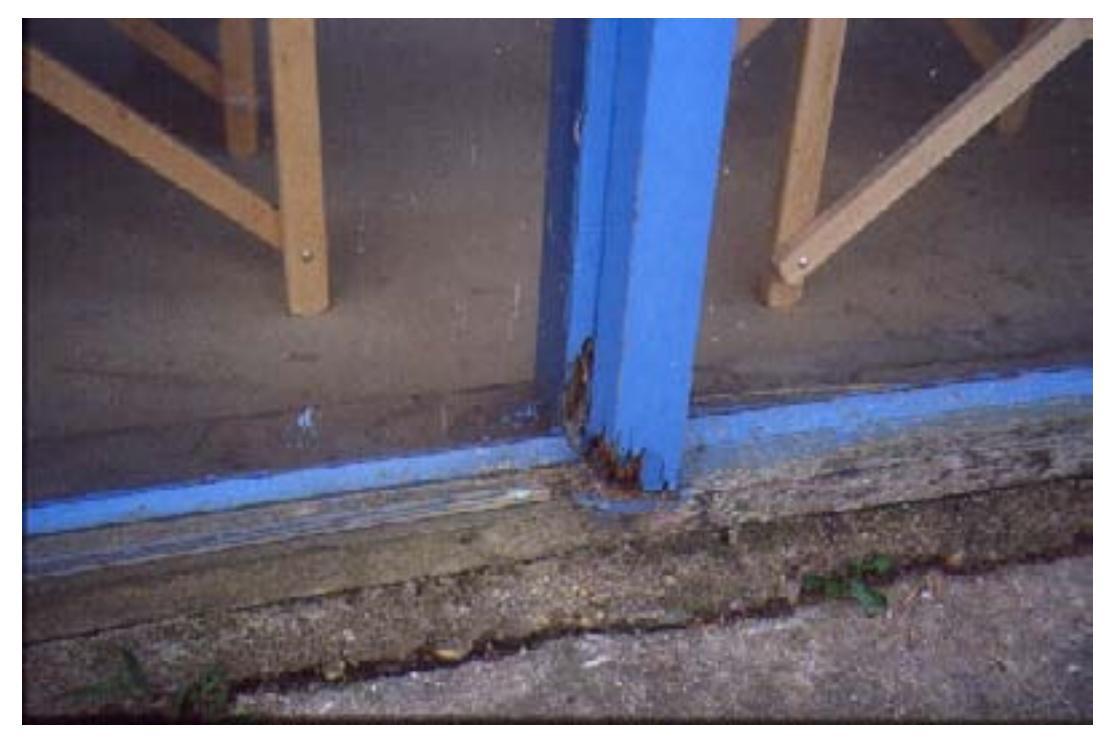
Figure 1.2: Brown rot in a 20 year old untreated western red cedar window.

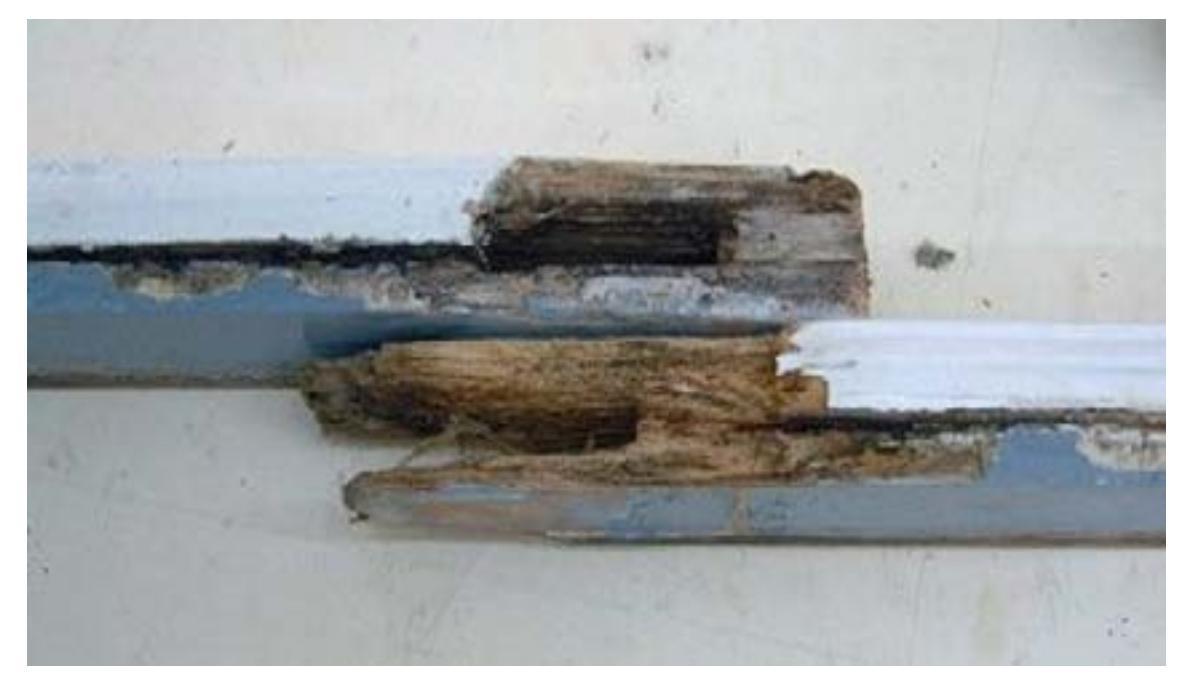
Figure 1.3: White rot in bottom joint of dismantled 50 year-old eucalypt window.

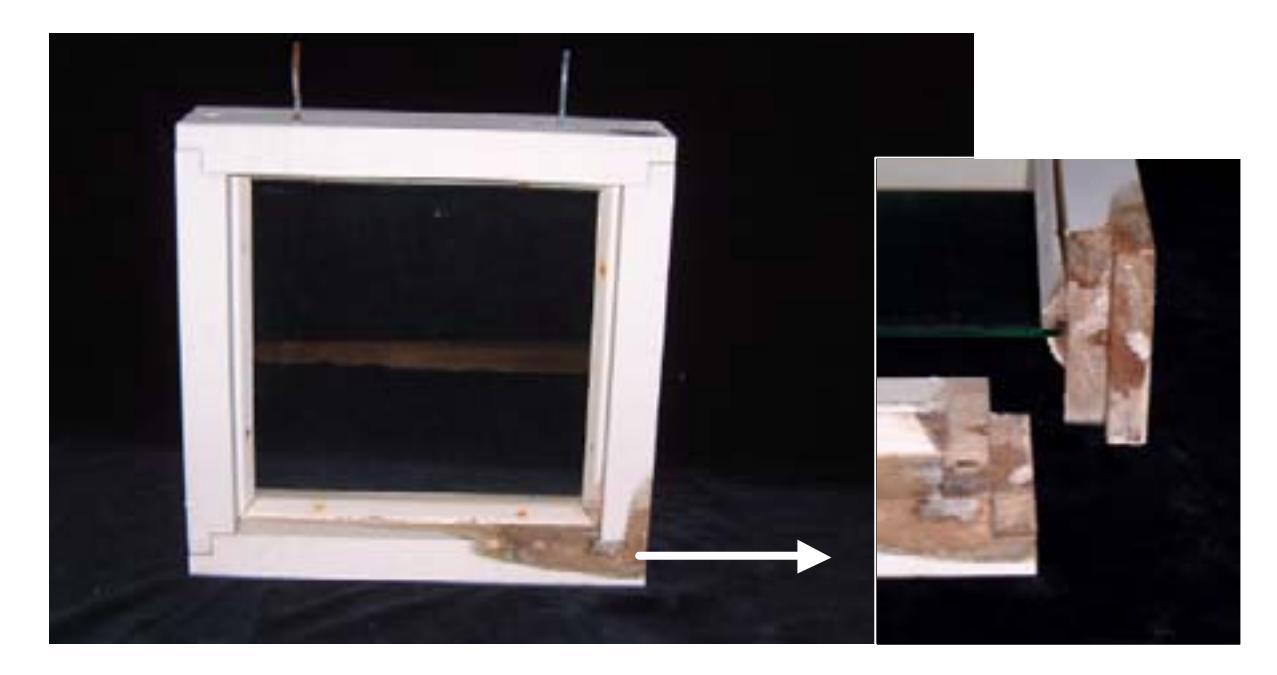
Most painted window frames constructed from untreated *E. regnans, E. delegatensis* or *Shorea* spp. failed to decay after three years exposure. Severe decay was often denoted by heavy discolouration of the paint. This discolouration also gave an insight into the pattern of attack, as the decay appeared to originate at the ends of the particular component (within the rebate) and moved progressively away from the rebate, along the grain. This phenomenon is clearly illustrated in Figure 4.2. The value of maintaining the paint coating was also demonstrated in the window survey.

Figure 4.2: Discolouration in the paint due to severe decay in the bottom component of a *Shorea* spp. model window frame. The inset illustrates the extent of the decay in the rebate.

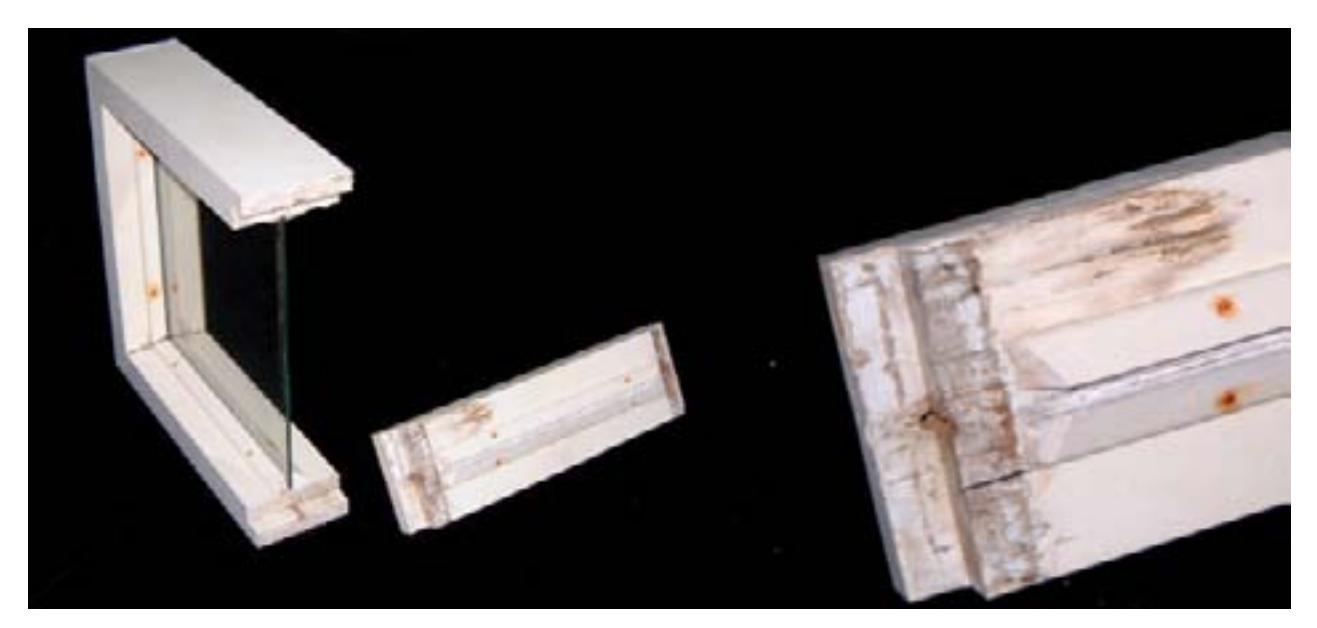
The practice of sealing the end grain before window assembly appeared to promote window durability when 30-40 year-old ash windows were examined in Bairnsdale¹³. The end grain in these windows had been sealed with a lead-based paint which is no longer available. It was thought that additional protection to untreated windows might be obtained by end sealing the internal rebates with primer prior to window assembly. Some evidence in support of this procedure was obtained in the lower rows of frames, where the bottom rebate for end sealed windows had a mean rating of 6.5 compared to 2.7 for similar windows (Table 4.1). While at least some of the aspects of the good performance of joints sealed with lead-based paints can be attributed to the good fungicidal properties of this type of paint, it is likely that the performance of joints with sealed end grain would have been better if the paint used was oil-based, instead of the water-based paint. Figure 4.3 illustrates typical decay in the rebate of an untreated *E. regnans* window that had the end grain sealed prior to assembly.

Figure 4.3: Heavy white rot in the rebate of an *E. regnans* model window frame with sealed end grain.

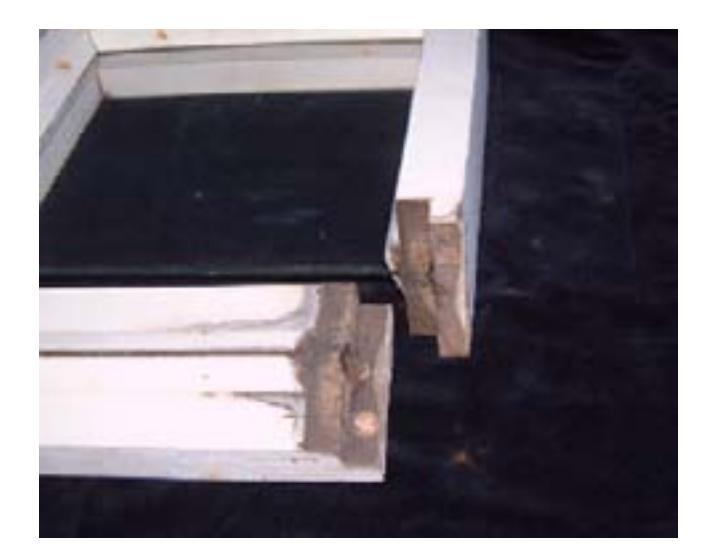
Figure 4.4: Slight decay in the rebate of a boron-treated *E. obliqua* window frame.

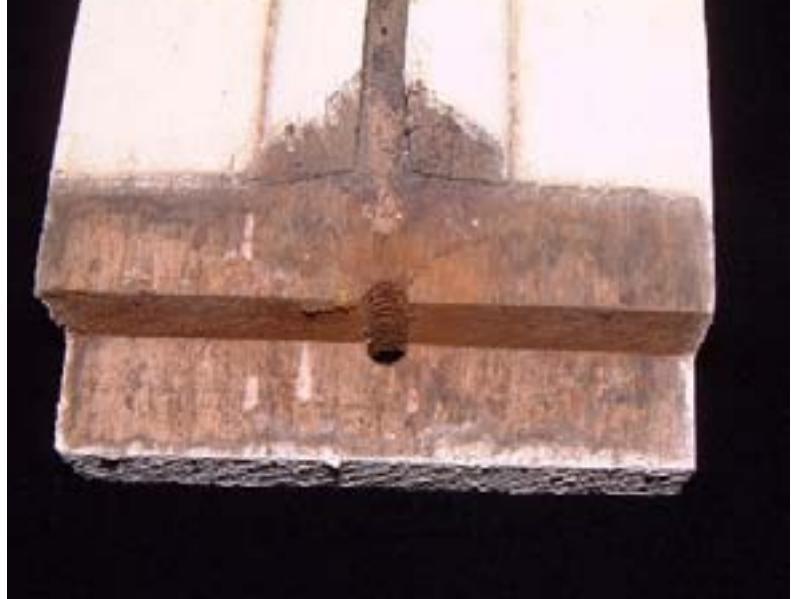
After three years exposure in the AFS and on the roof at Clayton, the LOSP-treated window frames were in good condition with only the one *E. regnans* window frame with slight decay. This *E. regnans* frame had been treated with the current LOSP formulation and had prominent decay, particularly where the glass was in contact with the timber (Figure 4.5).

Figure 4.5: Decay in a window frame made from *E. regnans* treated with the current commercial LOSP formulation.
