PROJECT NUMBER: PNB036-0607

MAY 2009

Mechano-Sorptive Nailplate Backout in Nailplated Timber Trusses

P. Paevere, M. Nguyen, M. Syme, R. Leicester, K. Ho

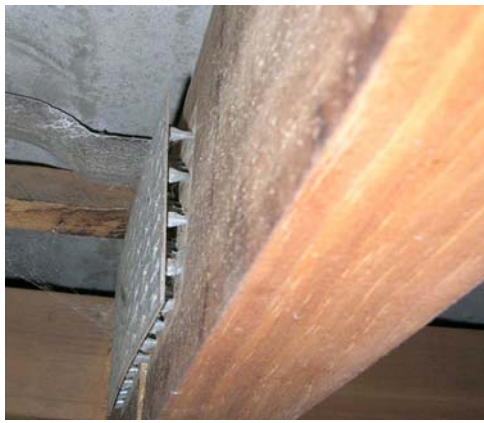
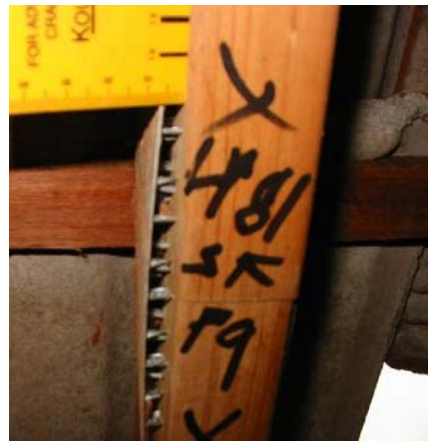
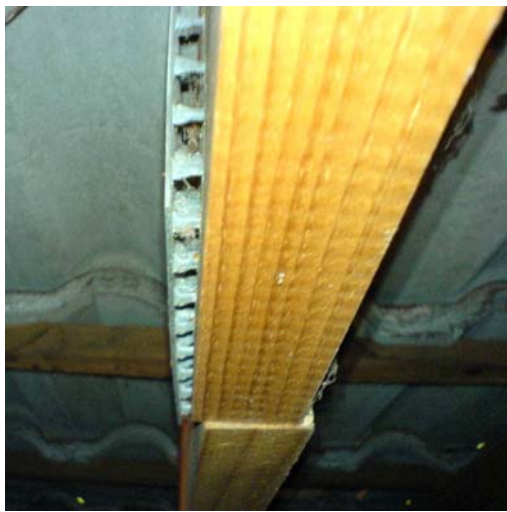
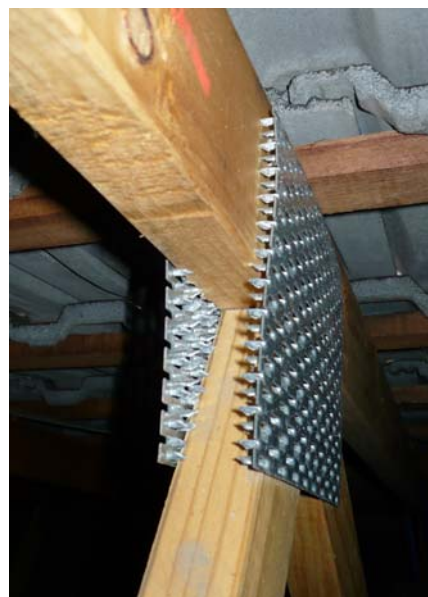
Figure 2.1 - Examples of nailplate backout inside roof spaces

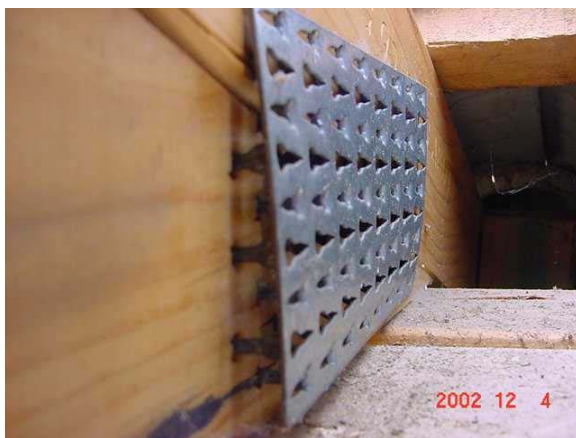
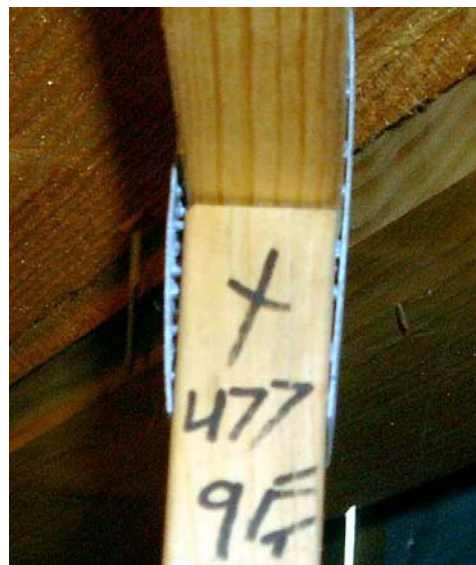
Figure 2.2 – Backout of nailplates exposed to the weather for 20 years

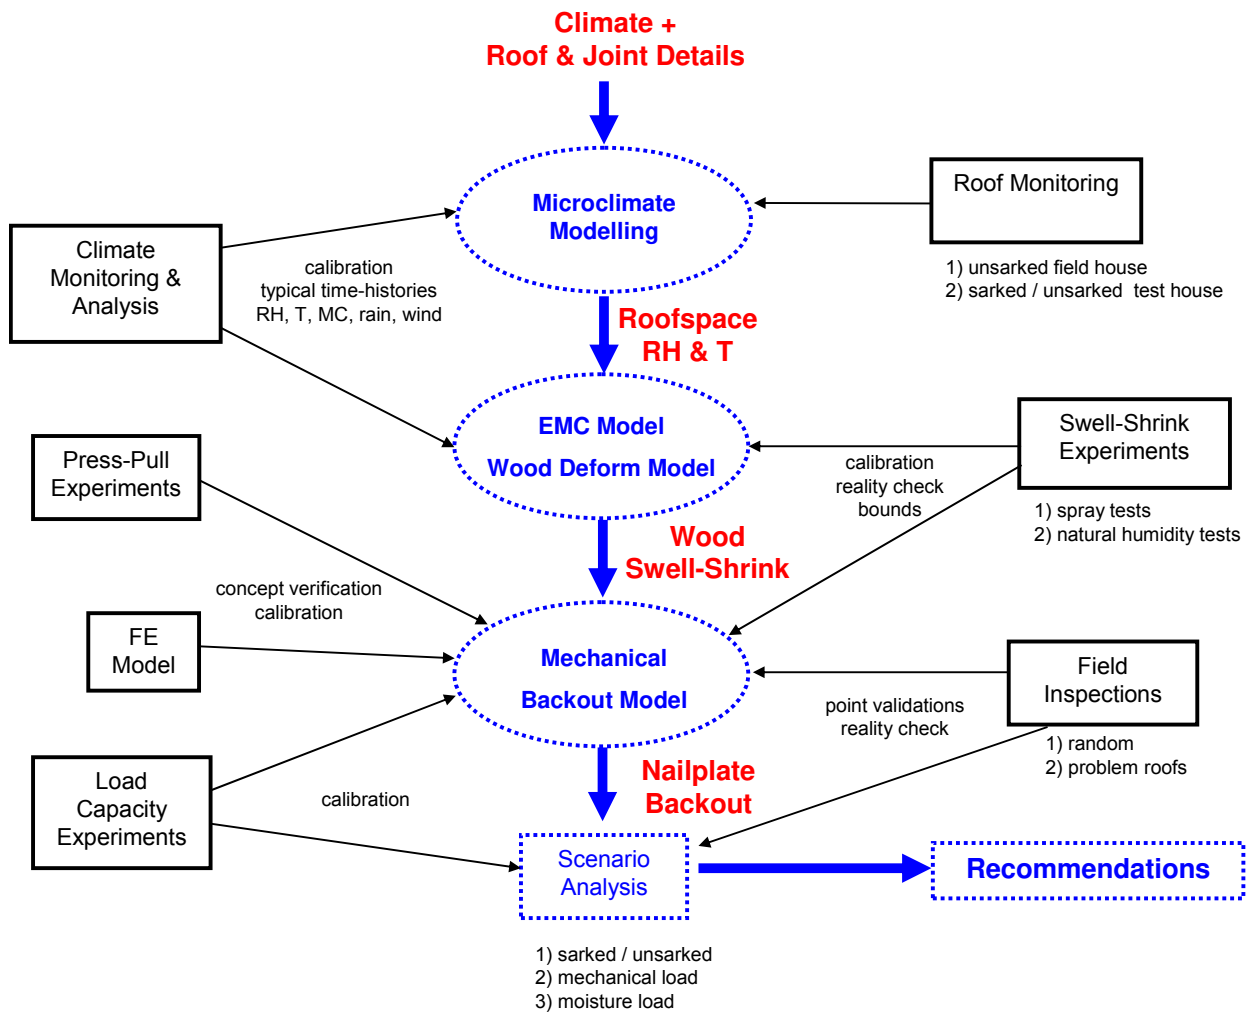
Figure 2.5 – Overview of research project activities

A diagrammatic overview of the research program and supporting activities is given in Figure 2.5. The following sections of this report summarise the objectives, methodology and results of the different components of the research program.

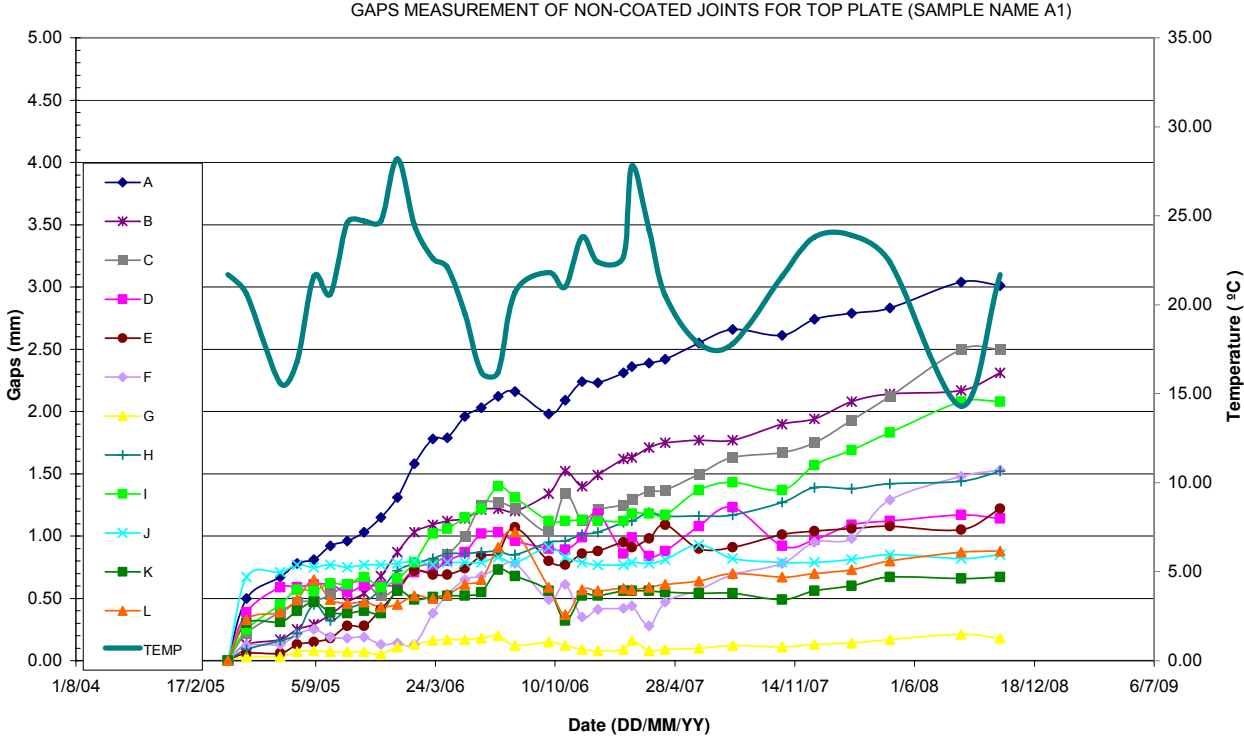
Figure 3.7 – Typical results of backout measurement on one nailplate

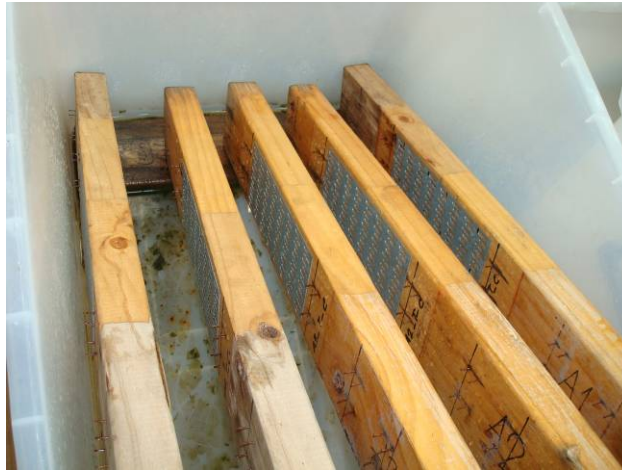
Figure 3.10 – Joints coated with 'Seal and Peel' WB5000. No backout observed.

Backout of coated joints with 'Seal n Peel' products was not measured. From visual observations of the backout, it was found that the 'Seal n Peel' WB5000 has excellent performance in preventing the nailplate backout, giving almost no backout over the years with about 800 wetting cycles, as seen in Figure 3.10. The 'Seal n Peel' 660, however, gave poor performance, where breakage of the seal and hence nailplate backout occurred, as seen in Figure 3.11.

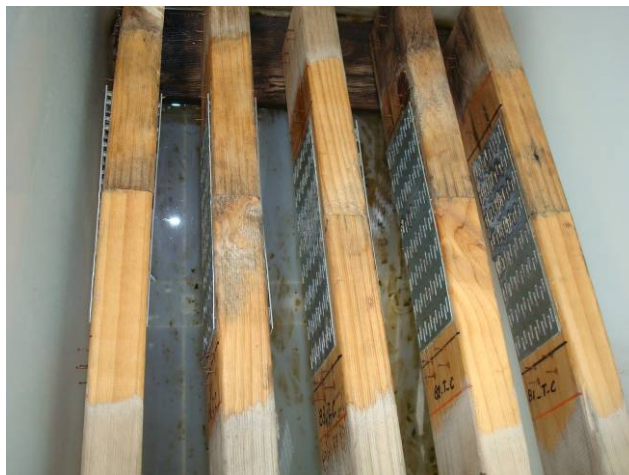
Figure 3.11 – Backout in joints coated with 'Seal and Peel' 660

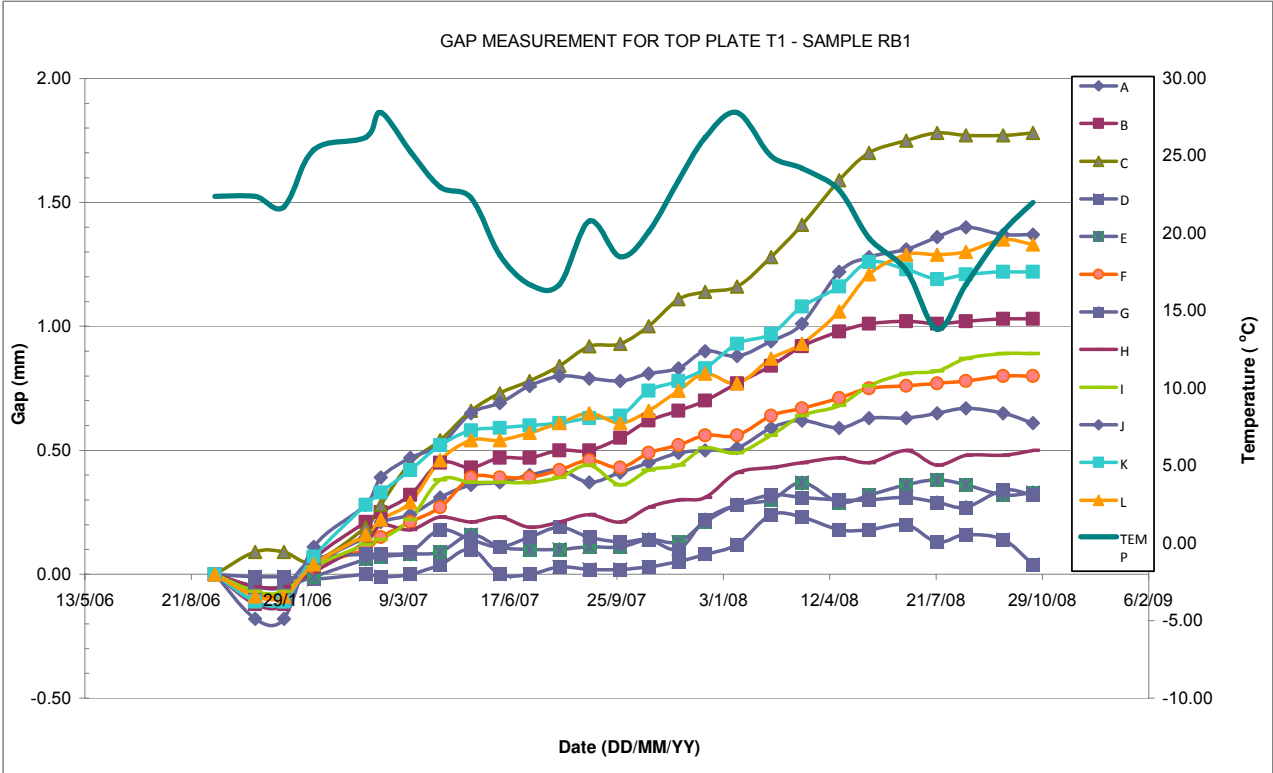
Figure 3.12 – Typical results of backout measurement on one nailplate

For the second test (Mechano-Sorptive) MiTek also reported the results of the test in terms of backout measurements on each nailplate with time, as typically shown in Figure 3.12. Figure 3.13 shows the backout on back-sawn Radiata pine specimens. Figure 3.14 shows the backout on quarter-sawn Radiata pine specimens. Figure 3.15 shows the backout on back-sawn Slash pine specimens. No clear difference between the backout in back-sawn and quarter-sawn Radiata pine specimens was observed.

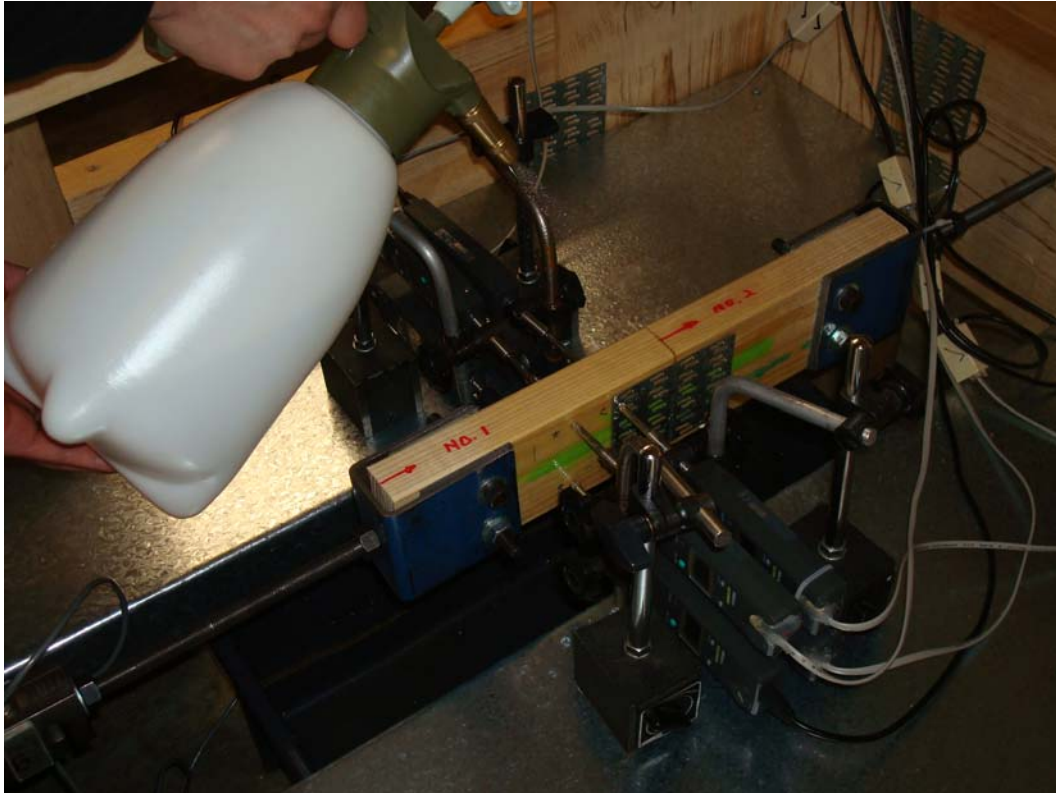
Figure 3.16 – Wetting of specimens using a pressurised spray bottle

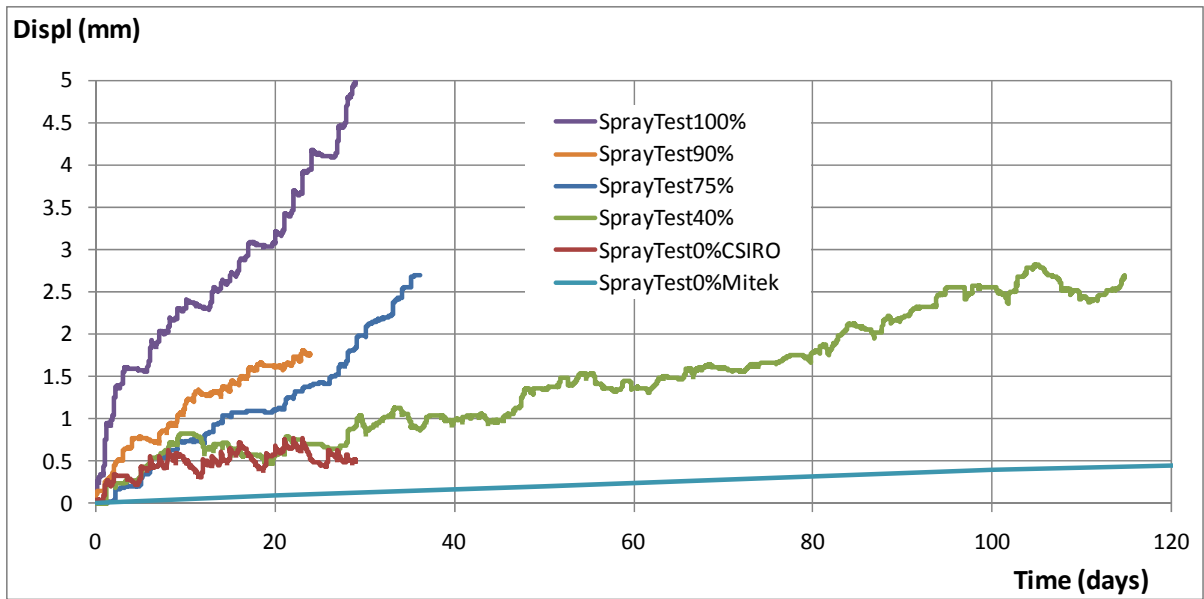
Figure 3.21 – Comparison of spray tests under different loading levels

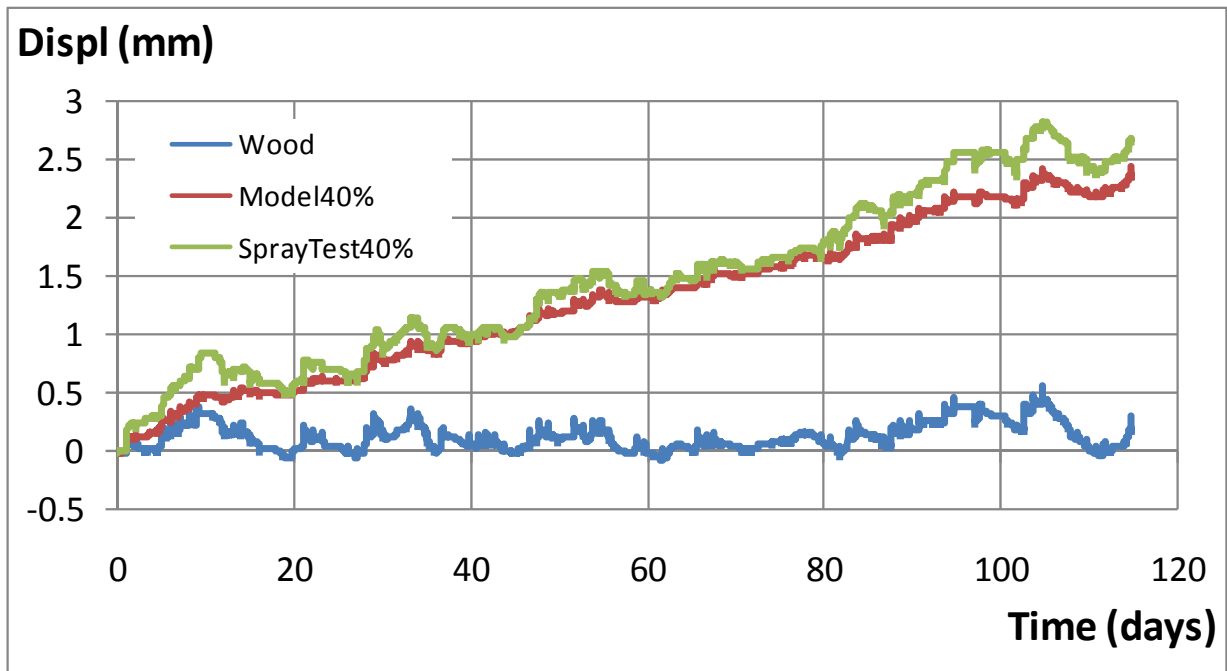
Figure 3.22 – Comparison of model prediction and spray test result for loading level of 40%.

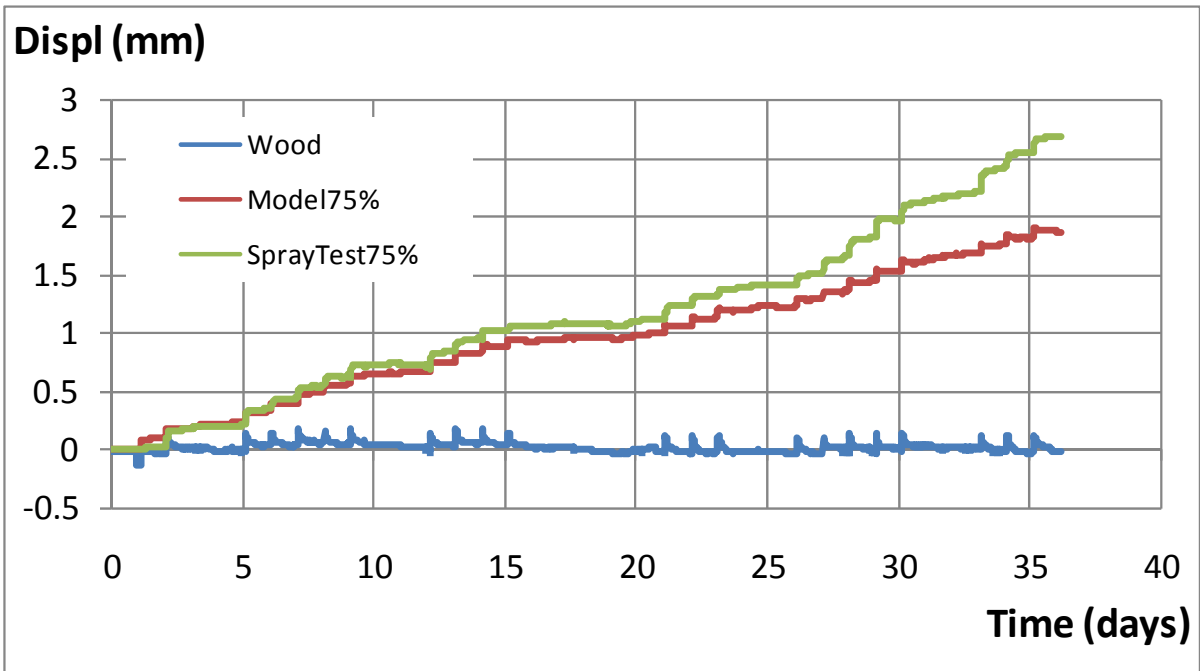
Figure 3.23 – Comparison of model prediction and spray test result for loading level of 75%.

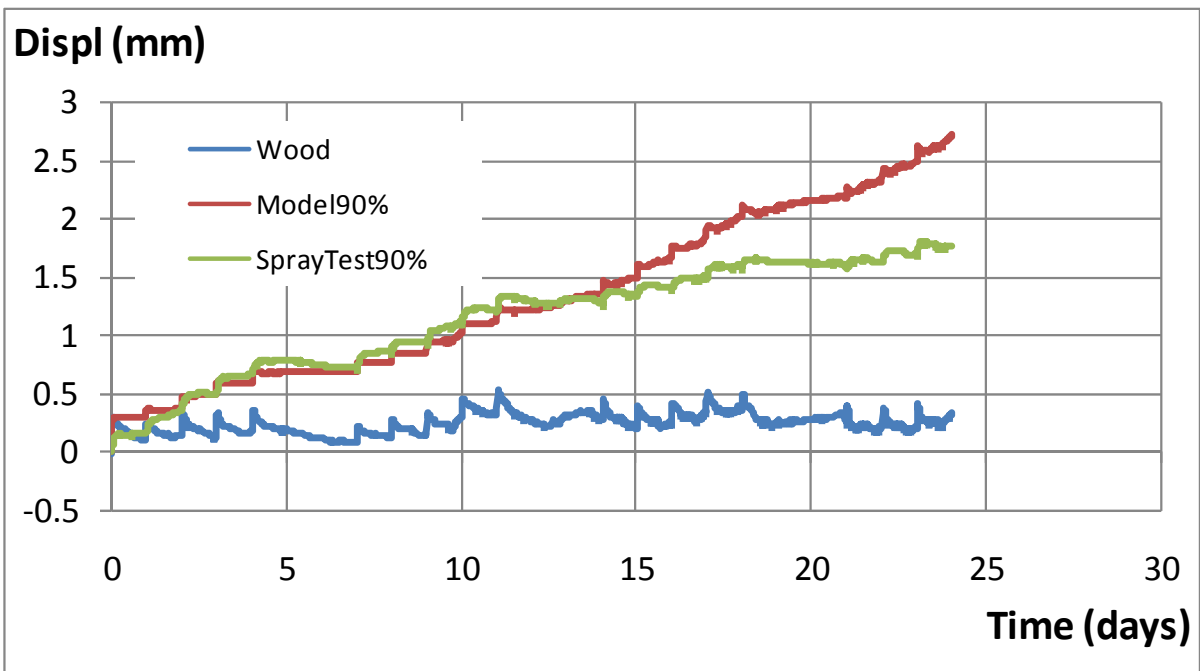
Figure 3.24 – Comparison of model prediction and spray test result for loading level of 90%.

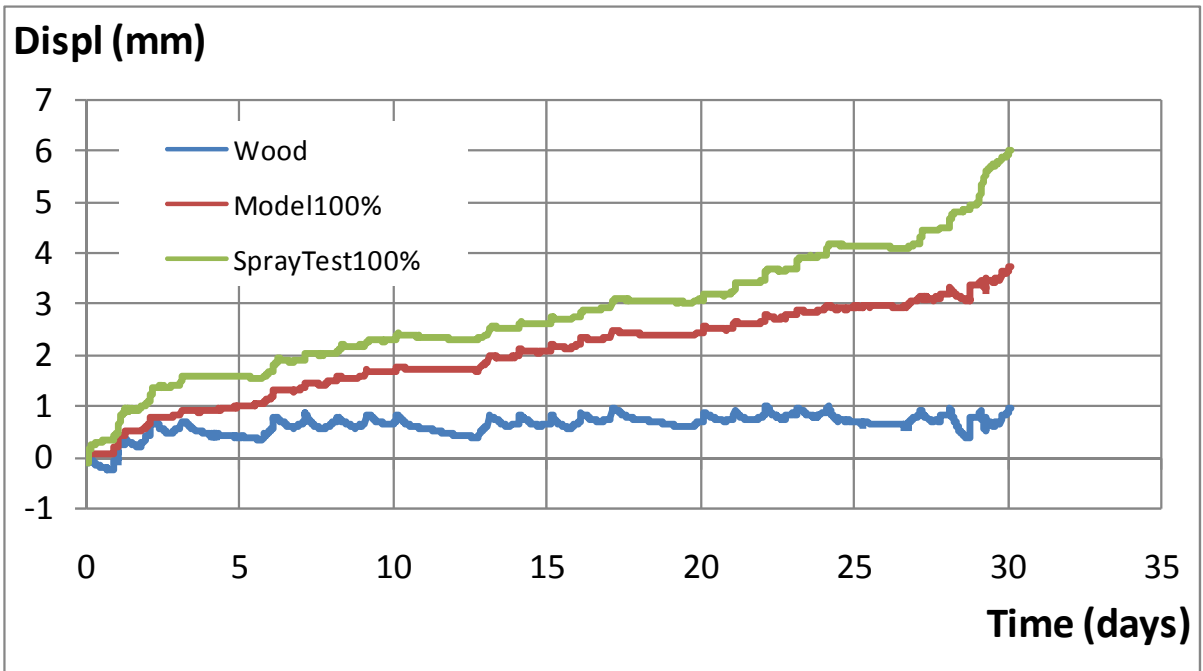
Figure 3.25 – Comparison of model prediction and spray test result for 100% loading

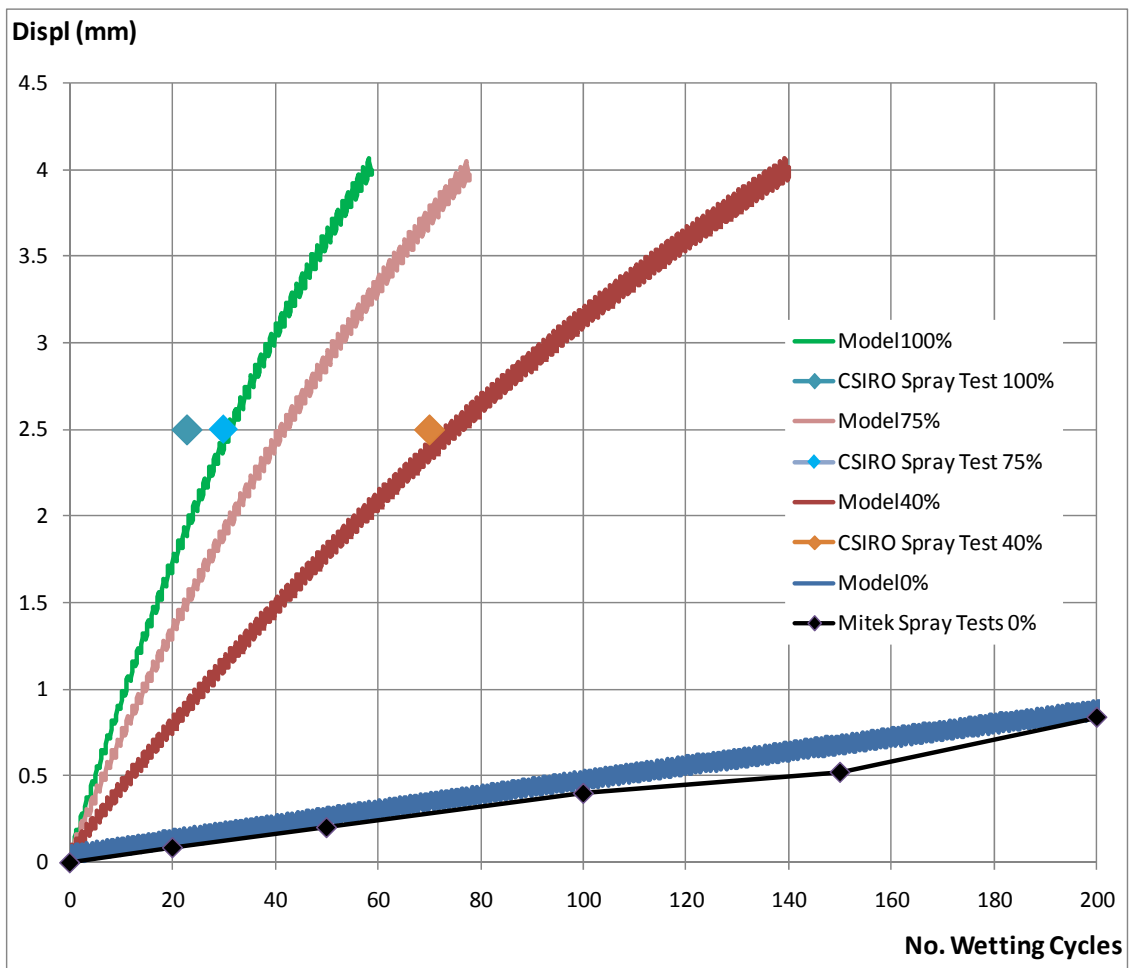
Figure 3.26 – Comparison of Pulse Model predictions versus spray test results

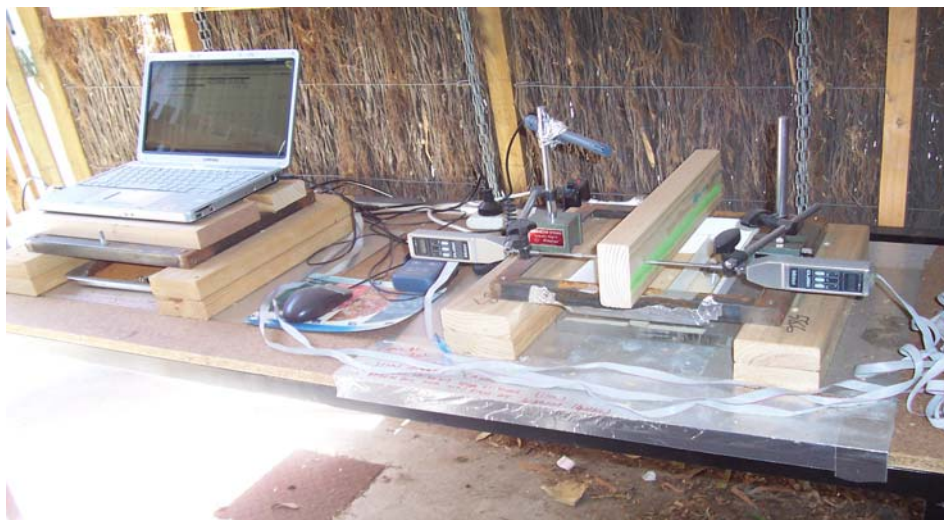
Figure 3.27 – Natural Humidity Test set up

The timber used in the test was similar to specimens chosen for the spray-test experiments (90x35mm radiata pine). As shown in the test setup in Figure 3.27, swell-shrink deformations were measured on opposite sides of the specimen on one end only. Temperature, Relative Humidity and deformations were recorded continuously every ten minutes for more than a month during summer. The data collected is used to calibrate the algorithm to compute wood shrinkage with time from T and RH data.

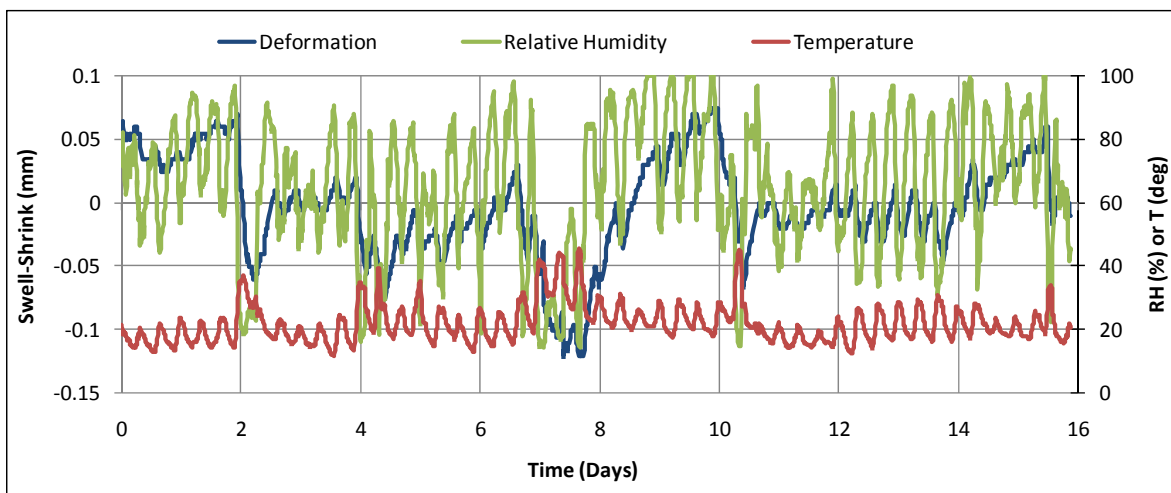
Figure 3.28 – Example of measured deformation, RH, and T in natural humidity swell-shrink tests

An example of the swell shrink deformation, relative humidity and temperature data for a period of 16 days is shown in Figure 3.28. This graph shows how the measured deformation is quite well correlated with the long-term relative humidity trend. Figure 3.29 shows the measured swell-shrink deformation compared to the value calculated using the swell-shrink model described in Section 7. The model uses the measured temperature (T) and relative humidity (RH) data as an input and does a good job of simulating the measured deformation. Based on these results, we can be confident that the swell shrink model can predict wood deformation reasonably well, so long as the T and RH data is appropriate.

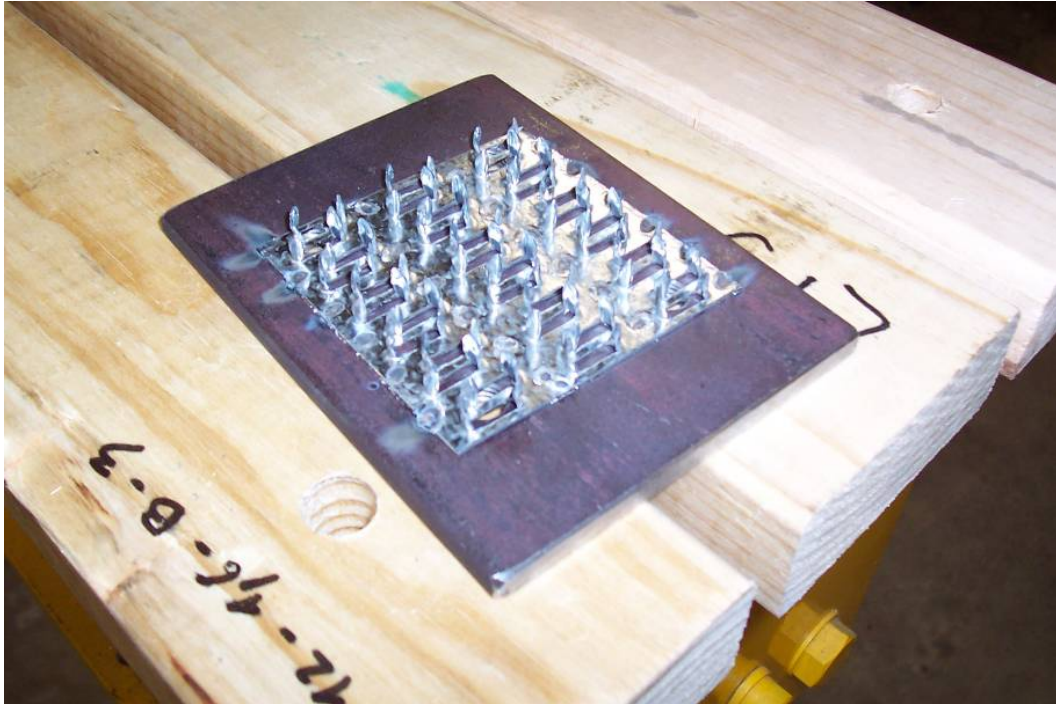
Figure 3.35 – MiTek 1.0 mm thick GQ nailplate spot welded to 5 mm thick nailplate.

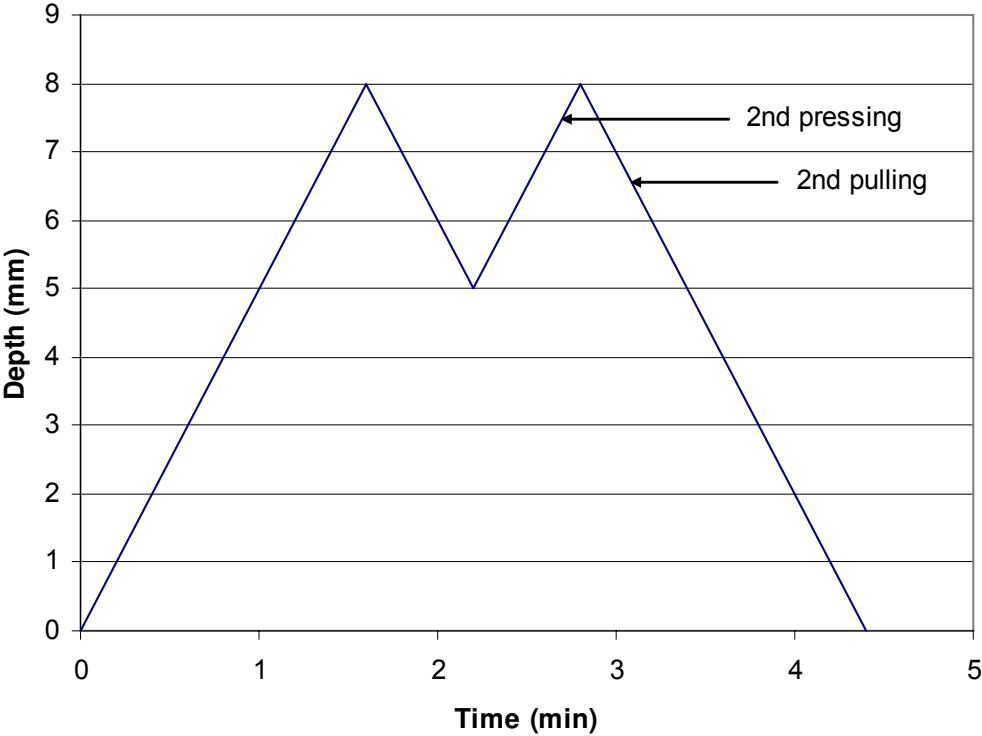
Figure 3.37 – Notional loading for 12% mc specimens, 3.0 mm withdrawal.

For 12% mc specimens, the nailplate was fully pressed again and withdrawn for a second time. On the second (last) withdrawal, the nailplate was fully withdrawn. The nailplate loading for the 12% mc specimens was represented notionally as shown in Figure 3.37.

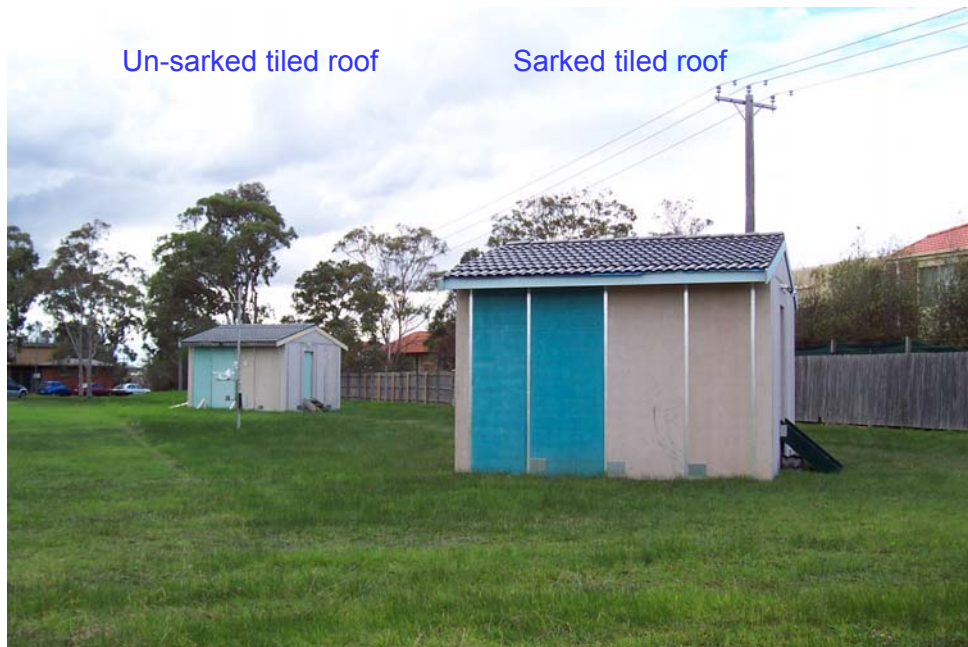
Figure 5.1 – Two test houses at CSIRO Highett site

Two test houses have been built at CSIRO Highett site, as shown in Figure 5.1. The houses are identical in dimension, configuration and materials used, except one is sarked with a moisture barrier under the tiles, and one un-sarked, as shown in Figure 5.2. Monitoring systems, including 2 sets of Oregon Scientific wireless weather stations and additional independent sensors with data loggers, are installed at various locations in the 2 test houses, as depicted in Figure 5.3. Figure 5.4 shows the data logging systems on PC windows.

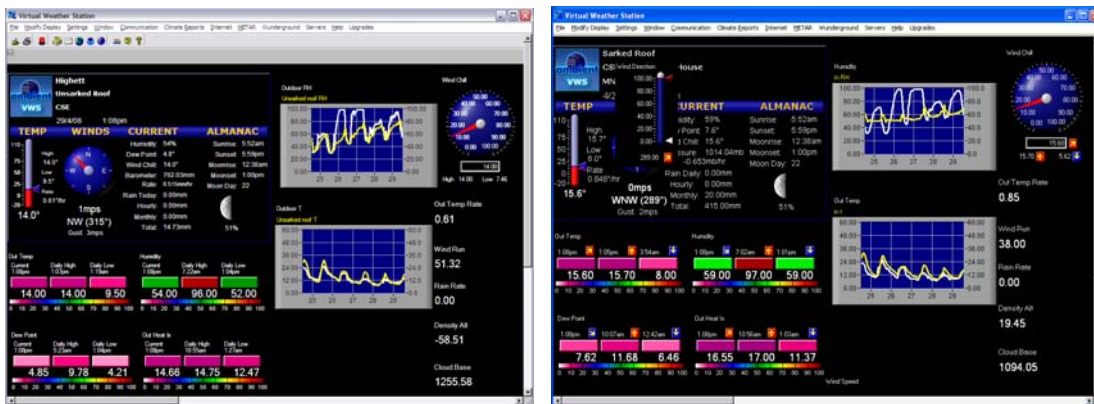
Figure 5.4 - Data logging systems on PC

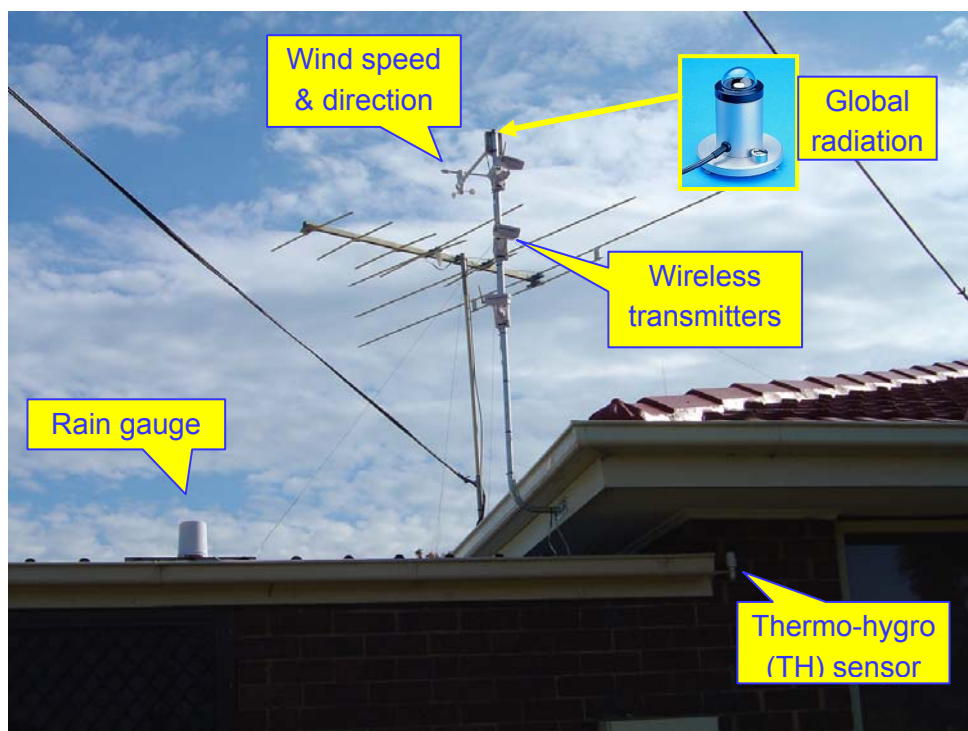
Figure 5.10 - Monitoring system for outdoor climate parameters, including air temperature & humidity, wind direction & speed, rain intensity and solar radiation

The outdoor monitoring systems, the sensors within the roof space, and the data logging station at the house are shown in Figure 5.10, Figure 5.11, Figure 5.12 respectively.

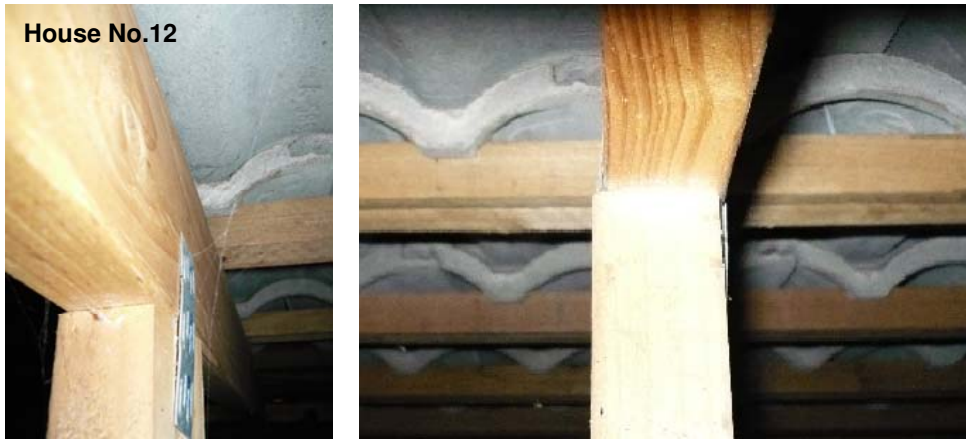
Figure 6.1 - A typical case of the 'alignment' type – the most common type found in the inspections

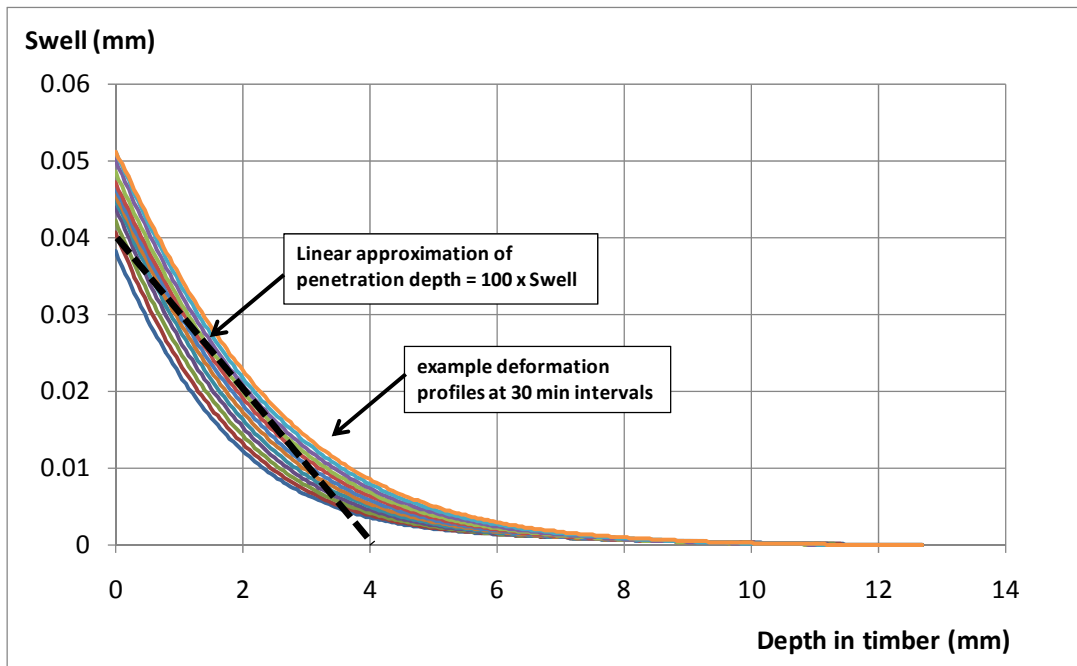
Figure 7.3 – Approximation of timber moisture profile due to humidity variation

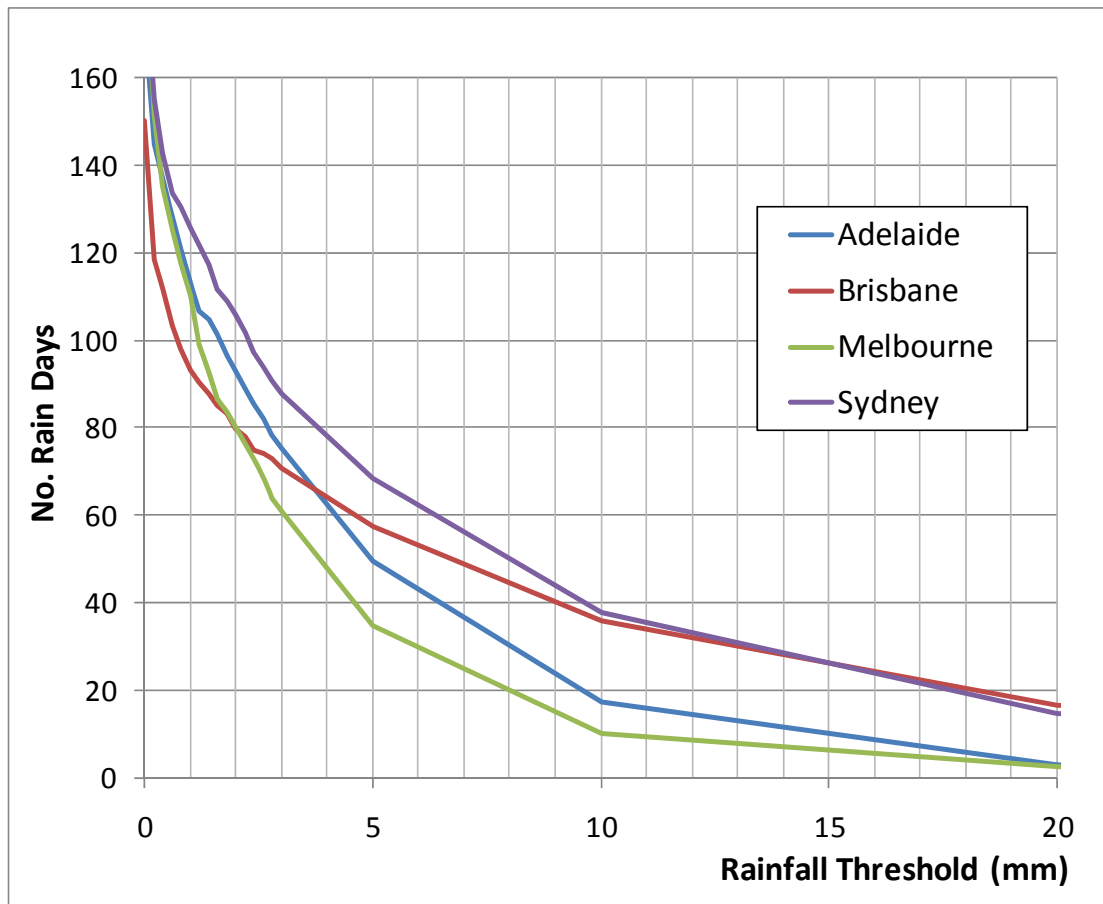
Figure 8.1 – No. of raindays vs rainfall threshold

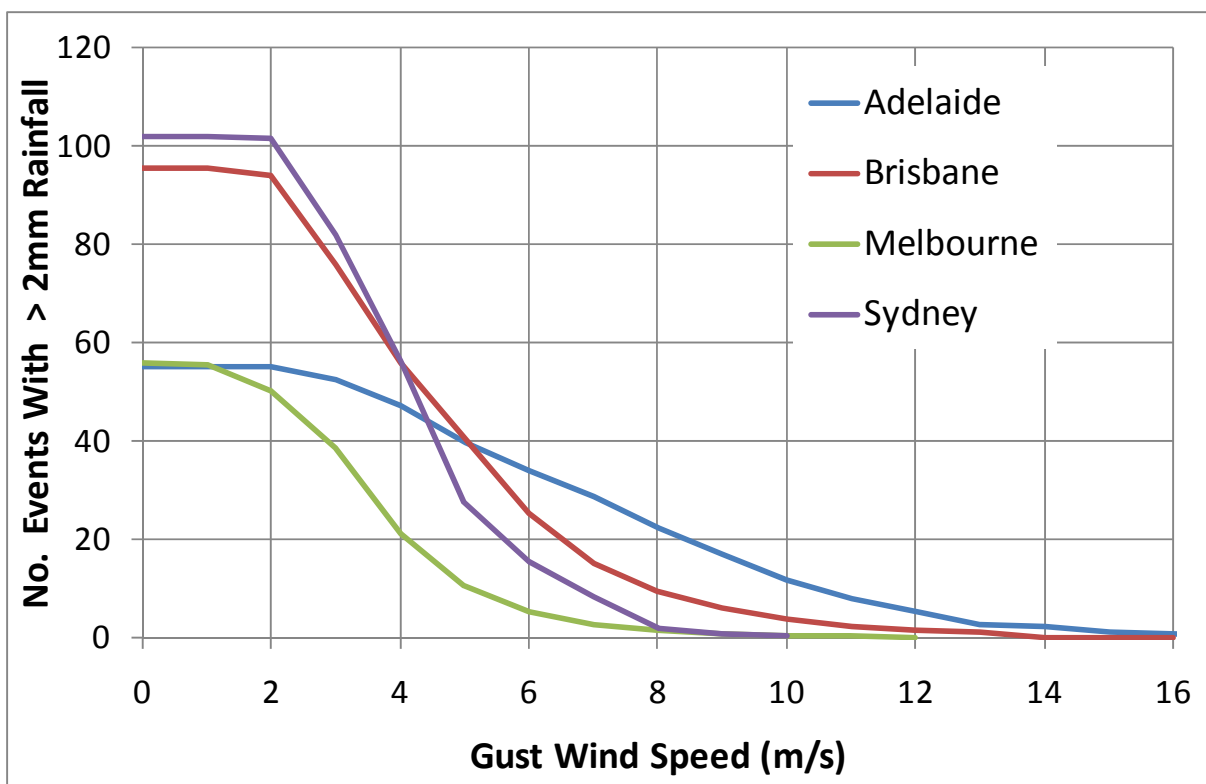
Figure 8.2 – No. of wind driven rain events vs gust wind speed

- The mechanical backout model was used to predict the number of wetting cycles required to cause failure (i.e. the number of wetting cycles required to result in a backout of 2mm) under loading of 0%, 40%, 75% and 100% of joint capacity. Each cycle of wetting and drying was represented by a wood swell shrink of +/- 0.1mm, and cycles were assumed to be independent of each other.
- Tables 8.3 to 8.6 were used to look up the windspeed threshold (for 2mm threshold of rain) that would just cause the number of annual wetting cycles required for failure over a 50 year life.
