PROJECT NUMBER: PNA023-0809

AUGUST 2010

# Pine timber roof environments in Western Australia and its susceptibility to European House Borer

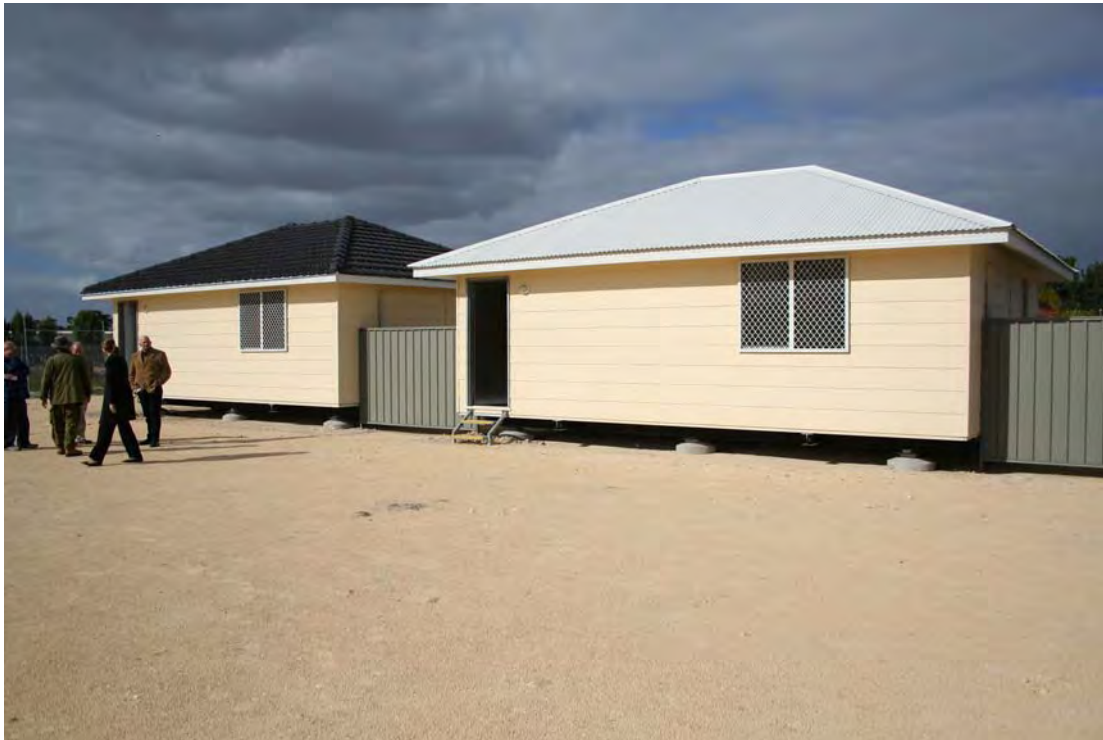
**Figure 1: “PR houses” - EHB proxy roof buildings at the Gnangara site, showing design and construction overview.**

These sites form a triangle around the *Gnangara Pine Plantation* with a mean distance of  $\approx 8$  km between sites. Figure 1 illustrates the design of the buildings.

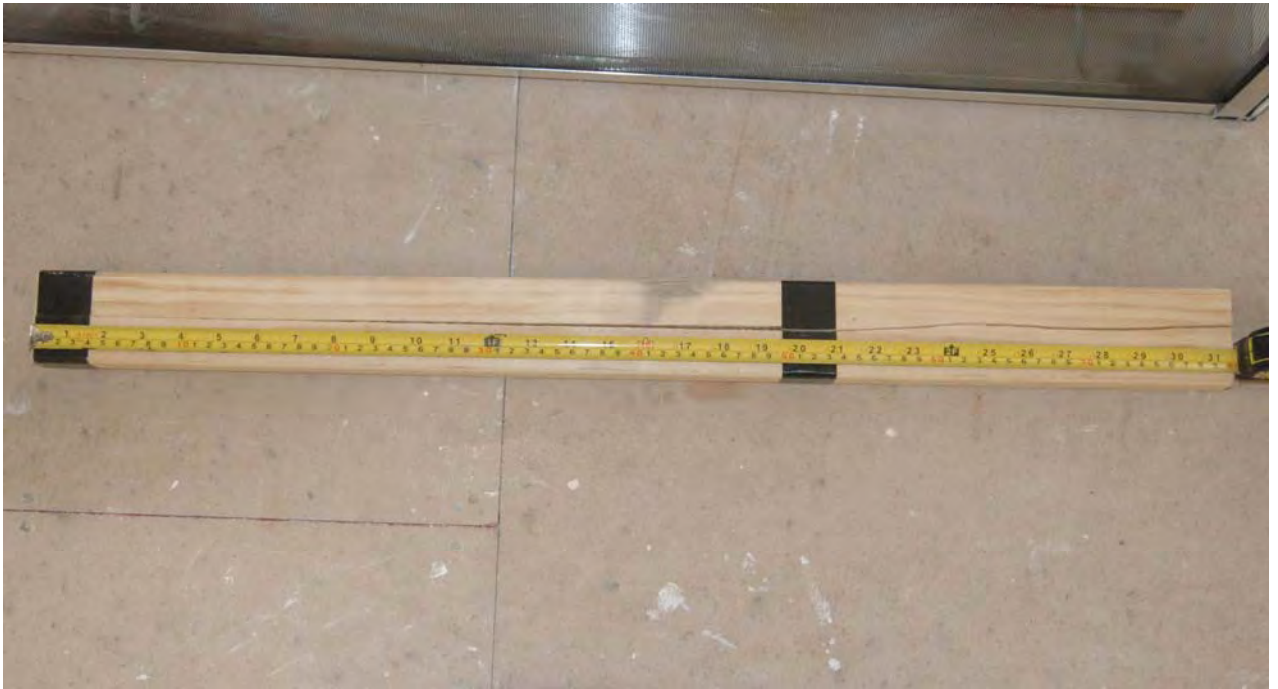
**Figure 2: Typical split-beam (trial 1 design) showing tape binding with the left part being the sawn groove and the right part the split section** (Photo: RJ Cunningham)

All split-beams were labelled so provenance could be matched. Strict selection criteria (requirement for 90% sapwood, no checking, no knots or other wood faults that could provide alternative oviposition sites) and irregular or jagged splitting resulted in a high ( $> 70\%$ ) rejection rate for material drawn from a pack of timber and processed to produce a proxy-beam.

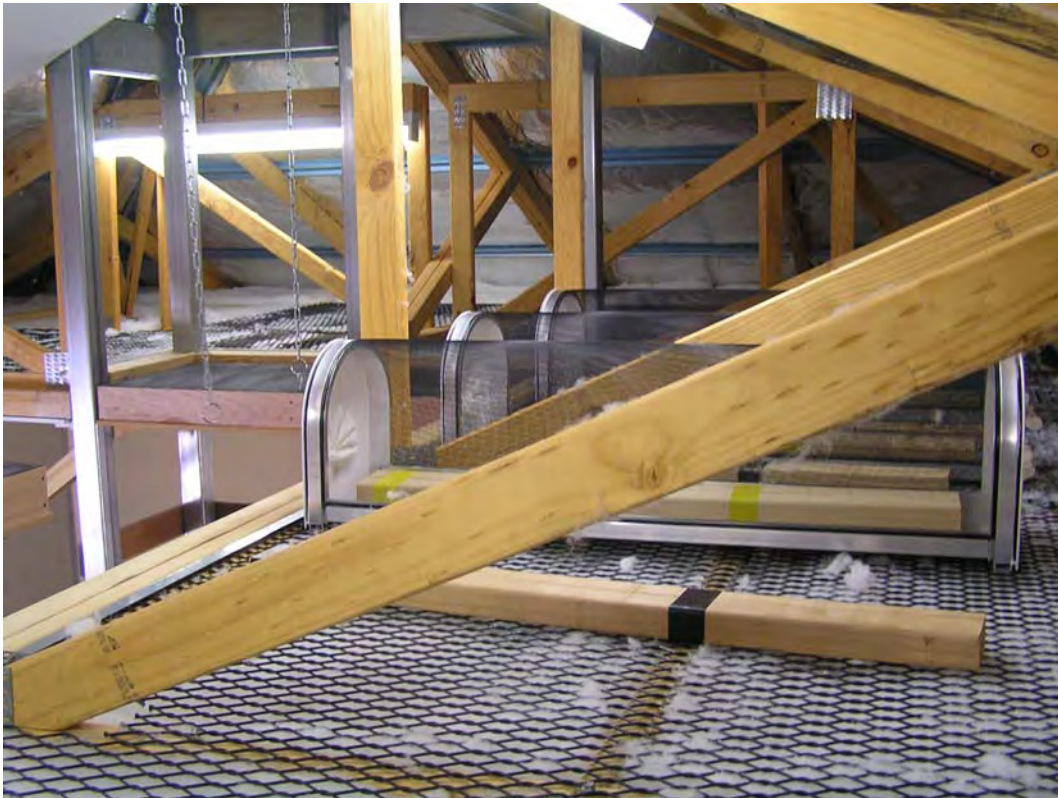
**Figure 3: Roof space with cages and split-beams from trials 1 and 2 visible** (Photo: L Vagg)

Six tunnel cages were placed in each PR house, three in the cool living space on the floor surface and three in the hot roof space on the ceiling surface (see Figure 3), giving a total of thirty-six cages. Each cage had one split-beam and a pair of colony *H. bajulus* placed in it. Pairs of adults were case-matched as pairs, one pair of each pair placed in the hot roof and the other in the cool living area. Similarly split-beams from the same source length were paired with parts of each pair placed in the hot roof and the other in the cool living area.

The oviposition sites of all clutches showed a marked non-random distribution ( $\chi^2_{[9]} = 178$ ,  $p < 0.001$ ) over the length of the split-beams with a strong aggregation at the basal end of the sawn section (where the sawn groove narrowed near the binding tape or cable tie) and another aggregation in the cracked 300mm section (Figure 3).

Using estimates of the groove width the mean crack width of oviposition sites in the grooved section of the split-beams was 0.29mm ( $\pm 0.054$  mm), see also Figure 3.

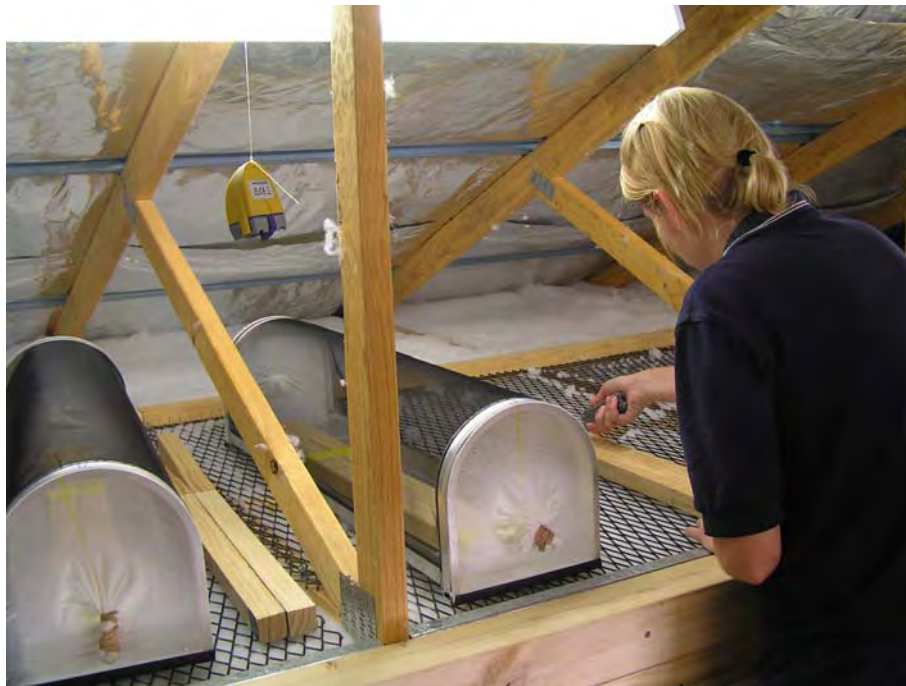
**Figure 4: Cutting split-beams open for inspection in a roof space. A “Tiny Tag”™ datalogger can also be seen** (Photo: L Vagg).

After a period of 4-8 weeks the bindings of the split-beams were cut and the pieces taken apart to inspect for egg clutches and/or signs of early larval feeding (see Figure 4, Figure 5 and Figure 6). Any clutches found had the following parameters recorded:

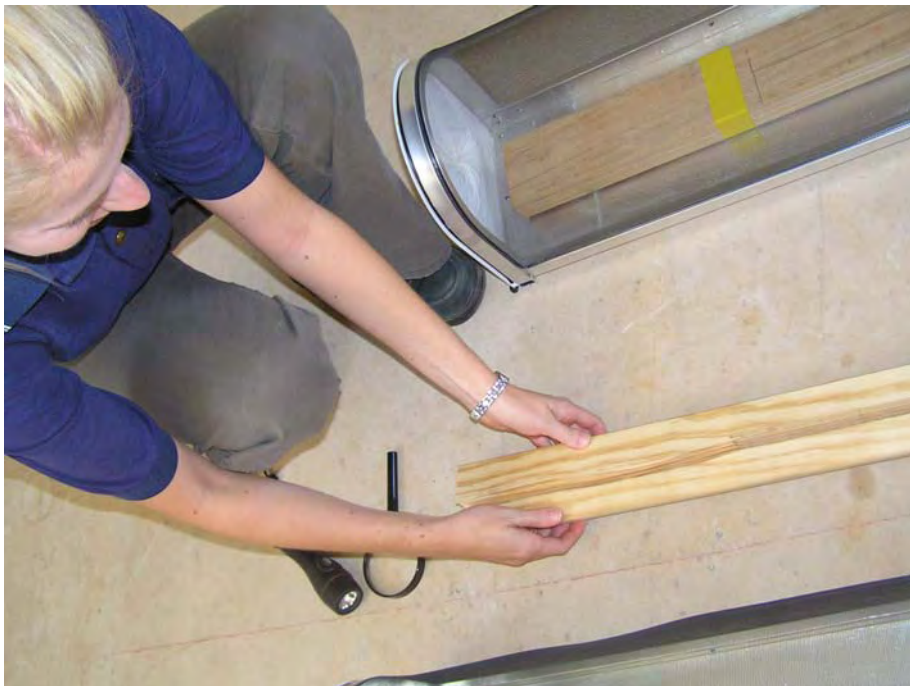
**Figure 6: Opening and examining a split-beam in a living space** (Photo: L Vagg)

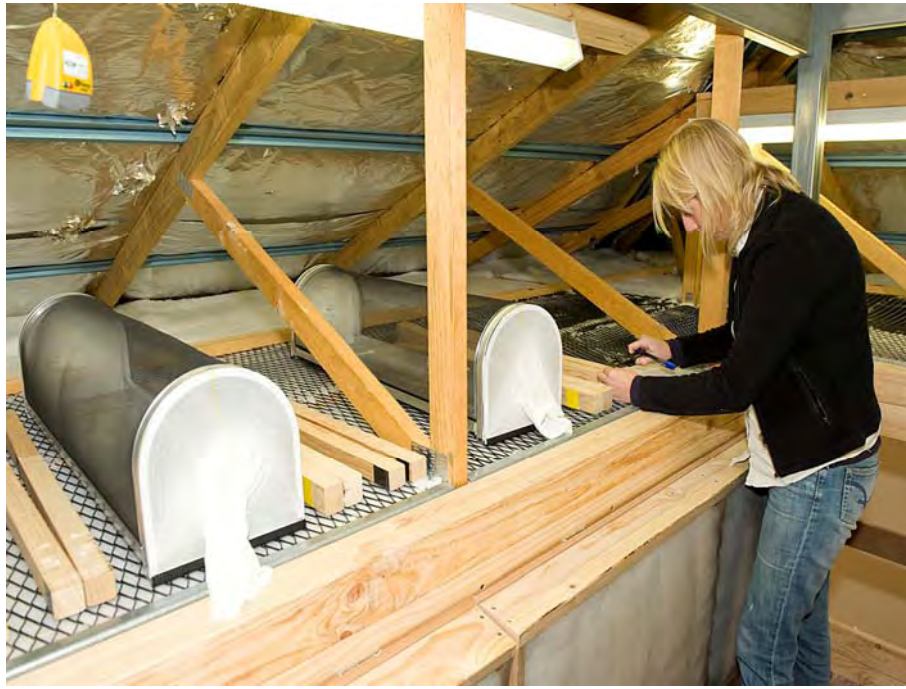
**Figure 7: Measuring clutch size and position in split-beams in a roof space** (Photo: P Scanlon)

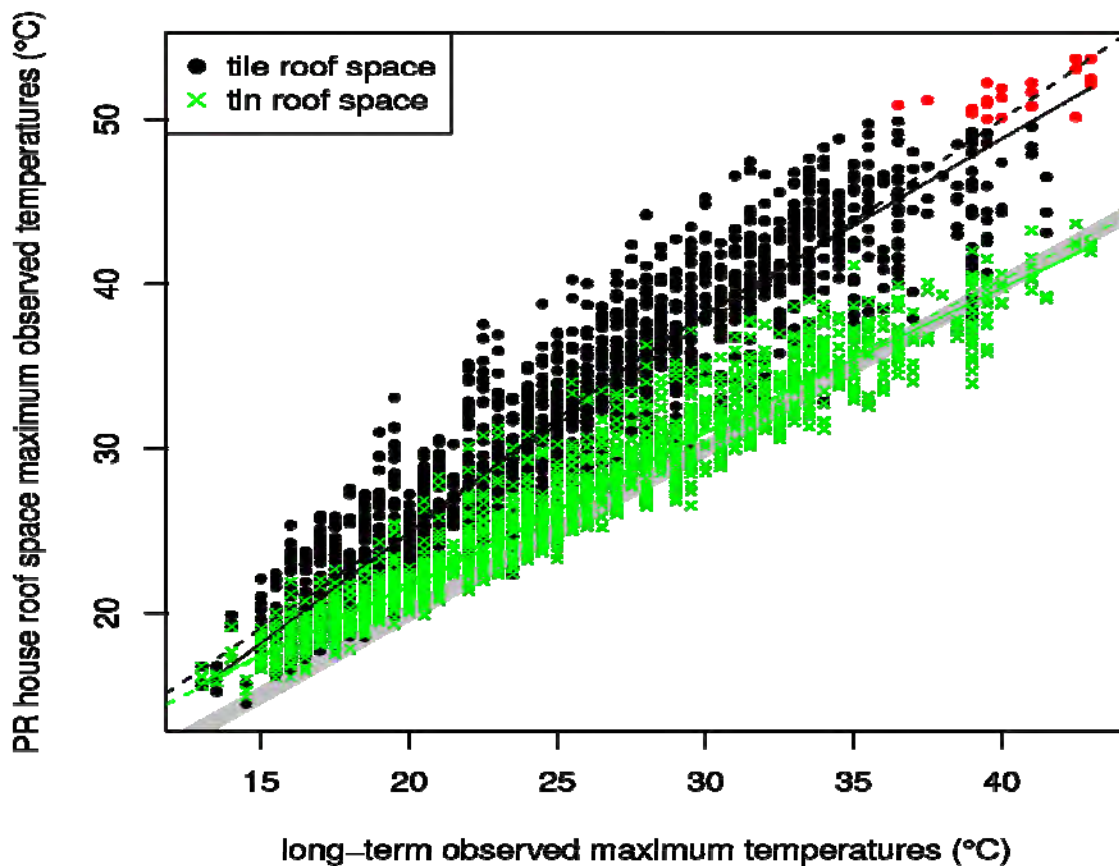
Figure 10: Relationship between long-term observed maxima from the Wanneroo station (No. 9105) and tile and tin roof space data from all PR houses. Red points mark roof space temperatures  $> 50^{\circ}\text{C}$ , solid lines represent fitted splines and dashed lines linear fits for each roof type. The grey band shows parity

There is a strong relationship between long-term observed maximum temperatures and maximum temperatures seen in PR house roof spaces (Figure 10). Over the range of available data the relationship is well approximated as a linear model ( $PR_{house} = (1.24 \times \text{long-term observed maximum}) + 0.503$ ,  $F_{[1, 1719]} = 12974$ ,  $p < 0.001$  and  $PR_{house} = (0.914 \times \text{long-term observed maximum}) + 3.65$ ,  $F_{[1, 1707]} = 21795$ ,  $p < 0.001$  for tile and tin roof spaces respectively), though the tile roof space, in particular shows, deviations towards the extremes. Tile and roof spaces had a mean temperature of  $6.54^{\circ}\text{C}$  above observed long-term maxima, while tin roof spaces had a mean temperature  $1.49^{\circ}\text{C}$  above observed long-term maxima.

Figure 10 also shows that the first observed critical event (temperature exceeded  $50^{\circ}\text{C}$  in a roof space) occurs when long-term maxima exceeded  $36.5^{\circ}\text{C}$ , and that the long-term maxima must exceed  $42.0^{\circ}\text{C}$  before *all* observed PR house roof space observation exceed  $50^{\circ}\text{C}$ .

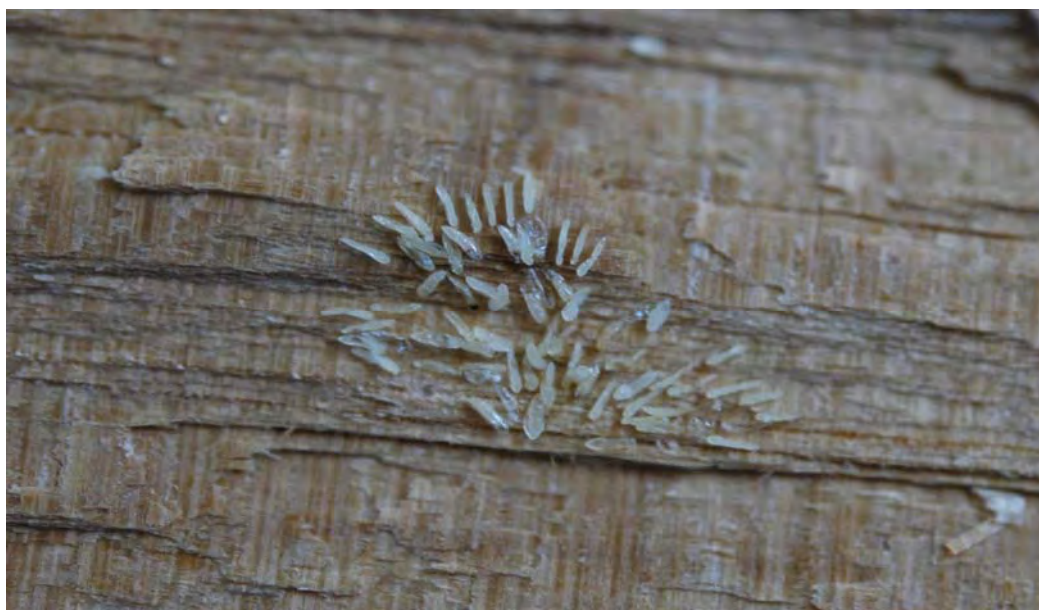
**Figure 11: Hatching clutch. Pictured are eggs ready to hatch, egg casts and unfertilised eggs** (Photo: RJ Cunningham)

*H. bajulus* successfully oviposited in all of the treatment combinations (living/roof space and tile/tin roof). Figure 11 shows a typical clutch as oviposited inside a grooved section crack of a split-beam. All three trials had clutches laid in every treatment combination with the exception of living spaces under tin roofs in trial 2, trial 2 being marked by overall low rates of oviposition (Table 8). Aside from the low rate of oviposition during trail 2 there was no consistent, nor statistically significant, effect seen, and in particular no bias towards particular roof or space types (Figure2).

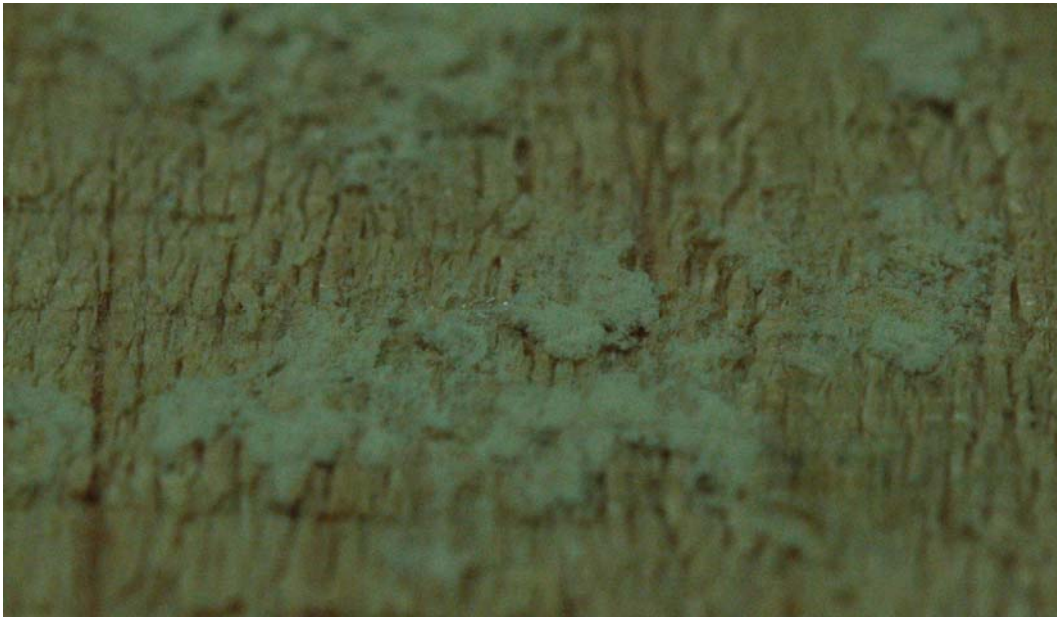
**Figure 14: Hatched clutch with frass indicating the newly hatched larvae have entered the split-beam and started feeding** (Photo: RJ Cunningham)

Clutches successfully hatched and commenced feeding in all treatment combinations (Table 11). Figure shows a recently hatched clutch with frass produced by feeding of early instar larvae entering a split-beam.

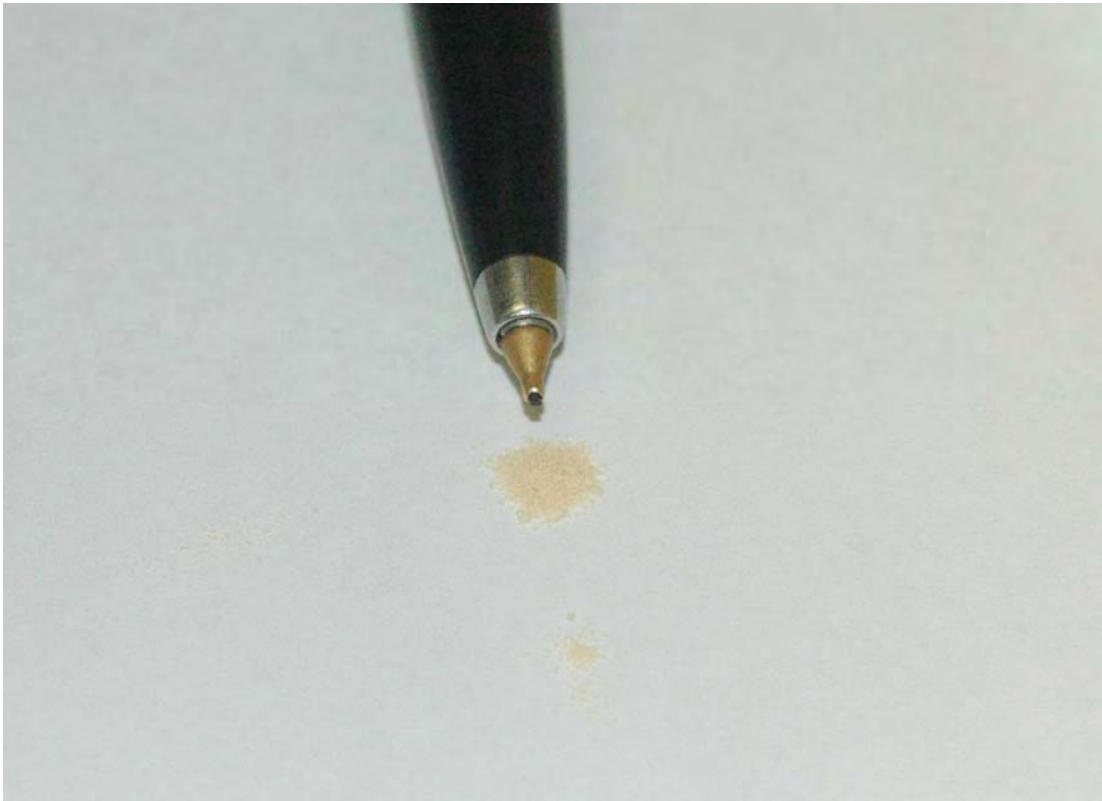
**Figure 2: An excess frass pile found under a split-beam 18 months after initial infestation. This frass pile was produced by  $\approx$  3 months feeding (April–July 2010). (Photo: RJ Cunningham)**

Recent excess frass production was observed from 7 split-beams (four from trial 1, three from trial 2) infested during the 2008 emergence season trials ( $\approx$  18 months and two summers post-infestation), see Figure 26. Excess frass production is probably not usual (most frass production will be contained in hidden galleries) so these data are only indicative of what may be happening. Nevertheless, it seems that as at July 2010 *H. bajulus* larvae are alive and actively feeding in both tile and tin PR houses and in the living and roof areas (Table 12).
