Six Storey Timber Framed Building's Movement and Moisture Content

Project number: PRA449-1718

December 2020

**Forest & Wood
Products Australia**

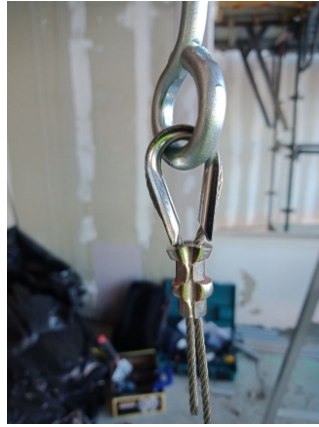
To anchor the non-extendable thin stainless steel wire to the floor above, a galvanised hook bolt (Eye Bolt) is connected to the floor above by an aluminium angle that is also used to secure the String Pot box to the next level, refer to Figure 10.

Figure 10: Connection Eye-bolt and stainless steel wire, Image Credit: TDA

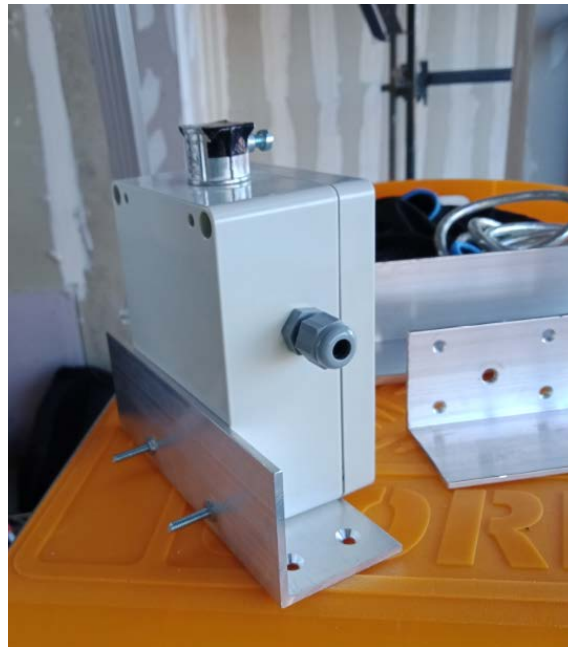
The hook bolt runs through a hole in the CLT floor and is anchored to an aluminium angle used to fix the next floor's String Box, refer to Figure 11. To ensure the fire rating of the ceiling is not compromised, the hole the hook bolt is contained in is protected by a 32 mm HPDM conduit, refer to Figure 12.

Figure 11: Aluminium Angle used to secure eye bolt and String Pot Box, Image Credit: TDA

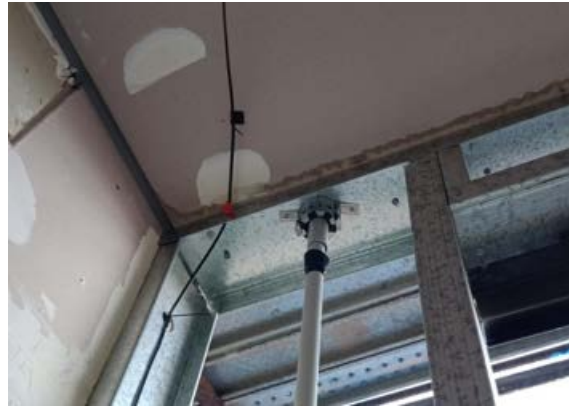
At the underside of the fire-rated plasterboard directly fixed to the CLT floor, is a fire-rated collar from Promaseal® which is installed around the conduit, refer to Figure 13.

Figure 13: Fire Rated collar around the conduit, Image Credit: TDA

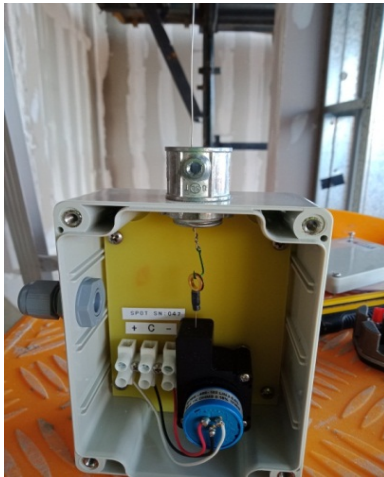
Figures 14 and 15 show the connection of the stainless steel wire to the rotary potentiometer by a fishing hook and tracer line.

Figure 14: Connection of a fishing hook and the displacement sensor, Image Credit: TDA

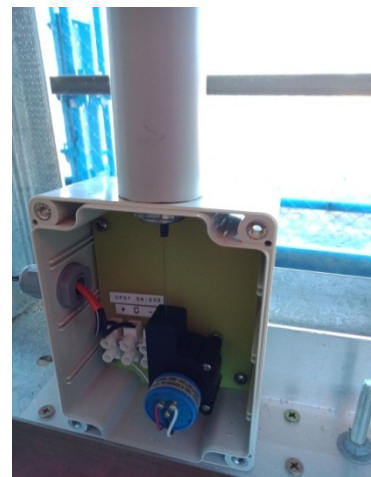
Figure 15: String Pot Sensor prior to being enclosed, Image Credit: TDA

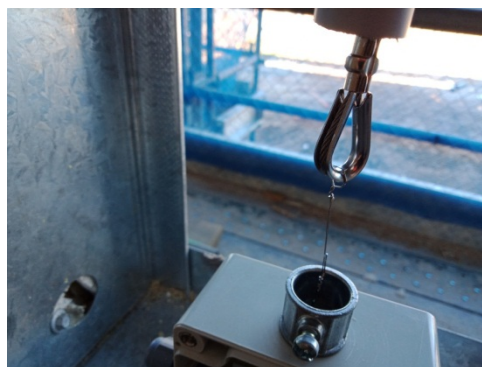
Figure 16 shows the fishing hook tracer connected to the non-extendable stainless steel wire inside the 25 mm HPDM conduit.

Figure 16: Connection of the stainless steel wire to fishing hook tracer, Image Credit: TDA

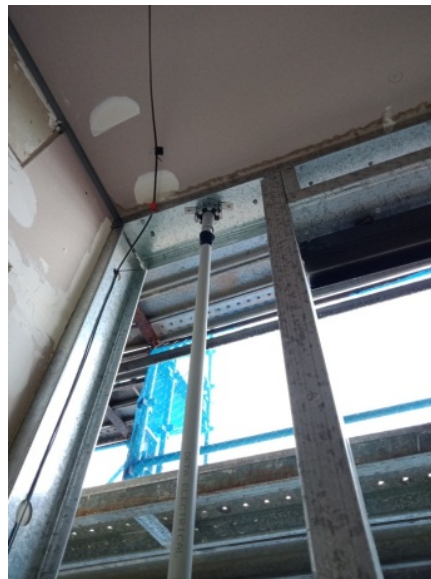
The non-extendable stainless steel wire runs through a 25 mm diameter conduit, to prevent the wire elements within the wall cavity from getting caught on any

insulation or services, refer to Figure 17. At the top of the wall, the 25 mm diameter conduit is cut short off the floor and placed inside a larger 32 mm diameter conduit. This arrangement forms a slip joint, preventing the conduit from getting caught between the floors, as the floor to floor height changes.

Figure 17: 25 and 32 mm conduit in a wall cavity with fire-rated collar, Image Credit: TDA

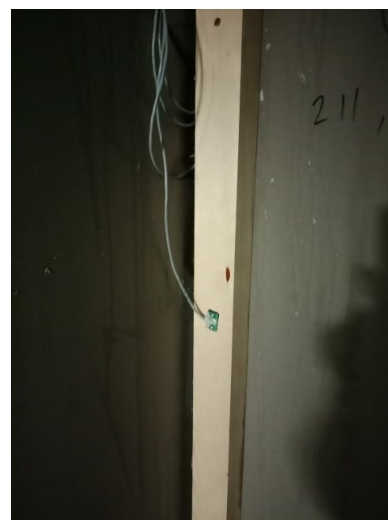
Figure 22: Spruce stud with PMM sensor, Image Credit: TDA

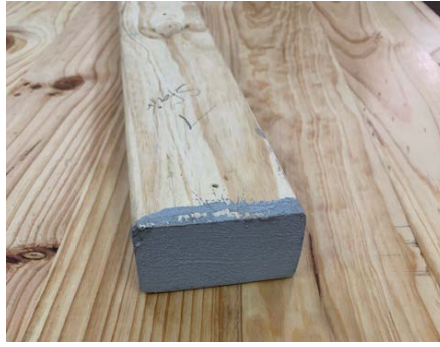
To ensure that the studs measure the moisture content is equivalent to a long length stud, each dummy stud was at least 1,000 mm long, and the end of the studs was sealed with a moisture-proofing compound, refer Figure 23.

Figure 23: Dummy stud showing moisture-proof compound attached, Image Credit: TDA

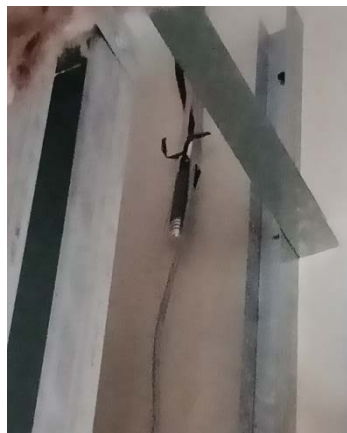
The Relative Humidity and Temperature sensors were installed in the non-load-bearing wall cavities and behind bathroom pods next to the PMM sensors. Figure 26 shows a Relative Humidity and Temperature sensor installed behind a bathroom pod.

Figure 26: Relative Humidity and Temperature sensor behind a bathroom pod, Image Credit: TDA

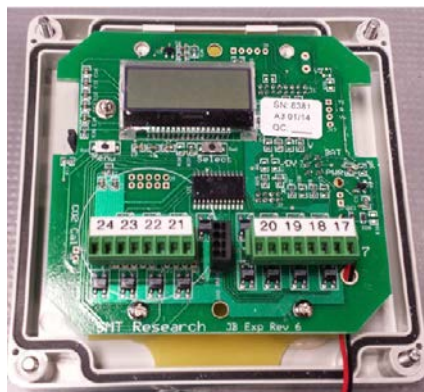
A four resistance 4 Volt channel data acquisition unit is used to collect the data from the Relative Humidity and Temperature (RH/T0) and the displacement (string Pot, SPOT) sensor. Figure 28 shows an A3 4R 4V Data Acquisition Unit. The wires from the RH/T and the SPOT sensors are connected to the inputs numbered 17 - 24.

Figure 28: A3 4R 4V Data Acquisition Unit, Image Credit: TDA

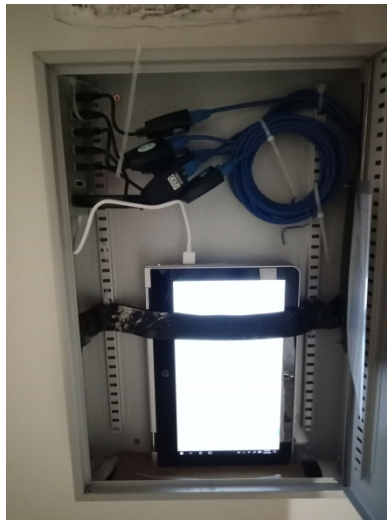
The BIG system collects real-time data from the variety of sensors used within the building. It also provides a local analysis of data such as moisture correction for timber species and temperature, as well as distribution to a central monitoring database and reporting system. The BIG also forwards the collected data to the web-based Building Analytics monitoring centre that can be accessed via the internet, refer to Figure 30 for an image of the installed BIG.

Figure 30: Locked box with the BIG installed, Image Credit: TDA

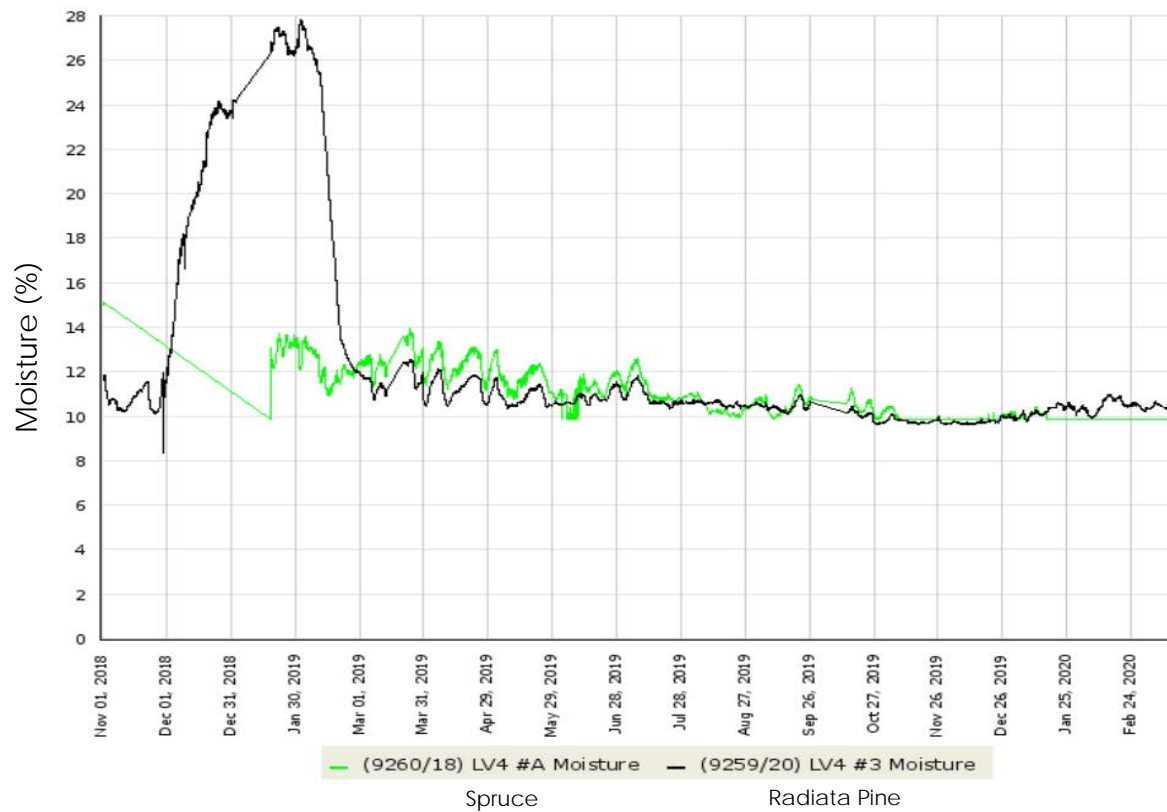
Figure 52: Level 4 Moisture content in radiata pine and Spruce studs

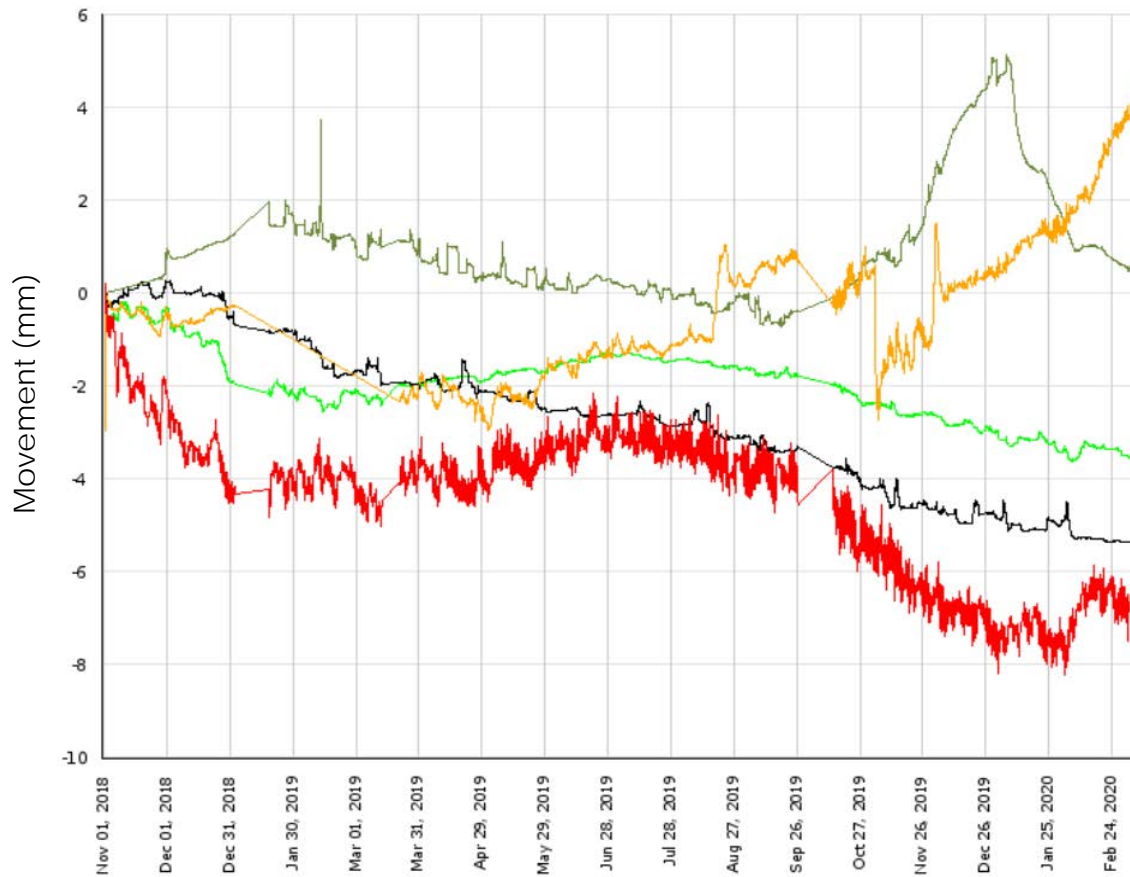
Figure 59: Vertical movement of each level measured in a wall close to the hallway – Position #2

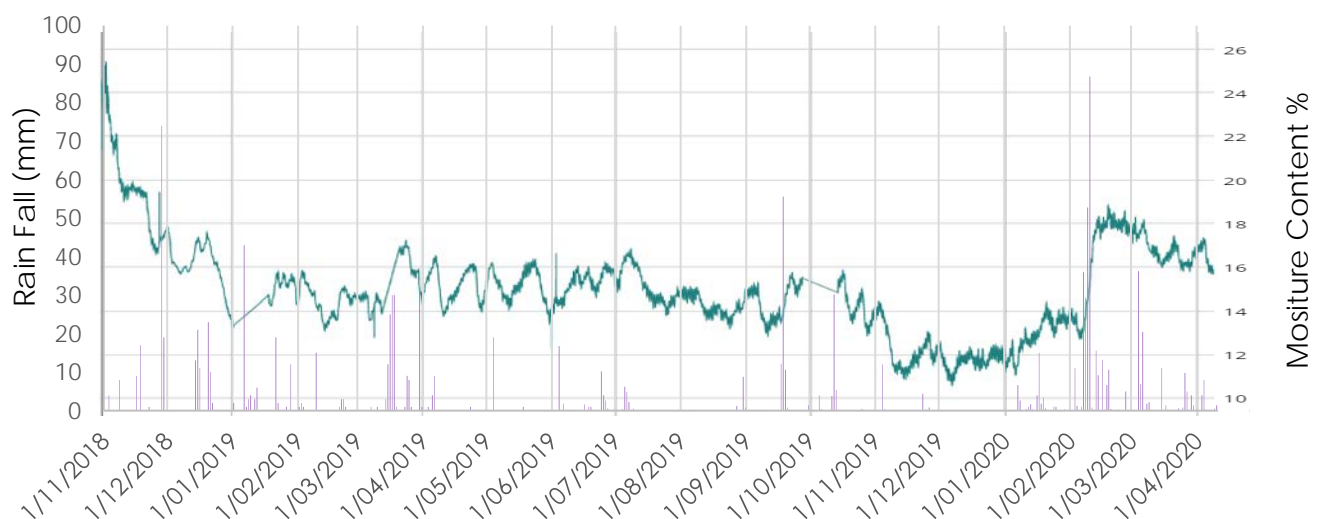
Figure 67: Rainfall data overlaid onto the moisture content of a wall stud in a corridor – Position LV1 #2
