# Investigation of Preservative Treated Plantation Timber Fencing and Sleeper Markets in Bushfire Prone Areas

**Paul England**

**Project No: NIF144-2122 [NV054]**

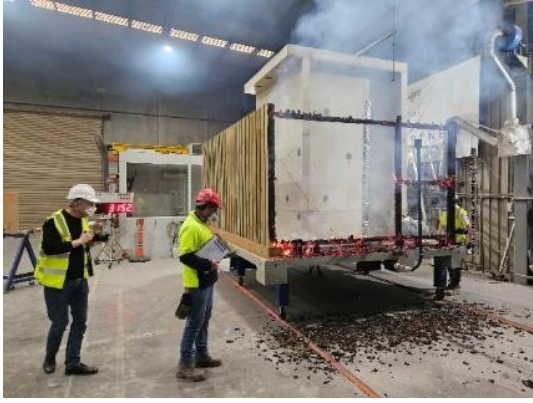
| <p>t=30 view heavily charred and smouldering west frame.<br/>Discolouration of north wall at corner post</p> | <p>t=31min 52s mid rail falls away from main section of west wall – no damage to reference building or north fence other than associated with NW corner post</p> | <p>t=33min 30s<br/>Smouldering combustion of NW corner post showing minor spread to palings</p> |

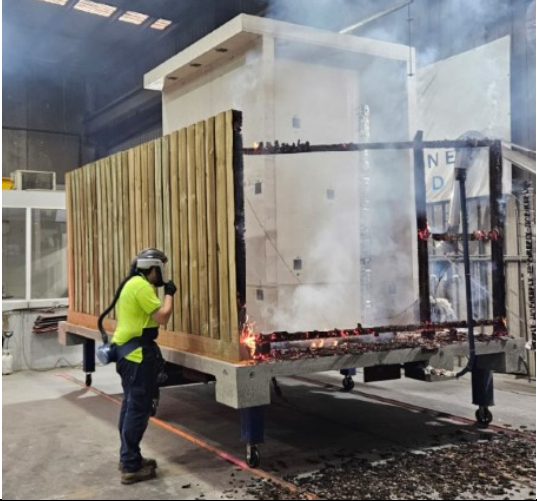
| <p>t=37min top rail falling away from northwest post</p> | <p>t=41 min frame members fell away no damage to west face of reference building. NW corner post in place but smouldering. No significant spread to north fence</p> | <p>t=41 min frame members SW corner</p> |

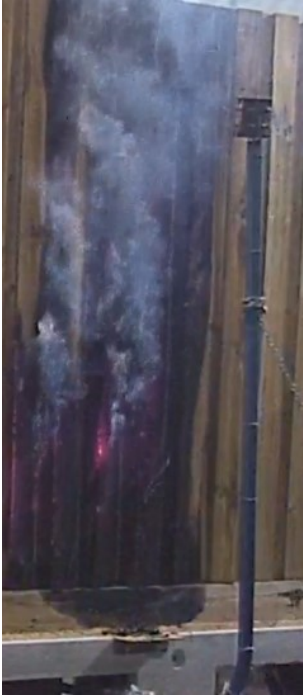
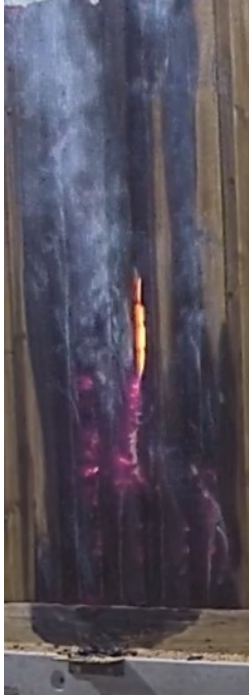
| t=12min no flaming | t=18min<br>smouldering<br>continuing | t=25min flaming<br>combustion<br>recommenced | t=30 min areas<br>burning through |

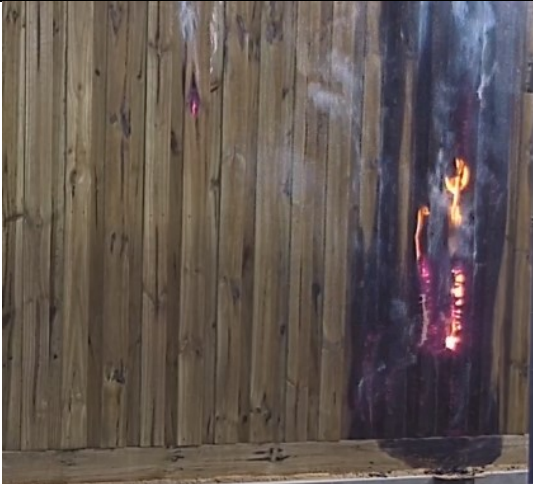
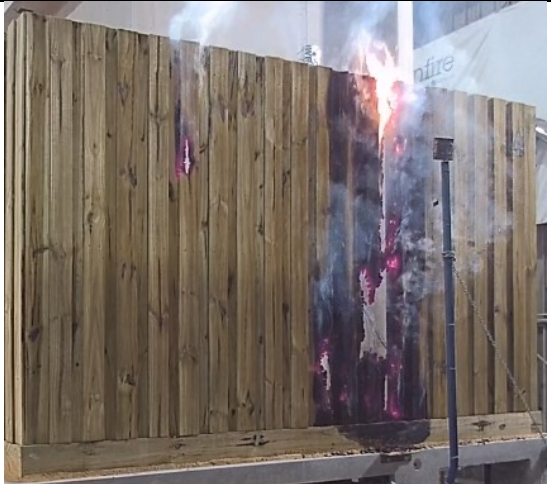
| t=27min small area to left of main zone<br>glowing and transitioning to intermittent<br>flaming | | t=40mins small area and large area<br>continuing to burn with intermittent<br>flaming | |

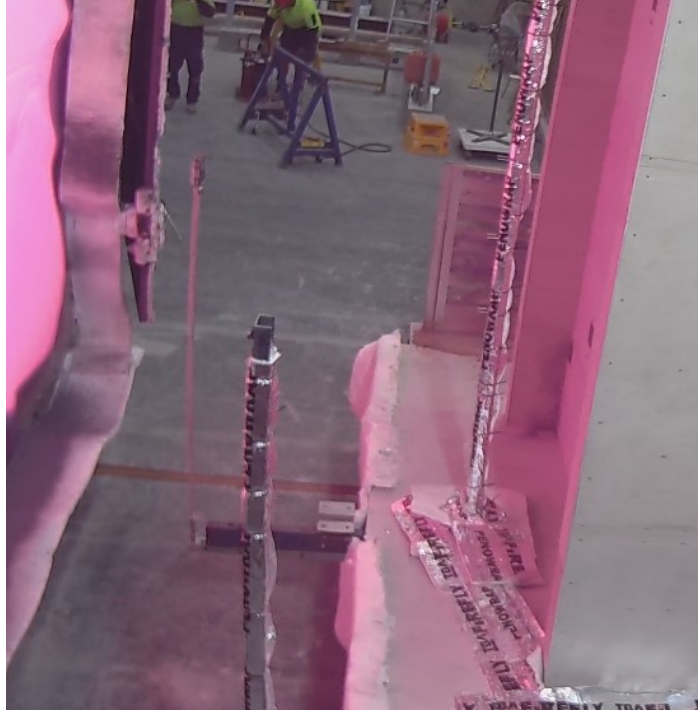
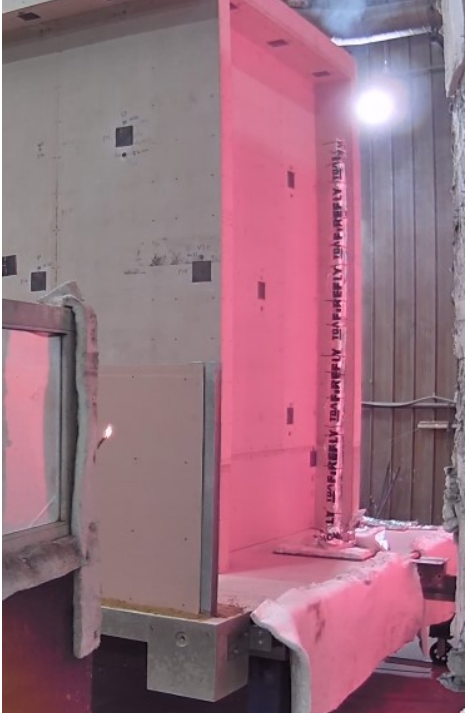
| Test configuration viewed from south with the subject building on the right and test wall on the right extending past the subject building. On the left is the heat source | Test configuration viewed from the north showing the back face of the specimen with backfill conditions simulated by coverings. The uncovered sleepers directly faced the north face of the reference building |

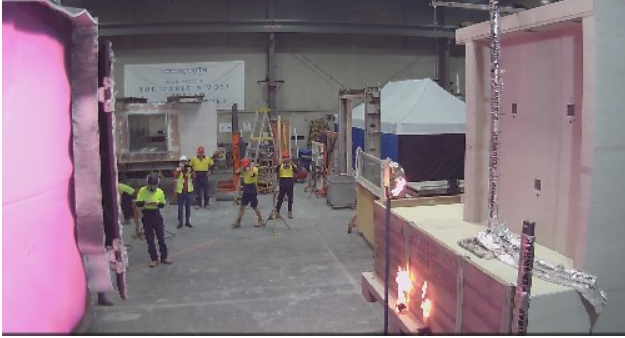
| t=10s test commenced. Radiant heat exposure and cribs applied | t=60s Flame spread over surface of central bay of sleeper wall |

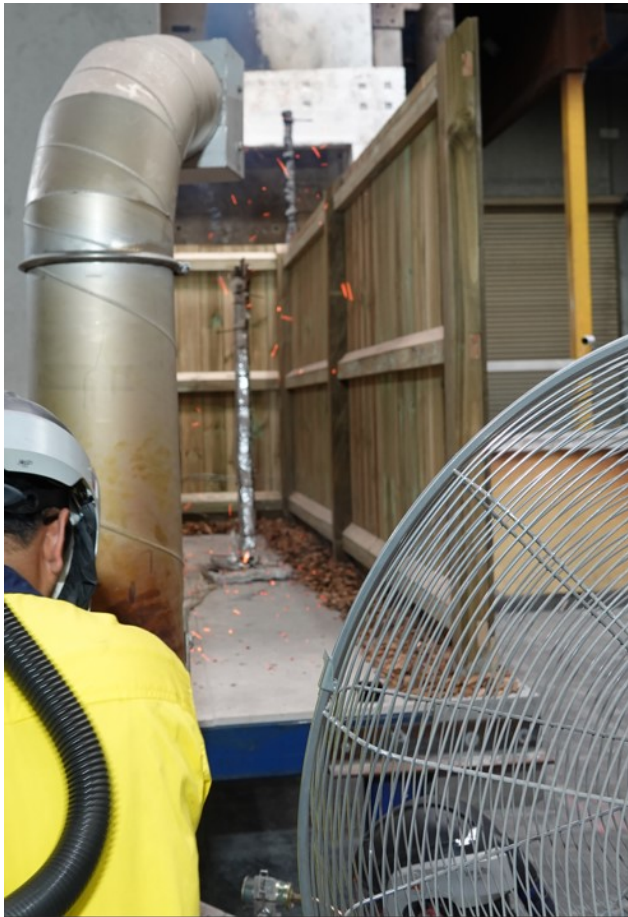
Figure 53 Ember generator and fan during test 1

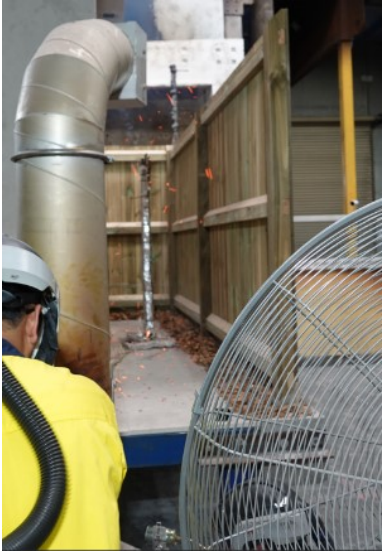
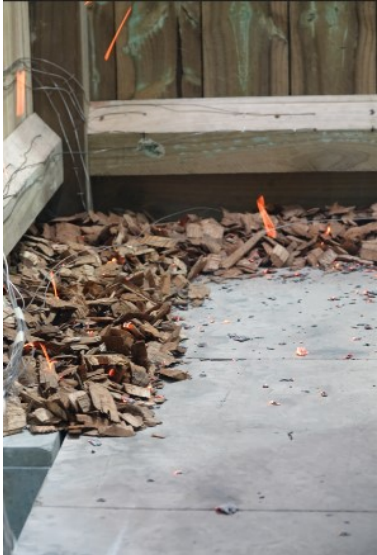
| <p>t=4.5 mins. View from east end showing release of embers from ember generator</p> | <p>t=5 mins. View of NW corner from the south showing embers interacting with mulch</p> |

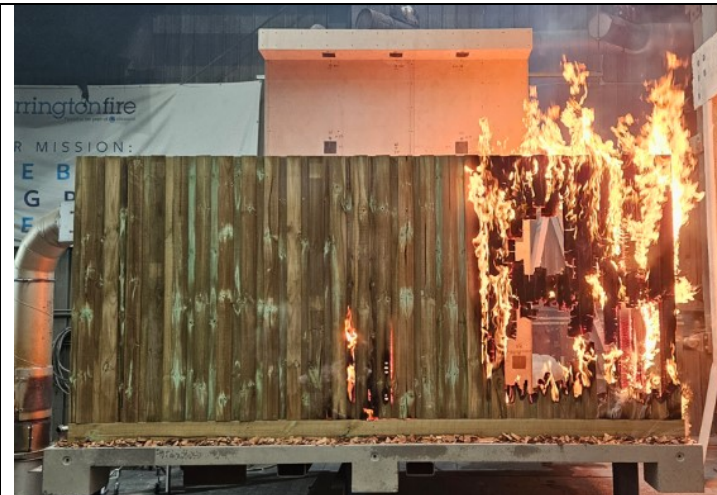
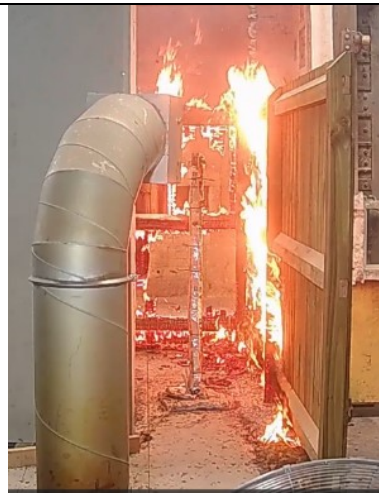
$t=34$  min fire spread and opening up of west end of north fence with minor burn through by central post

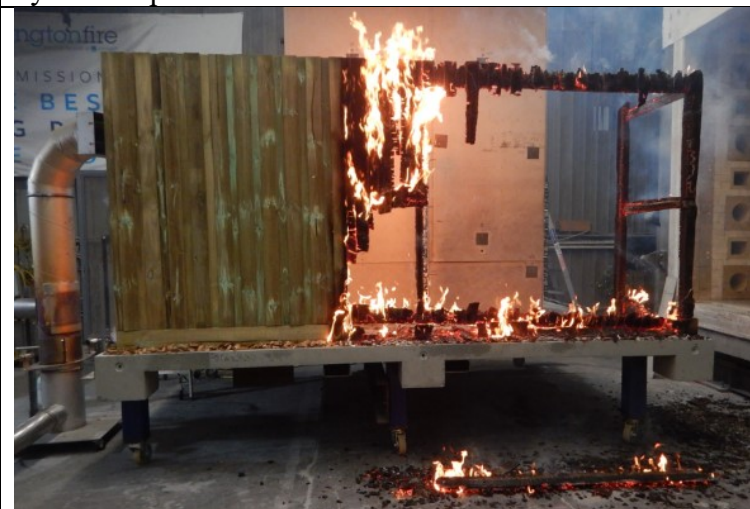
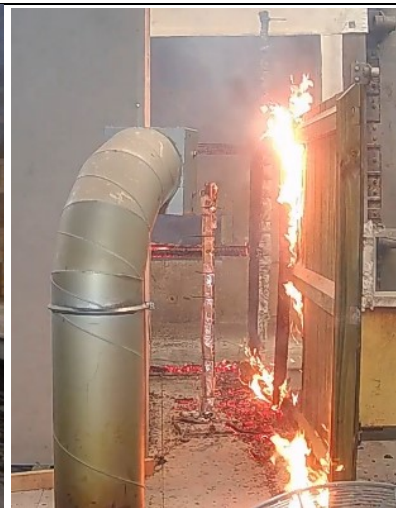
$t=50$  min air flow terminated - palings on west fence and western end of north fence consumed and central rail at western end of north fence fallen away.

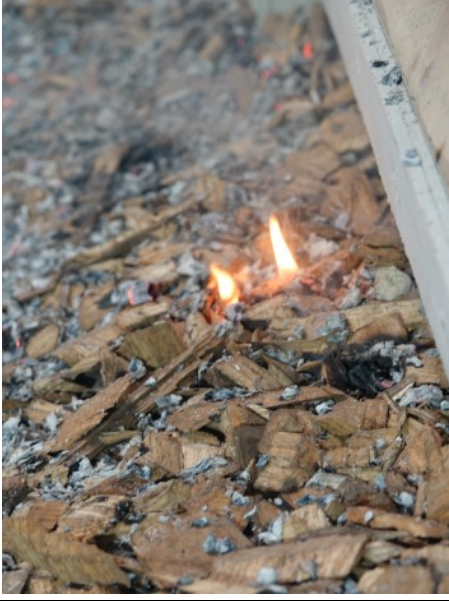
| <p>t=22.5 Initial ignitions</p> | | <p>t= 26.7 min burning mulch</p> |

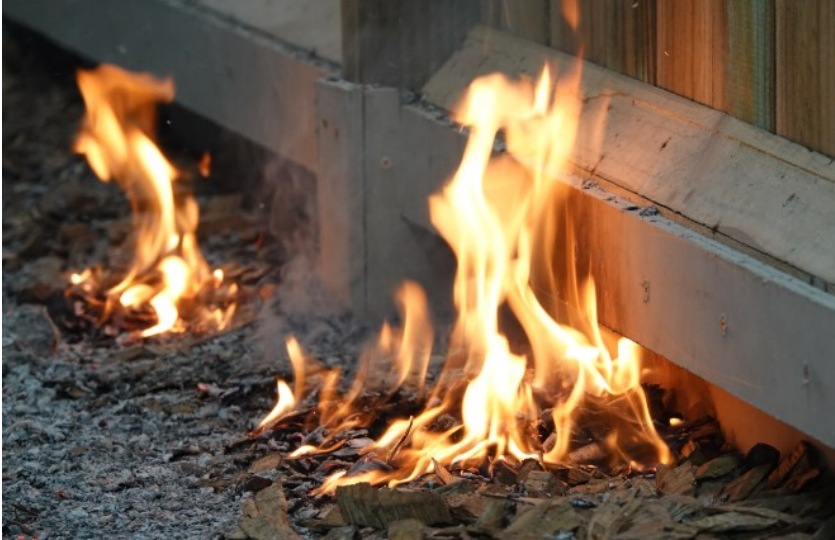
| | | <p>t=30 Established flaming ignitions of mulch – ember generator stopped</p> |

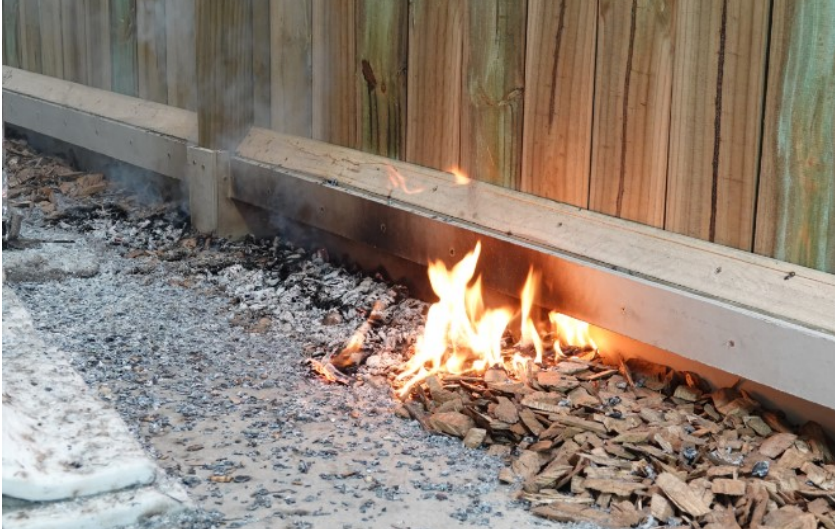
| | | <p>t=44min Mulch being progressively consumed as fire front moves against prevailing air flow but no evidence of sustained combustion of the fence.</p> |

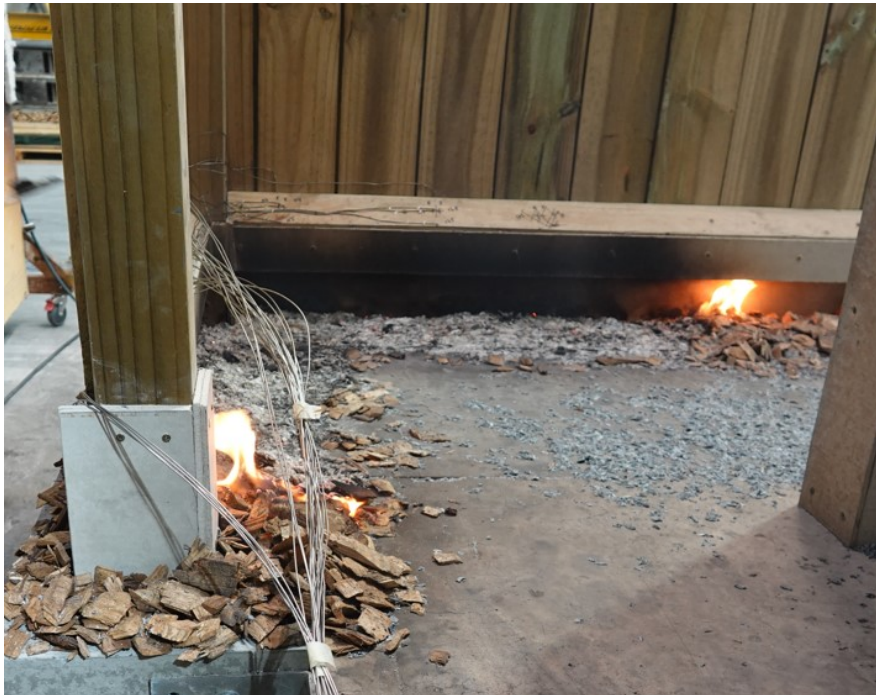
*Figure 72  $t=112\text{min}$  fire spread from NW Corner along west and north fences approximately 1m with no ignition of timber fencing.*

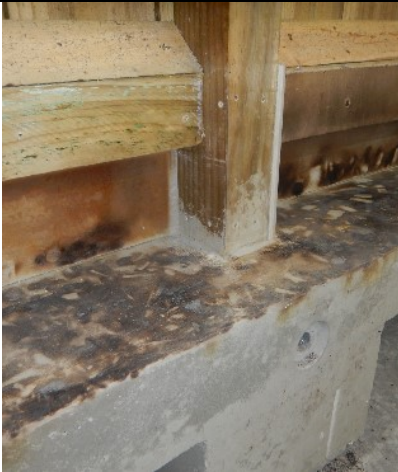
| | <p>Post at centre of north fence with protective coverings to face of lower rail and post in the foreground removed showing minimal impact on timber post and rail.</p> |

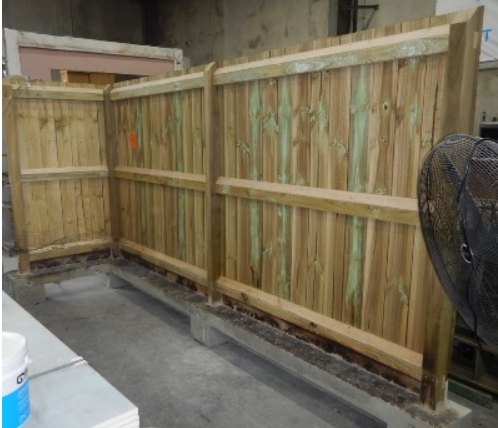
| | <p>Face of fencing that faced the simulated building with protection removed showing minimal damage to timber.</p> |

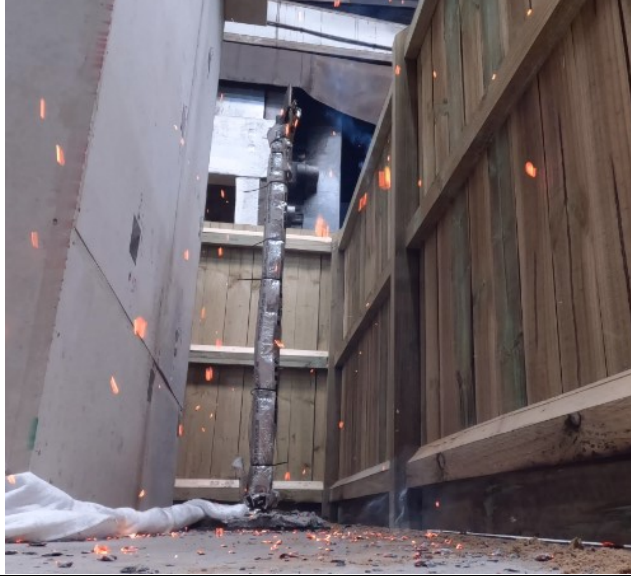
| | <p>t = 1 minute ember attack showing embers deflected away from fence rails by 45° section fitted to rails and collecting on the floor</p> |

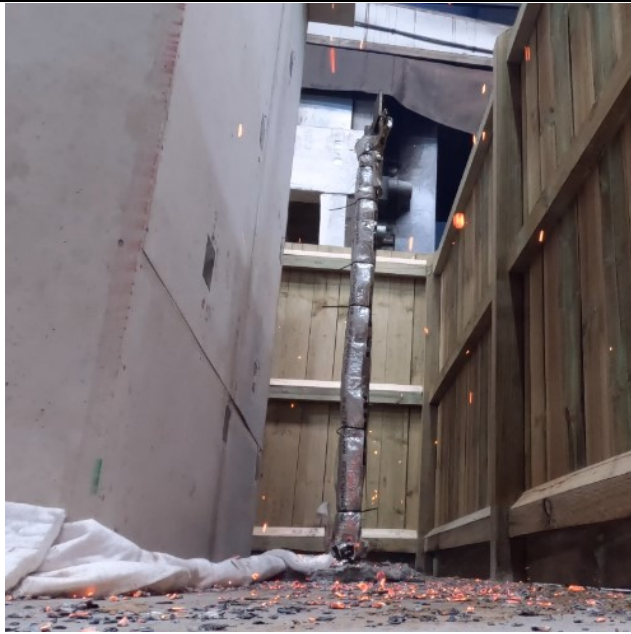
| | <p>t = 5 minute ember attack</p> |

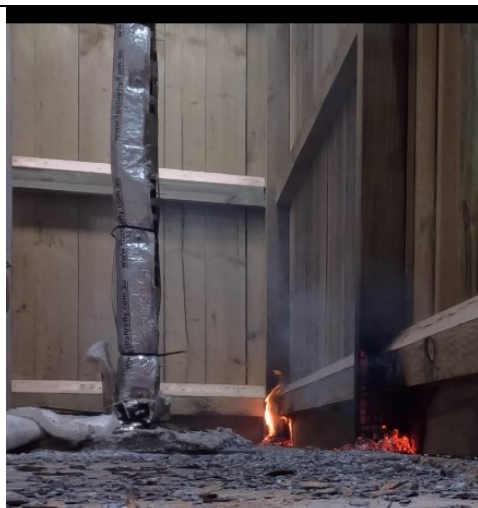
Crib 1 transitioning from flaming to smouldering combustion 42 minutes 50s after commencement of data logging - slight evidence of smouldering combustion from fence post. Flaming of crib 2 continuing at a reduced level
