Accelerated Testing of Window Joinery made from Eucalypts

Project no: PN98.702

D.K. Scown, L.J. Cookson, K.J. McCarthy & N. Chew **CSIRO FFP** Private Bag 10, Clayton South, Victoria 3169

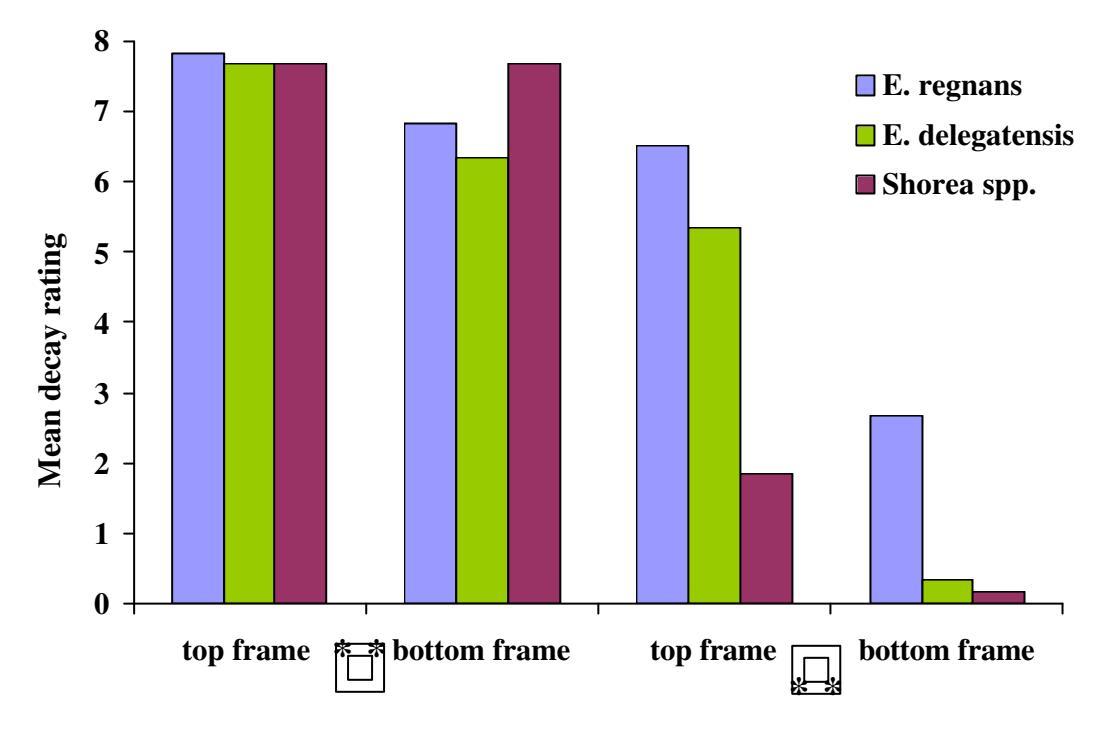
Decay was most severe in painted window frames constructed from *E. regnans* (mountain ash), *E. delegatensis* (alpine ash) and *Shorea* spp. It is accepted that the heartwood of these timbers is non durable¹⁷. Minor decay was also detected in frames made of untreated *E. obliqua* (messmate) and *E. sieberi* (silvertop ash), as was found in the soil-block bioassay, and is consistent with their higher in-ground natural durability rating of 3. The data in Table 4.1 show that the extent of decay was greatest in the bottom rebates. Furthermore, the decay was more severe in the windows that were suspended beneath another window frame (the lower row) (Figure 4.1). There was no decay in *T. plicata* (western red cedar) windows.

as water was able to bypass the paint layer at the joints and between the glass and timber beading (there was no putty or sealant). The paint appeared to have acted as a water trap. Accordingly, once wet, the painted timber required a much longer time to dry, accelerating decay.

Figure 4.1: Comparison of mean decay ratings in the upper and lower rebates of painted/untreated window frames made from *E. regnans*, *E. delegatensis* and *Shorea* spp. according to whether frames were suspended in the top or bottom row within the exposure bin.
