PROJECT NUMBER: PNB041-0708

OCTOBER 2012

# Four year inspection of a comparative trial of accelerated H3 decay test method

**Laurie J. Cookson, David Page and Tripti Singh**

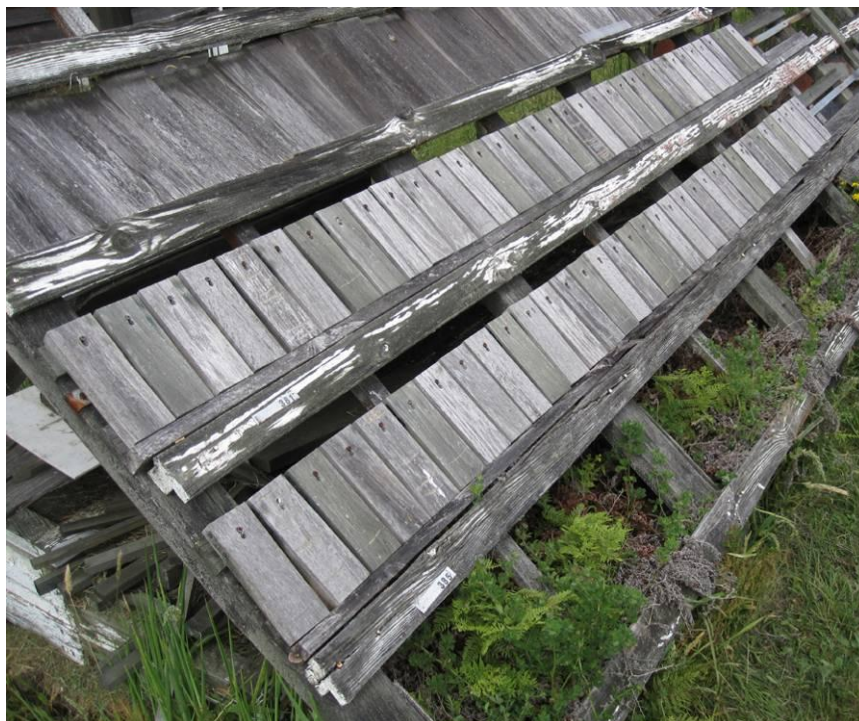
**Figure 42. Flat panel test at Rotorua after four years.**

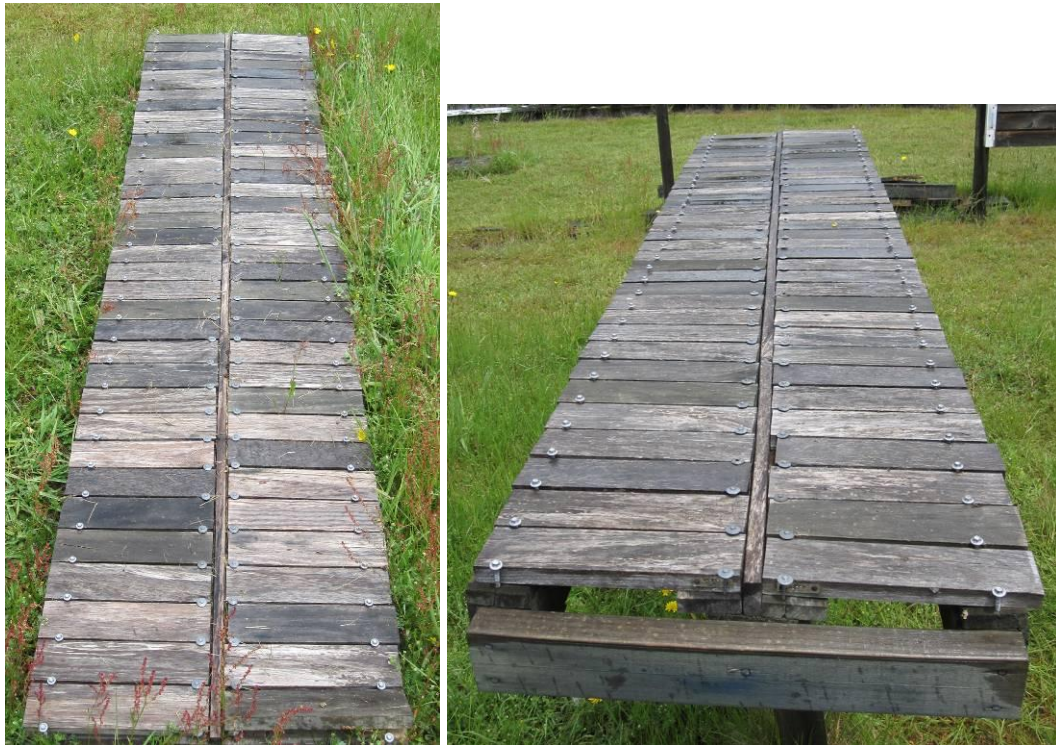
Figure 45. Decking tests at Rotorua after four years. Left, deck-on-grass. Right, raised deck.

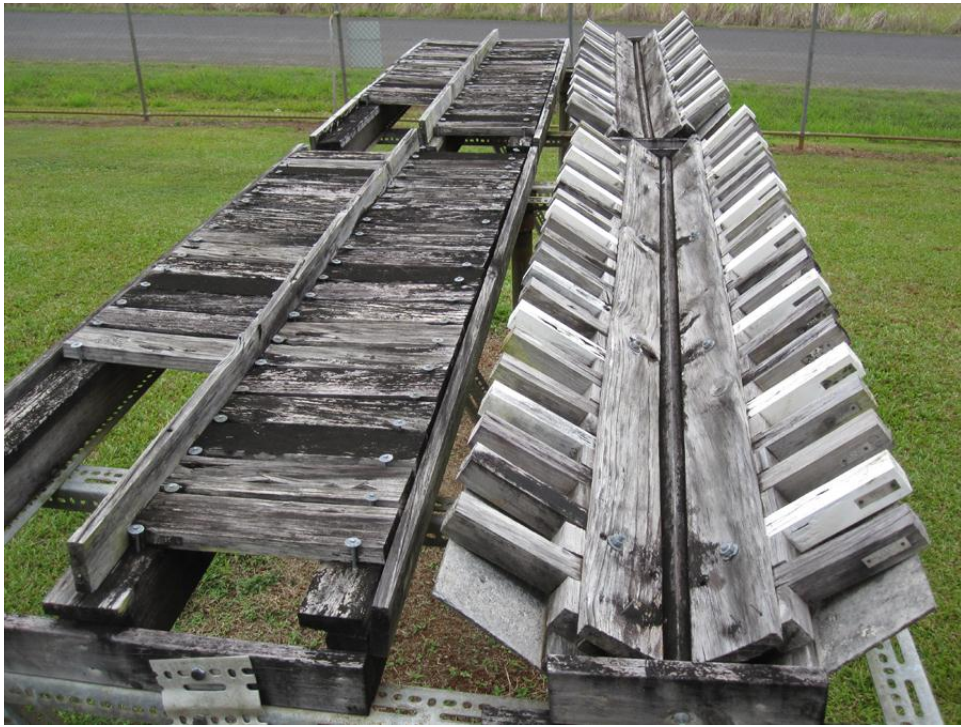
**Figure 48. Raised deck (left) and embedded test (right) at Innisfail after four years.**

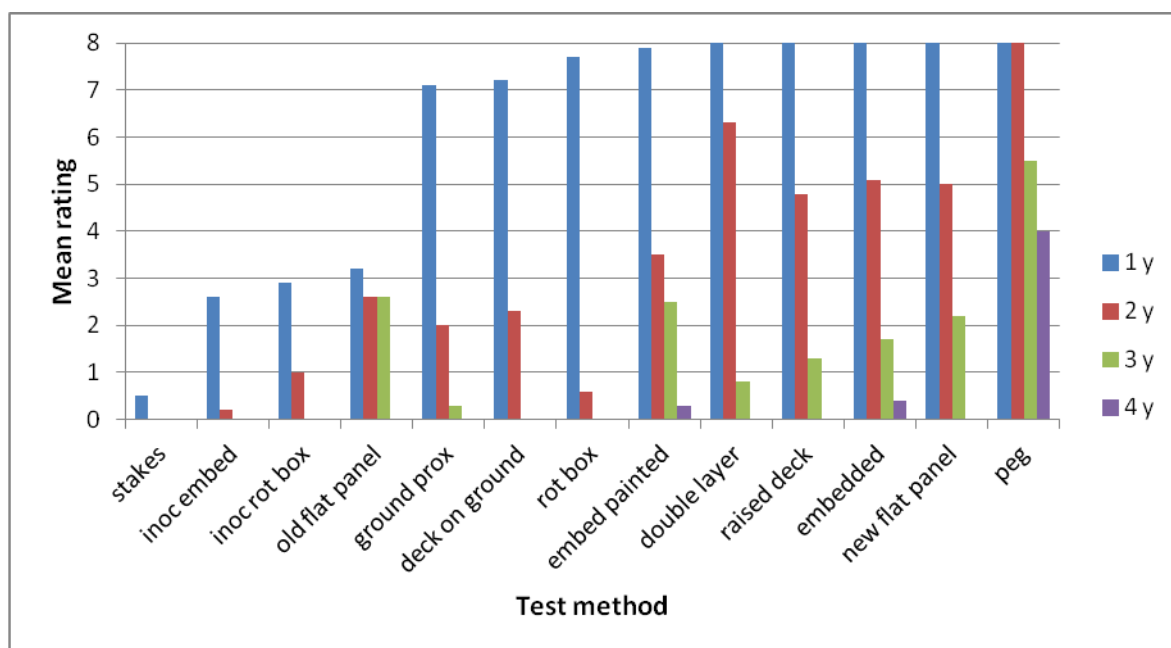
At Innisfail, water-treated *P. radiata* had failed (mean rating of 3 or less) in all tests except the peg test (Table 9, Figure 62). At Rotorua failure had occurred in the painted embedded test, ground proximity test, double layer test, and those tests pre-inoculated with *Gloeophyllum abietinum* and *Oligoporus placenta*, that is, the pre-inoculated embedded and rot box tests. Clayton was the least active of the field test sites, although water-treated *P. radiata* in the embedded test has now failed. Last year, Clayton field was the slowest site, whereas this year Clayton AFS was slower than Clayton field. In the Clayton AFS water-treated *P. radiata* had failed in the painted embedded, pre-inoculated (rot box and embedded) and stake tests. The Rotorua AFS was more active than the latter two sites, with failures of water-treated *P. radiata* occurring in all its tests, which were the pre-inoculated tests, as well as the embedded and rot box tests (not pre-inoculated) and the in-ground stake test.

**Figure 62. Relative performance of water-treated *P. radiata* at Innisfail after one to four years.**

The most striking change after the first year inspection was the sudden failure in the rot boxes (not inoculated) at Innisfail at the two year inspection, and the rating there for water-treated *P. radiata* is now 0.0. At Innisfail during the two year inspection, a previously used ‘old’ flat panel test frame behaved like a pre-inoculated test, as a brown rotting fungus (*Fomitopsis lilacinogilva*) caused extensive decay with a mean rating of 2.6 (5 replicates), while on the newer frame the mean rating was 5.0. After four years the ratings were 0.0 on both frames for water-treated *P. radiata* (Table 9).

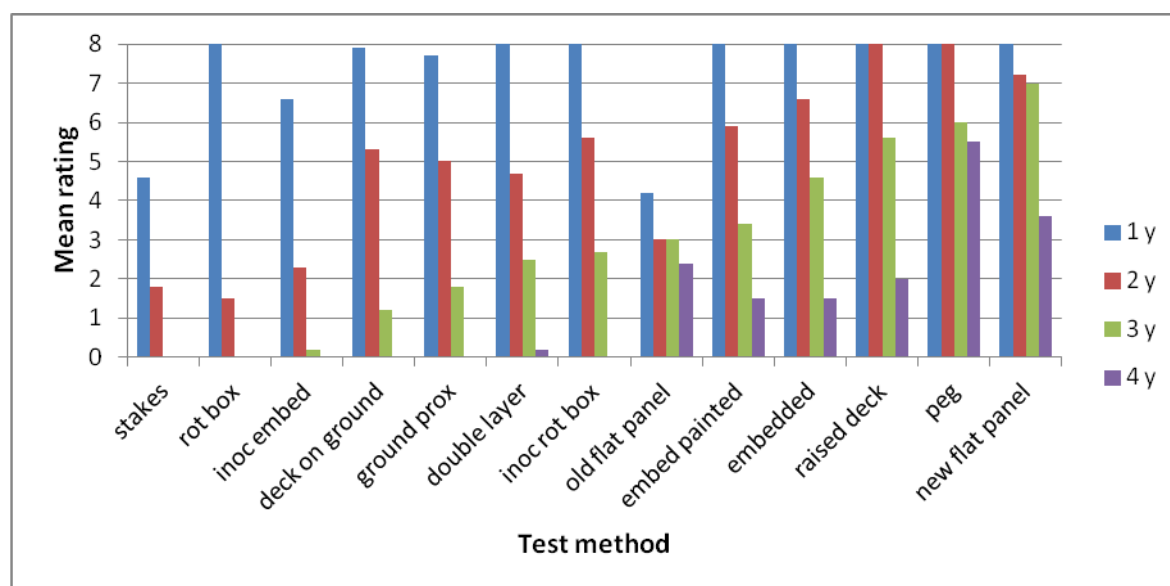
HFK was the next most susceptible treatment (Table 10, Figure 63), and generally followed the pattern of decay found for water treatment. For example, HFK-treated *P. radiata* in the embedded test at Clayton had a mean rating of 2.2 compared to 3.1 for water-treated *P. radiata*. Exceptions appear to be where solvent evaporation would have been inhibited, which was shown in the earlier rather than later inspections. For example after two years, the pre-inoculated rot box at Clayton AFS caused only moderate decay (mean rating 5.8) to HFK-treated *P. radiata* compared to a mean rating of 0.0 for the water treatment. Being surrounded by soil also appeared to reduce solvent evaporation, as after one year at Innisfail the mean ratings for stakes treated with HFK or water were 4.6 and 0.5 respectively.

**Figure 63. Relative performance of HFK-treated *P. radiata* at Innisfail after one to four years.**

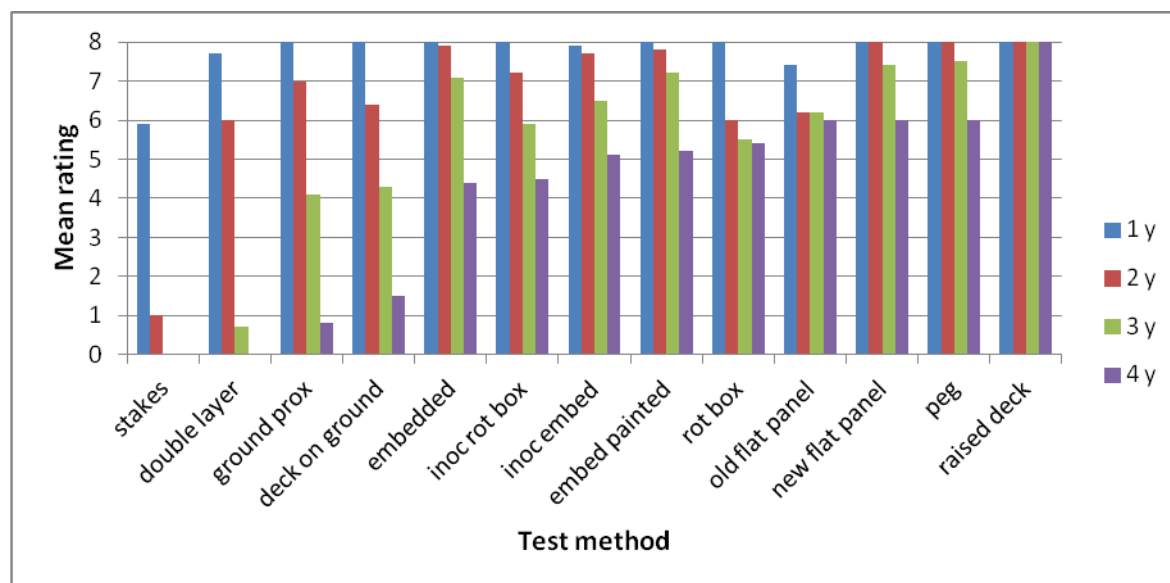
At Innisfail after four years, quarter-H3 AChQ-treated *P. radiata* (Table 11, Figure 64) had failed (mean rating 3.0 or less) in the deck-on-grass, ground proximity, double layer and in-ground stake tests. No treatment failures in the field had occurred at Rotorua or Clayton. However, the treatment had failed in the AFS's at Clayton and Rotorua in the embedded tests and in-ground stake tests. Oddly, there was a sudden failure of this treatment in the double layer test at Innisfail when the mean rating fell from 6.0 (2 years) to 0.7 after three years (Figure 64). It is surprising that AChQ did not perform even better given the very high quat retention used in this trial, suggesting there is a limit to how much additional quat is useful to the ACQ formulation.

**Figure 64. Relative performance of AChQ-treated *P. radiata* at Innisfail after one to four years.**

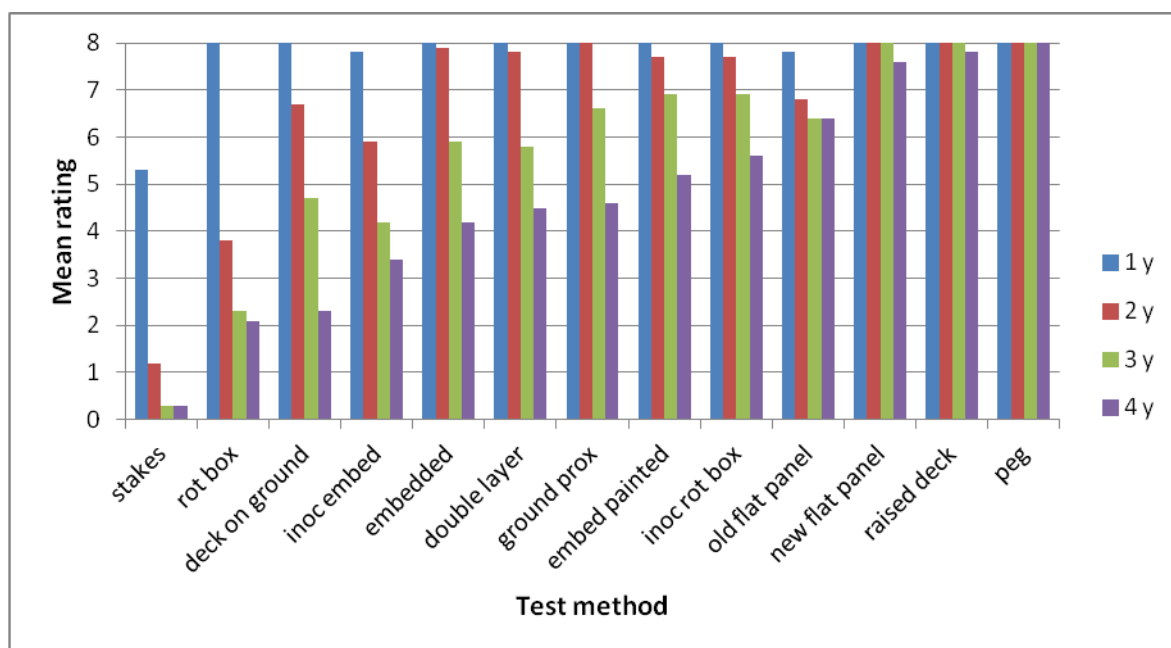
CCA is the most common reference preservative used in above ground decay trials. The most severe above ground trial was the rot box (uninoculated) at Innisfail, with heavy decay after two years (mean rating of 3.8) and three years (mean rating 2.3) although little changed after four years (mean rating 2.1) for *P. radiata* treated to quarter-H3 CCA retention (Table 12, Figure 65). These test specimens were still sound after one year, showing that once significant decay started in the rot box it progressed rapidly through many of the treatments.

**Figure 65. Relative performance of quarter CCA-treated *P. radiata* at Innisfail after one to four years.**

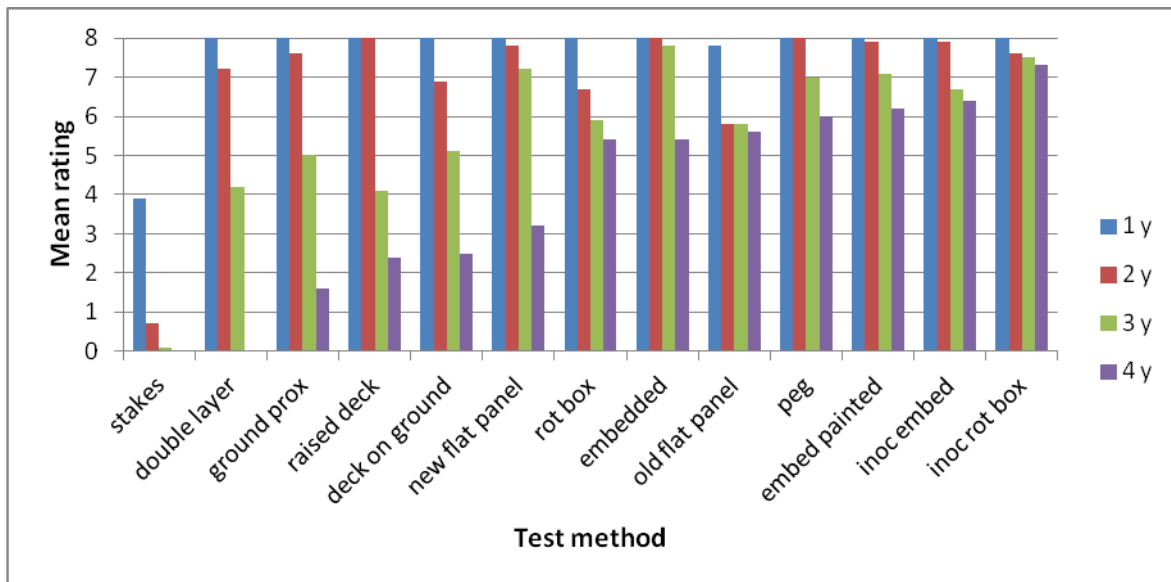
After two years, the quarter-H3 LOSP azole-treated *P. radiata* test specimens had only moderate to no decay in the various above ground trials, except in New Zealand where rot boxes and embedded tests pre-inoculated with *O. placenta* had heavy decay. After three years at Innisfail, there was also moderate-heavy decay in the raised deck (mean rating 4.1) and double layer (mean rating 4.2) tests (Table 13, Figure 66). Decay in the raised deck was clearly due to one particular species of brown rotting fungi, later identified as a species of *Heterotextus* (Figure 67).

Figure 66. Relative performance of azole-treated *P. radiata* at Innisfail after one to four years.

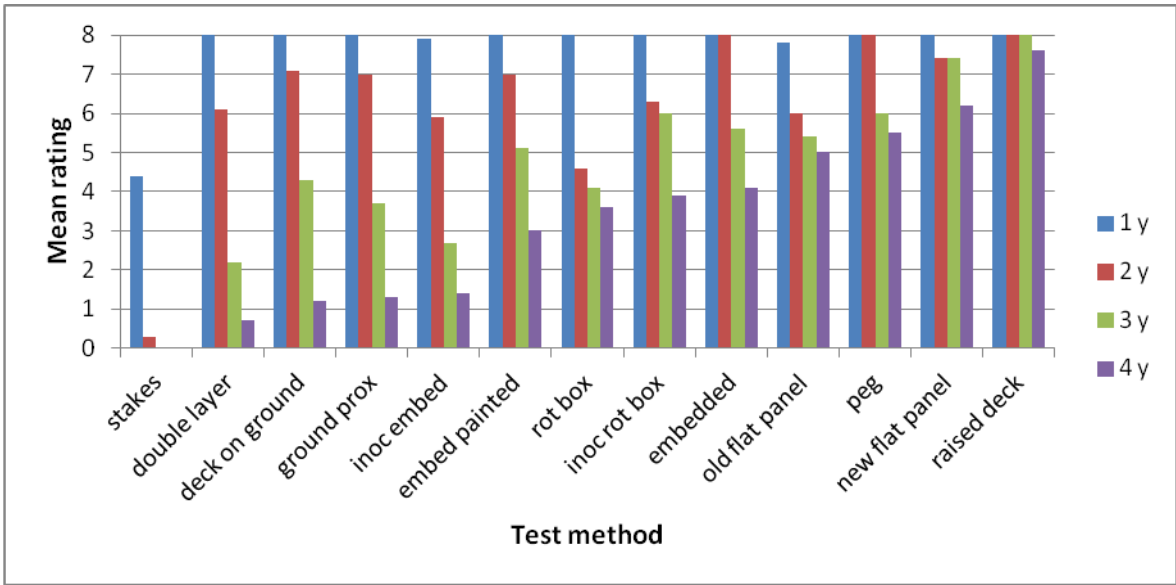
At Innisfail, the quarter-H3 TBTN-treated *P. radiata* test specimens had failed (mean ratings below 3.0) in the deck-on-ground, embedded tests painted or pre-inoculated, ground proximity and double layer tests (Table 14, Figure 68). It should be noted that the TBTN formulation included dichlofluanid, with unknown influence on efficacy. The in-ground stakes had mean ratings of 0.0, 0.3 and 2.8 at Innisfail, Rotorua AFS and Clayton AFS, respectively (Table 14). A coating of paint has been shown previously to improve the performance of TBTN; however, no such improvement occurred in the current trial with embedded tests. Perhaps too large a surface area was left uncoated, as the bottom end and sides of painted embedded test specimens were not coated with paint. However, these surfaces were then embedded within the test frame so were not exposed directly to the sunlight.

**Figure 68. Relative performance of TBTN-treated *P. radiata* at Innisfail after one to four years.**

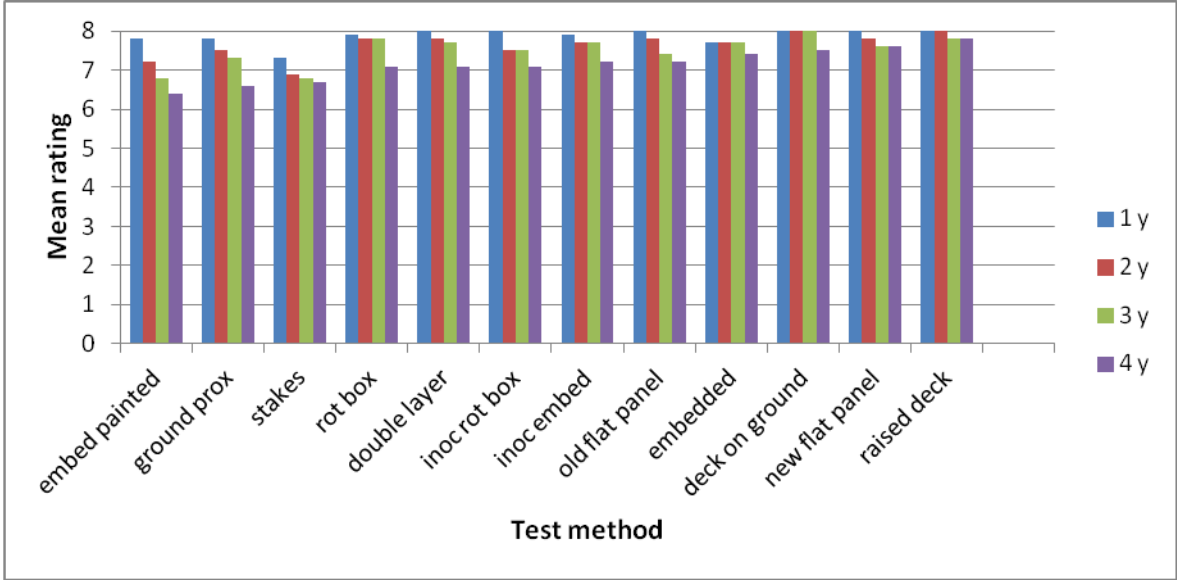
The naturally durable heartwood of *C. maculata* had some decay, mainly white rot, in some tests. However, mean ratings were above 7.0 in all above ground tests at all sites, except the painted embedded and ground proximity tests at Innisfail (Table 15, Figure 69). It was also the best performing timber in the in-ground stake trial at Innisfail, with a mean rating of 6.7.

**Figure 69. Relative performance of untreated *C. maculata* at Innisfail after one to four years.**
