MARKET ACCESS & DEVELOPMENT PROJECT NUMBER: PNA001-0405

Comparison of Test Cell Thermal Performance & The Empirical Validation of AccuRate in a Cool Temperate Climate

M. Dewsbury, F. Soriano, G. Nolan and R. Fay

#### Project No: PNA001-0405

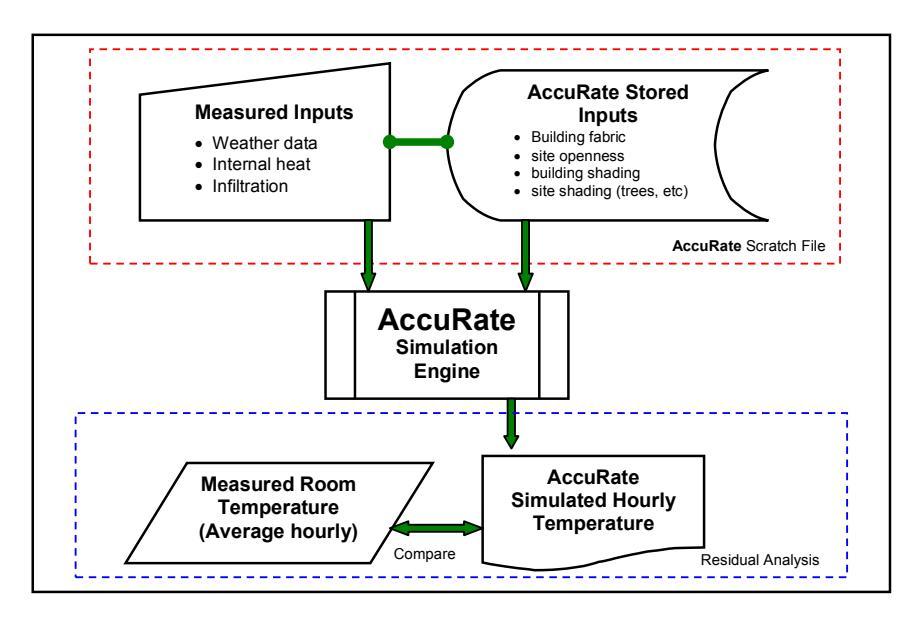
Figure 2 shows the schematic diagram of the thermal performance simulation specifically for empirical validation purposes in this project.

Figure 2: The Thermal Performance Simulation for the Empirical Validation of AccuRate

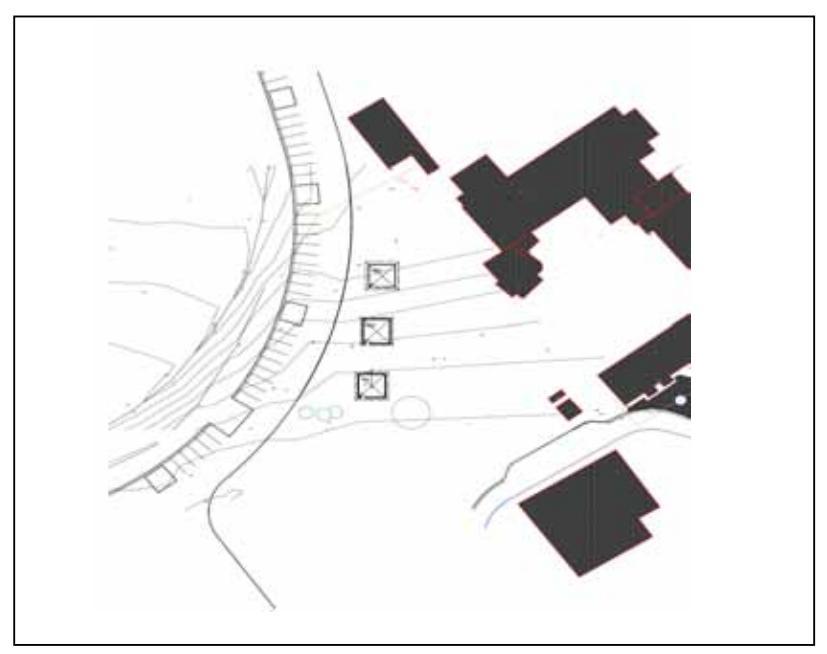
- a car park and sports oval to the west;
- well established trees to the south;
- open grass and distant buildings, about 30m 60m to the east; and
- open grass and distant buildings, about 13m-25m to the north.

Figure 3: Site Plan of the Test Cells

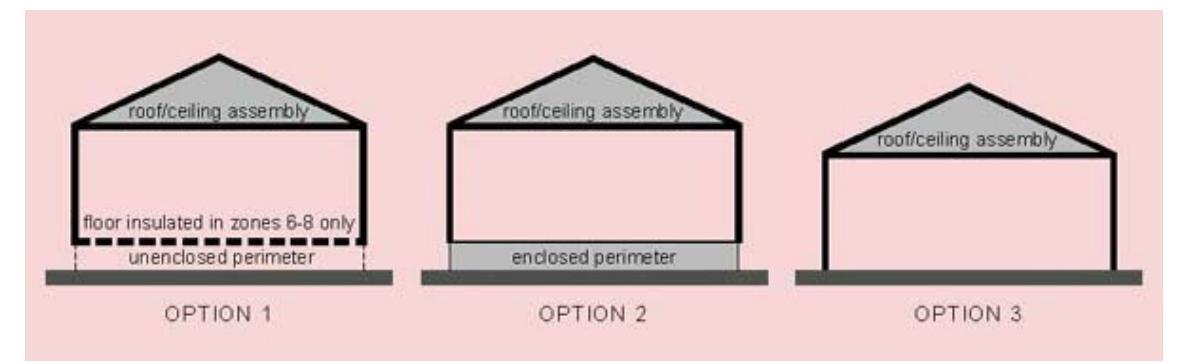
The BCA lists three standard types of flooring options for residential construction. As shown in Figure 5, these are the unenclosed perimeter platform floor, enclosed perimeter platform floor and slab-on-ground floor.

Figure 5: Standard Housing Floor Systems (ABCB., 2005)

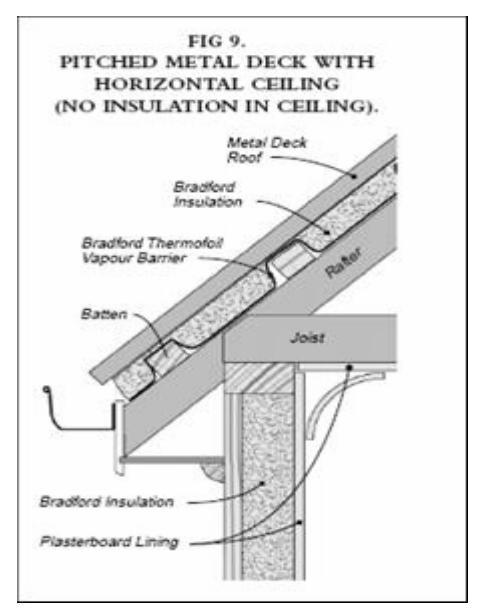
- For reflective foil sarking to work effectively, it requires a no contact air gap between the roofing material and the foil sarking. This is normally achieved by draping the sarking loosely over the battens. However, it has been observed in actual practice that the foil sarking is often being pulled tight for ease of installation. This creates a thermal bridge and counters the insulating effect of the sarking. Hence, it was decided to lay the sarking over the rafters and lay the battens on top of the sarking. This guaranteed a batten depth gap between the sheet metal roofing and the sarking.

Figure 6: Typical detail of sarking based on The CSR Bradford Building Design Guide

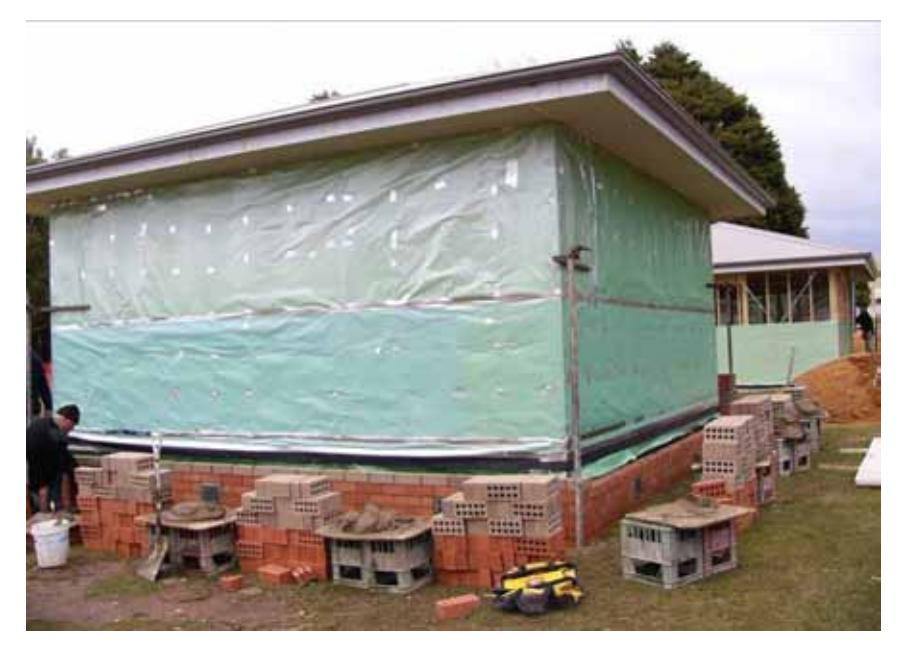
In the roof space, the application of the building wrap to the walls was considered at length. Standard installation practice provides a 150mm overlap between sheets and this is applied to the structure with steel staples. Common faults with this form of application include the puncturing of the wrap and the provision of air movement between the cavity air space and the outside face of the plasterboard lining. To eliminate this possible variable and to display best construction practise the building wrap was taped at joints. At the same time any punctures in the building wrap were also taped (See Figure 7).

Figure 7: Taped and patched building wrap

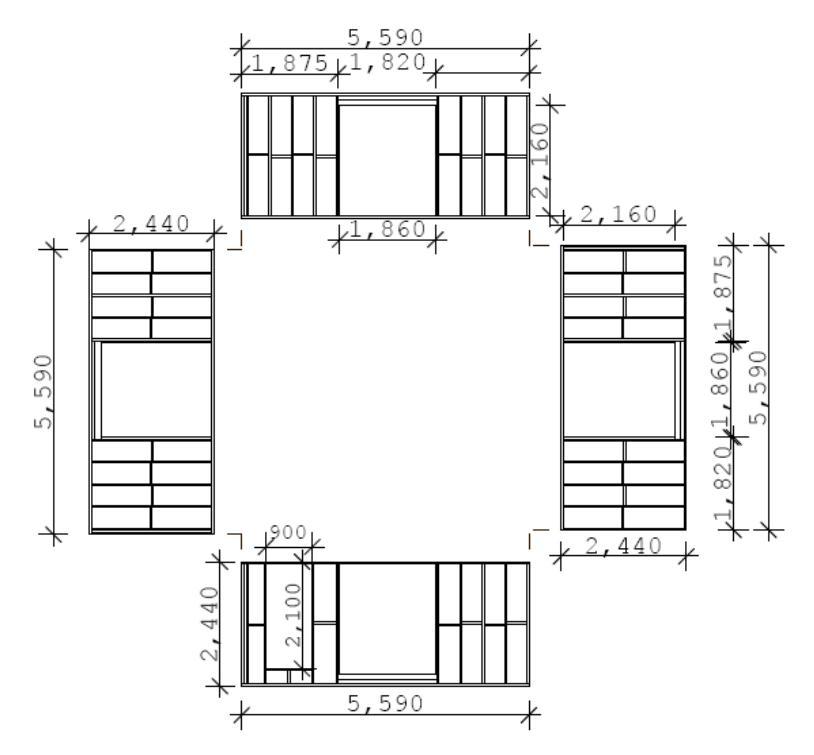
The wall framing has an integrated provision for the eventual addition of windows on each face of the building. This required the inclusion of framing within the standard stud work of the wall panel to allow a future 1800 wide full height opening to be made without alteration to the structural frame. Figure 8 shows the framing plan for the test cells while Figure 9 shows the framing as built for Test Cell 2.

Figure 8: Test Cell Framing Plan

The provision for future windows and current timber framing practises increased the framing factor of the wall from 12.3% to 18.3% compared to the conventional. The framing factor is the percentage of timber in the elevation of the wall. While timber is a better insulator than steel, it is not as good an insulator as bulk insulation and the greater the area of timber in a wall, the

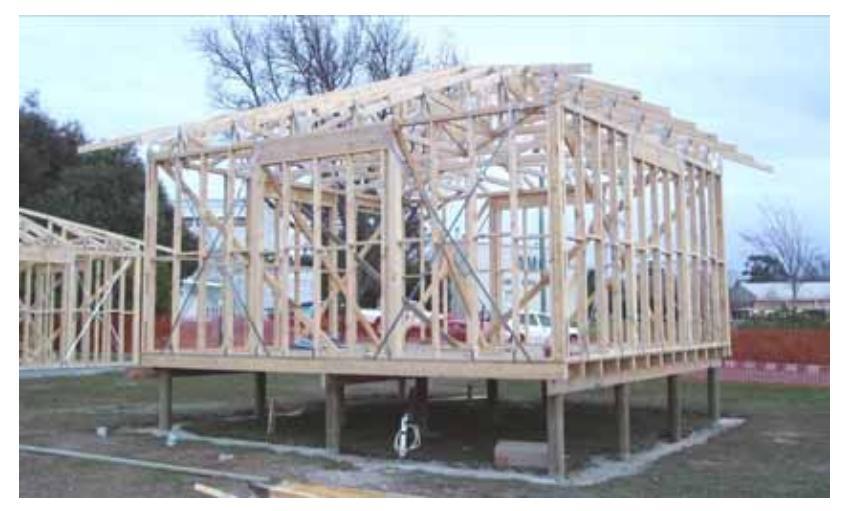
Figure 9: Test Cell 2 Wall and Roof Framing

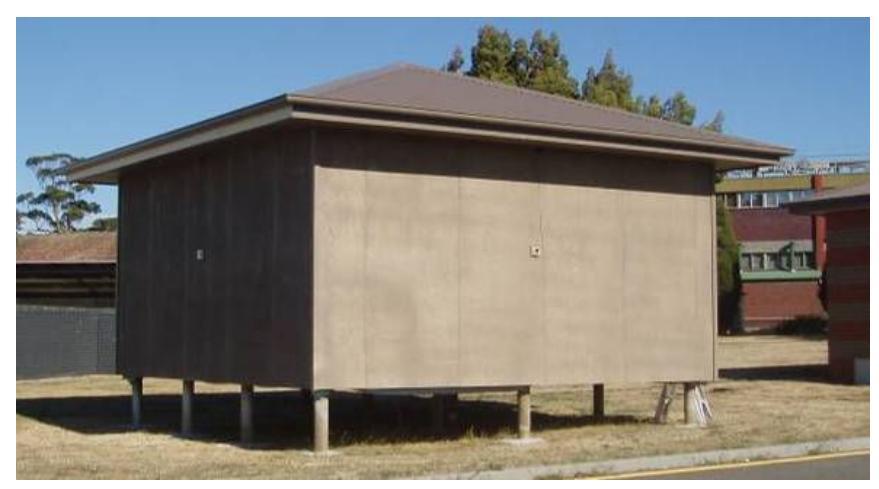
Test Cell 1 is an unenclosed perimeter platform floored building (See Figure 10). The building sits on timber poles, is timber framed with plywood cladding and has a sheet metal roof.

Figure 10: Test Cell 1 – Western View

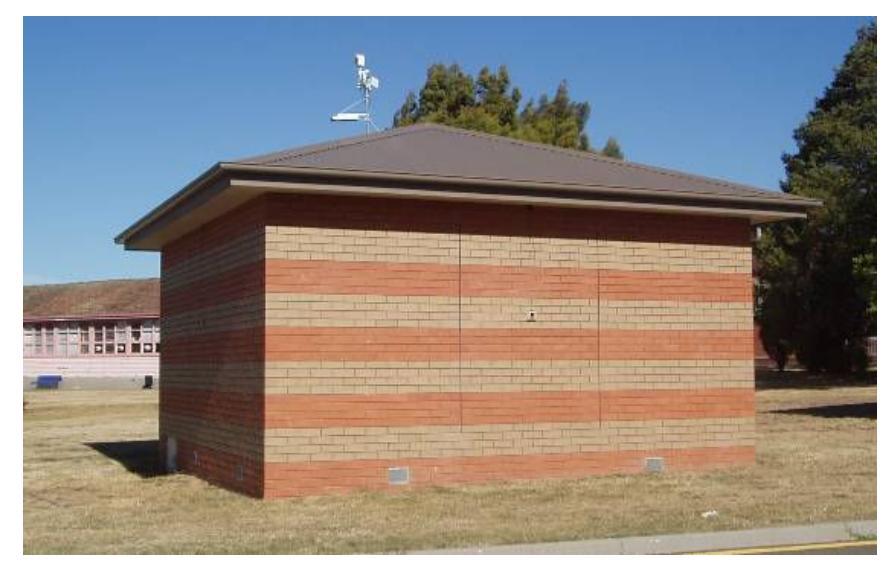
Test Cell 2 is an enclosed perimeter platform floored building (See Figure 11). The building sits on poles but has a brick veneer cladding that extends to the ground plane. There are vent holes in the sub floor brick work to allow for ventilation. Test cell 2 also has a sheet metal roof.

Figure 11: Test Cell 2 – Western View

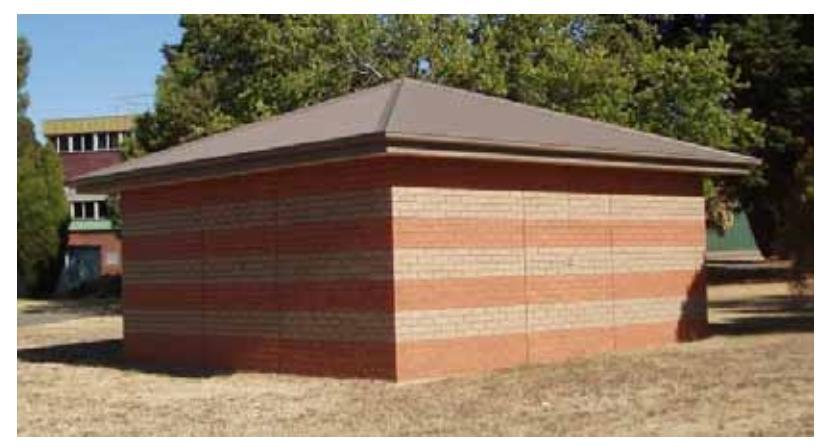
Test Cell 3 is a concrete slab on ground floored building (See Figure 12). The building sits on its concrete slab and has a brick veneer cladding that extends to the ground plane. Test cell 3 also has a sheet metal roof.

Figure 12: Test Cell 3 - Western View

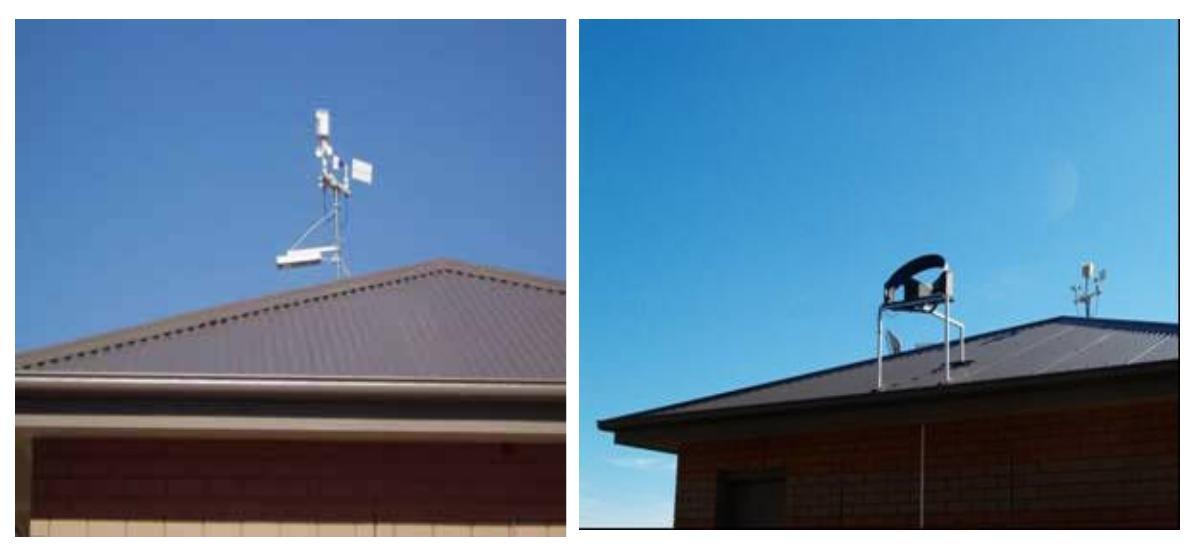
For the purpose of empirical validation, a new site-specific climate file was created based on measurements taken on a 10-minute cycle. The AccuRate climate file was modified using measured values instead of the built-in climate data for zone 26. This would essentially lead to a more reliable comparison of simulated and observed thermal performance as both are based on the same climate data.

Figure 17: On-Site Weather Station

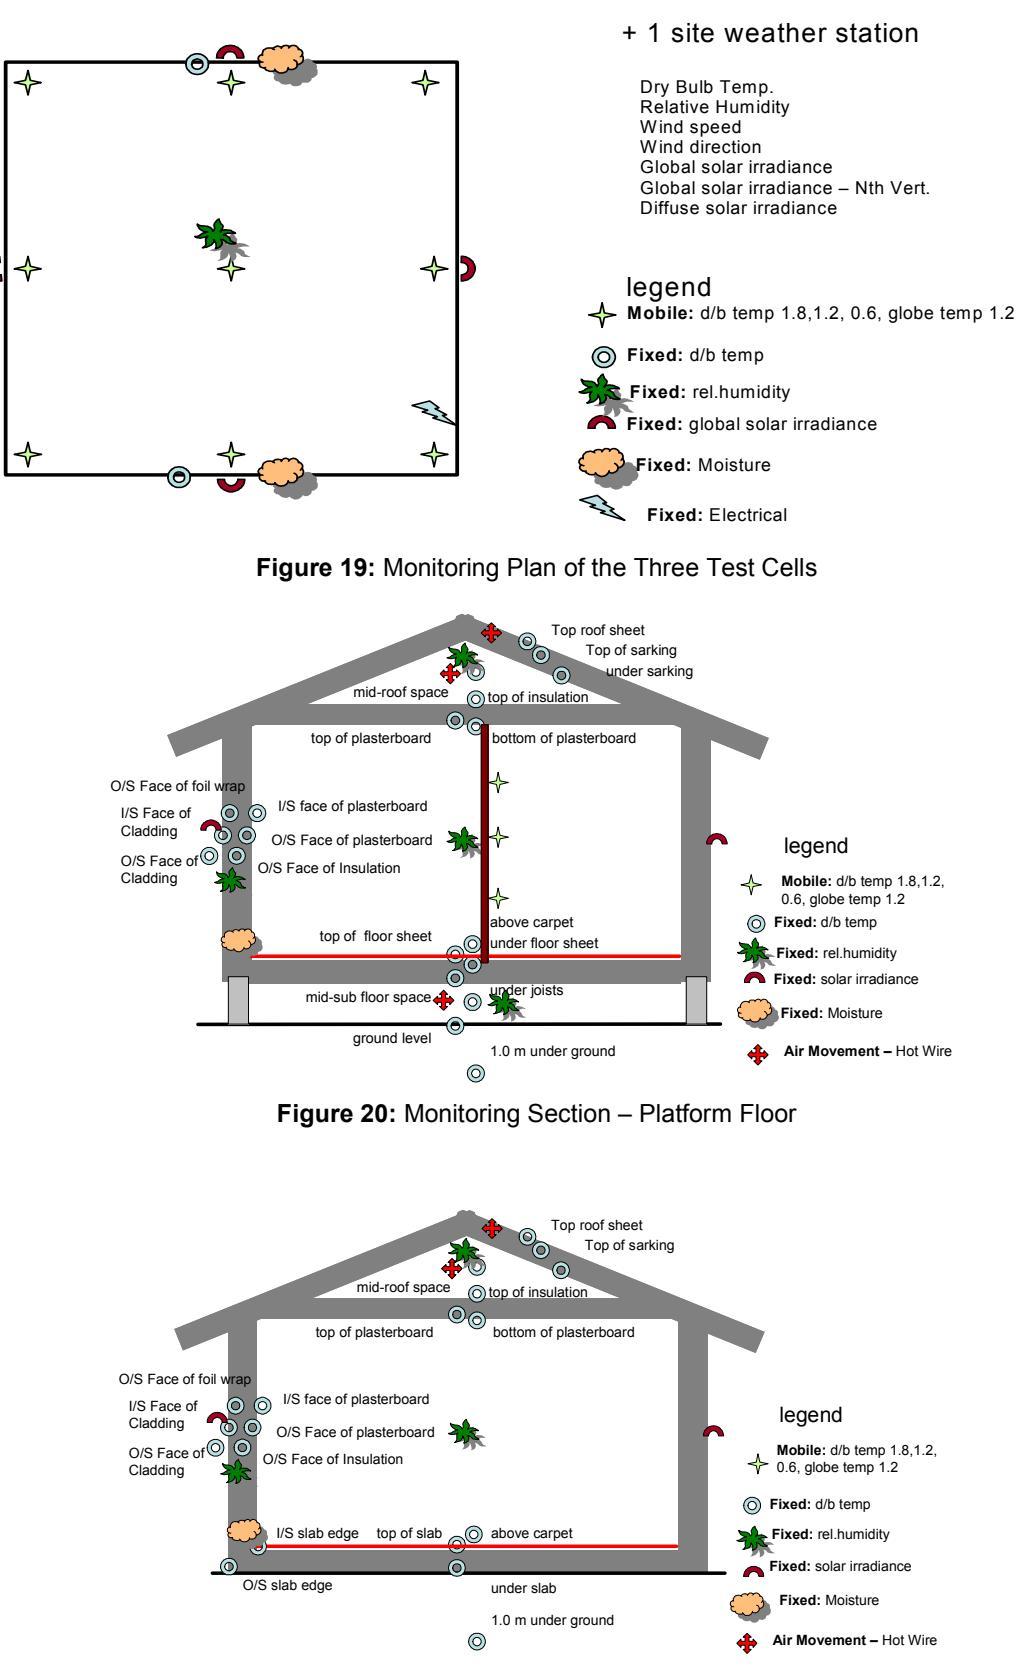
Empirical validation requires simulating each internal zone; hence each zone was fully instrumented. Measuring equipment was positioned at mid-height at the centre of each zone. Stratification and air movement in the room were monitored using additional sensors, i.e., at 600mm and 1800mm from the floor level in the test cell room. Figures 19, 20 and 21 show the monitoring plan and section of the test cells. This method differs from ASHRAE Standard 55-2004 for interior environmental measurement (ASHRAE, 2004) but is suited for the thermal performance measurement of test buildings (Lomas, 1994).

Figure 21: Monitoring Section - Slab on Ground Floor

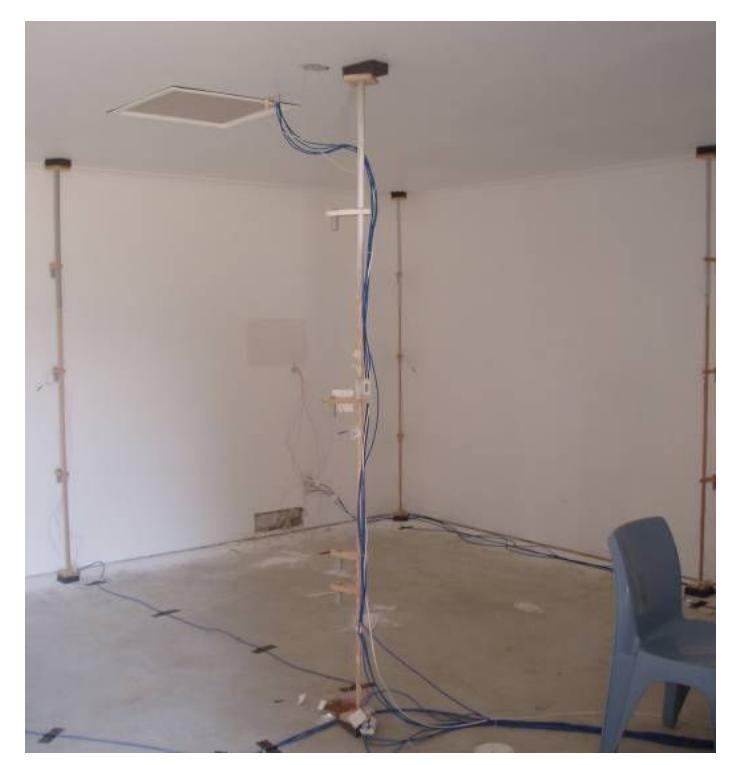
- Interior surface of particleboard platform floor;
- 600mm above floor (1/3 room height);
- 1200mm above floor (mid room height);
- 1800mm above floor (2/3 room height); and
- Interior surface of the plasterboard ceiling.

Figure 22: Sensors attached to the centre of room and edge of room poles

Room humidity was measured at 1200mm height. Initially, eight perimeter poles with sensors were installed in each cell, and were located 100mm from the wall surface in each of the four corners and at the centre of each wall as shown in Figure 22.

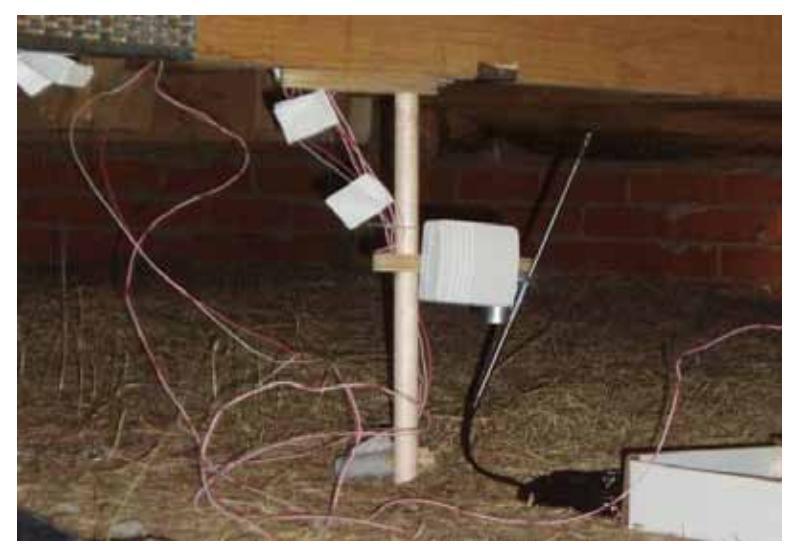
AccuRate treats the subfloor space as a distinct zone in both the enclosed and unenclosed perimeter platform floored test cells. To measure the environmental condition in these zones, a vertical pole was installed in the centre of the space. This pole records air temperature at ground level, mid sub floor height and the outside surface of particle board flooring. A humidity sensor was also installed at mid pole height (See Figure 23).

Figure 23: Sensors at the Subfloor Pole

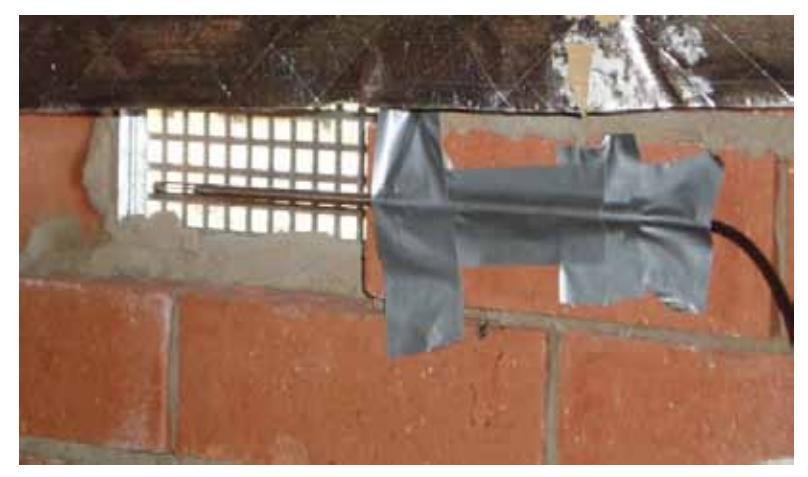
For an enclosed perimeter subfloor, AccuRate predicts the thermal condition for the enclosed perimeter sub floor zone based on the fabric matrix, ground condition and sub floor ventilation patterns. To examine this model, temperature, air movement and humidity sensors were placed in the mid subfloor area. In addition, air movement in the subfloor space was monitored by means of sensors placed in the subfloor perimeter vents as shown in Figure 24.

Figure 24: Hot Wire Air Speed Sensor at North Sub Floor Wall Vent

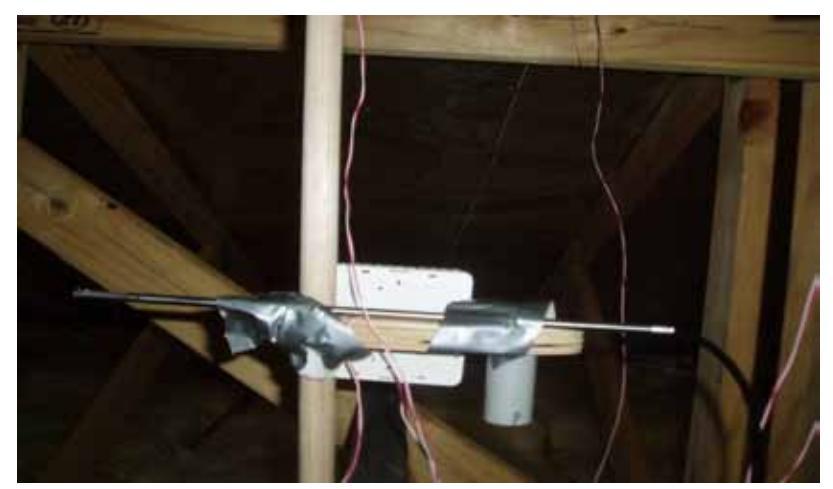
AccuRate treats the roof space as a thermally interactive zone. The simulation process predicts roofspace average hourly temperature. This is a combination of the effect of the environmental conditions on the roofing fabric matrix, the effect of the test cell room below and the rate of air infiltration in the roof space. To validate the roofspace simulation model, a sensor array was installed to measure air temperature, humidity and air movement within the roof zone. A pole with sensors placed at mid-height was placed at the centre of the roof space as shown in Figure 25.

Figure 25: Roof Space Pole for Sensors

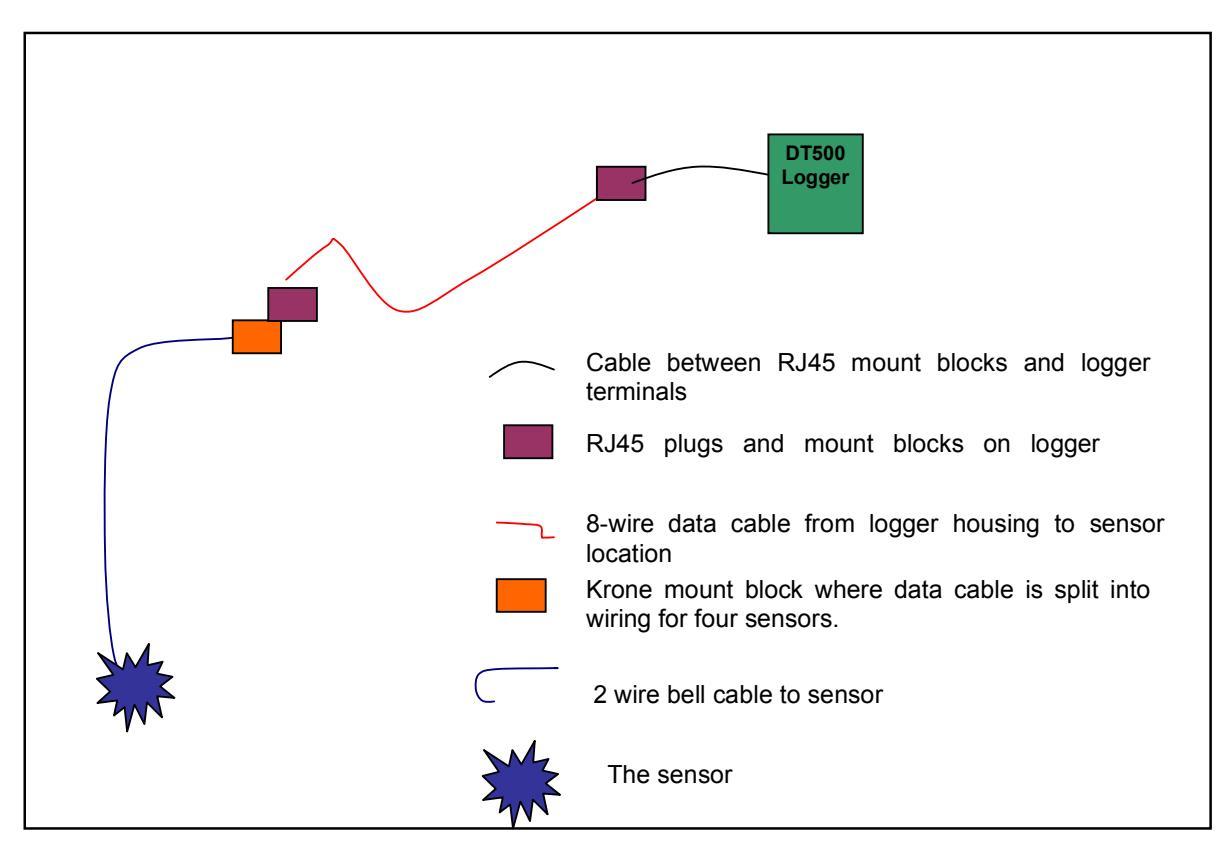
The cabling system was suited to provide a desired level of flexibility. Figures 26-30 show the cabling practice for the integrated system developed for this project. The approach allowed the location of the logger and sensor to be changed as needed. They can be placed side by side in one project and at differing ends of a house in another. A method of cable testing was developed to ensure data accuracy, preventing data anomalies noticed in the early stages of the project.

Figure 26: Diagram of Cabling System in the Test Cells

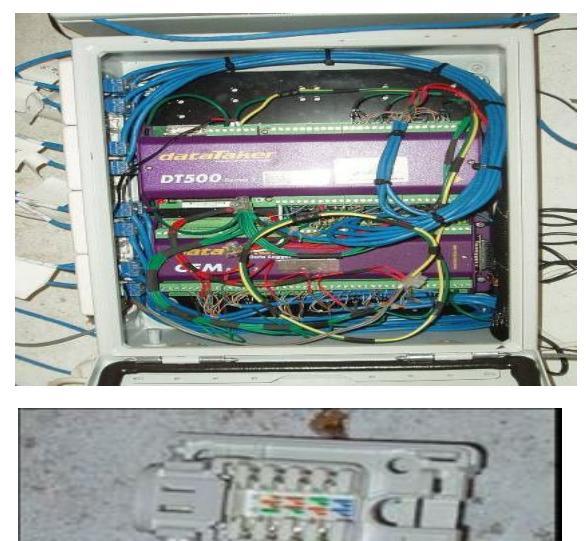
**Figure 28:** Cabling Practice showing Category 5 data cable, connector and 2 wire sensor connection

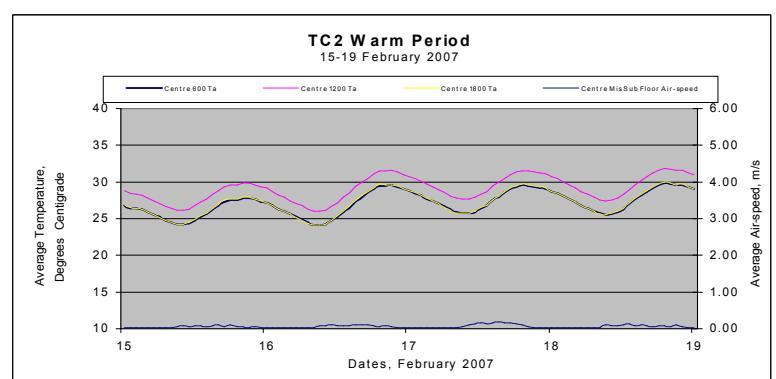
Figure 34 Test Cell 2 Room Temperature Stratification and Subfloor Airspeed during a Warm Week

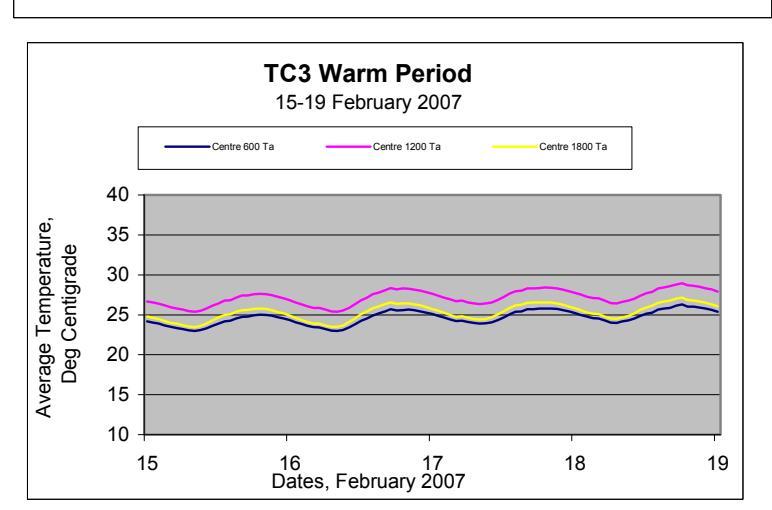
Figure 35 Test Cell 3 Room Temperature Stratification during a Warm Week

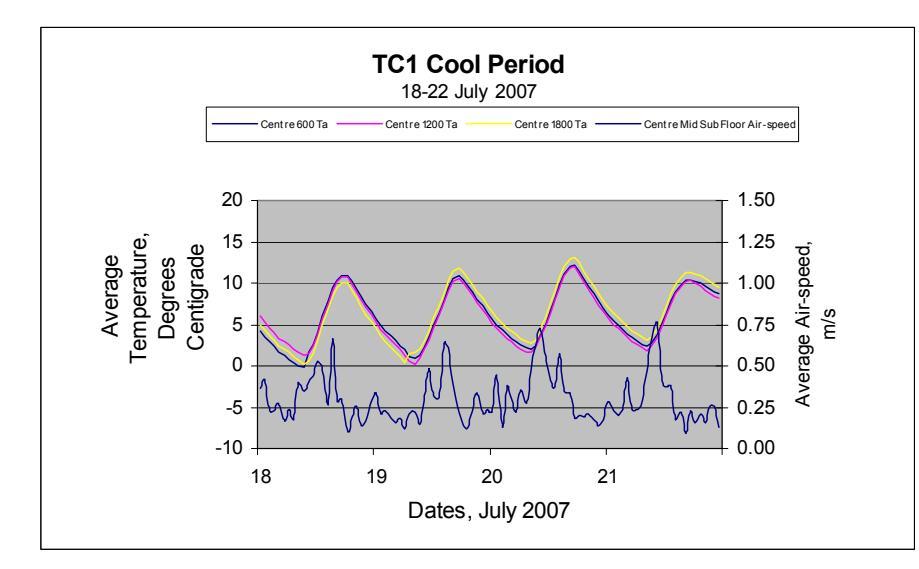
During the cool period, Test Cells 2 and 3 show more consistent and distinct trends compared with Test Cell 1. In Test Cell 2, the temperature at a height near the ceiling was higher than at mid-height and near the floor. In Test Cell 3, the near ceiling and mid-height temperatures were higher than near the floor. In Test Cell 1, a consistent trend towards the end of the four-day period showed that the temperature near the ceiling was the highest whereas at mid-height, the lowest.

Figure 36 Test Cell 1 Room Temperature Stratification and Subfloor Airspeed during a Cool Week

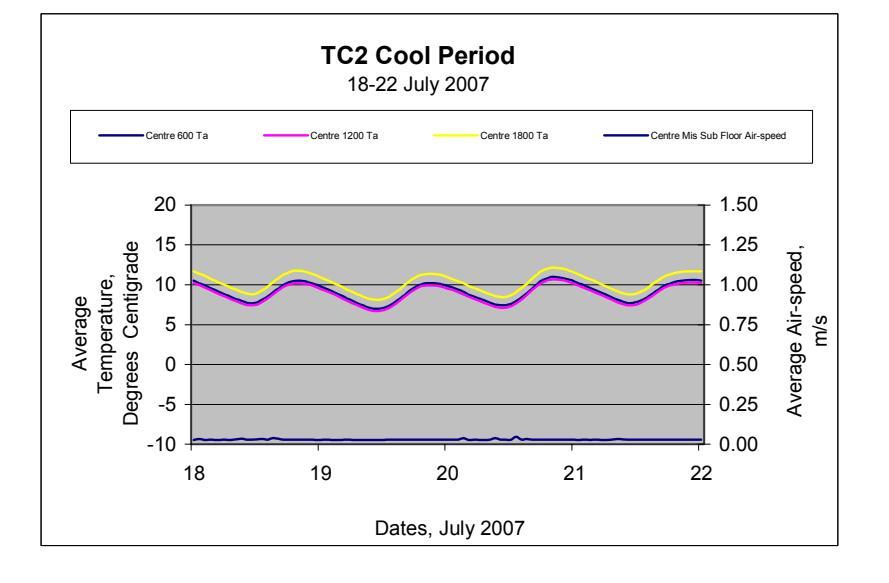
Figure 37 Test Cell 2 Room Temperature Stratification and Subfloor Airspeed during a Cool Week

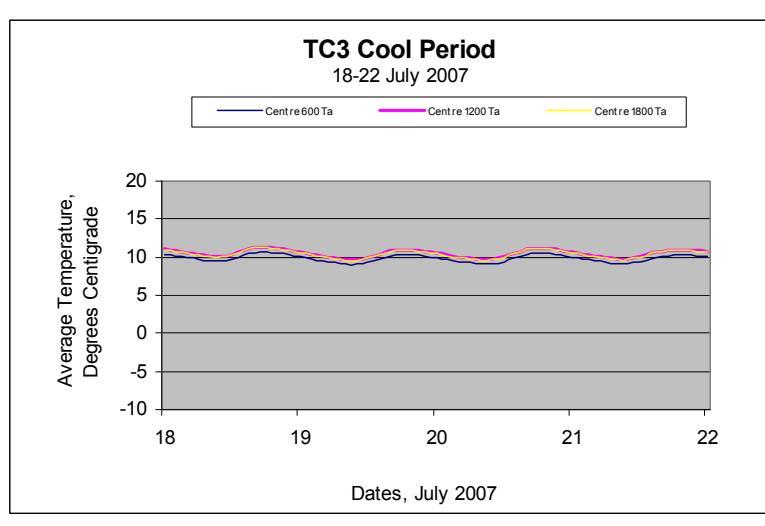
Figure 38 Test Cell 3 Room Temperature Stratification during a Cool Week

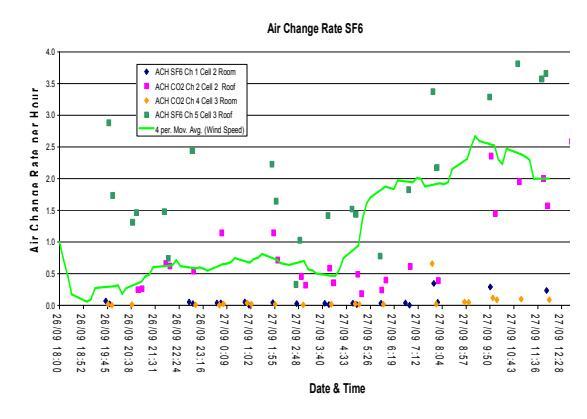
Figures 39, 40 and 41 show the wind speed and its effect on the air change rates per hour (ACH) in the roof and rooms over a two-day period. With ACH generally not exceeding 0.1, it can be said that the rooms were very airtight when the doors were shut. It was noted that measurements greater than 0.1 were instances when doors were opened such as when staff entered the room to monitor the tests. In the roof spaces, however, higher airflow was observed compared with the airflow in the rooms, with Test Cell 1 and Test Cell 3 roof spaces experiencing relatively higher airflows compared with Test Cell 2.

**Figure 41:** Wind velocity and air change rates in the rooms and roofs of Test Cell 2 and Test Cell 3

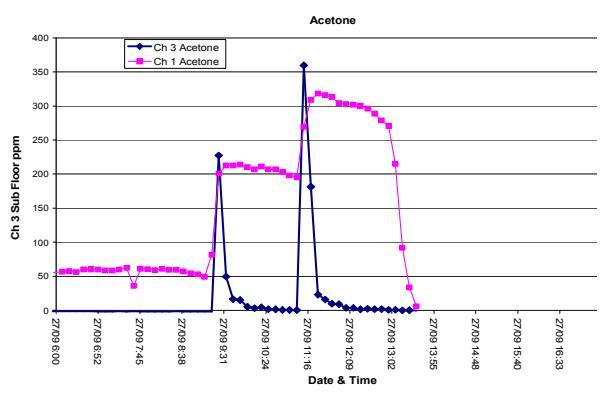
Figure 42 shows that in Test Cell 2, acetone tracer gas released in the subfloor space (Ch 3) was detected in the room (Ch 1), possibly due to leakage at the bottom plate-particleboard joint. Furthermore, the decay rate of the acetone tracer gas was significantly slower compared to its migration into the room. This could be attributed to the quality of building wrap installed in the wall cavity, which appears to have prevented the tracer gas from leaking out through the walls.

**Figure 42:** Volume of acetone gas migrating from the subfloor into the room in Test Cell 2

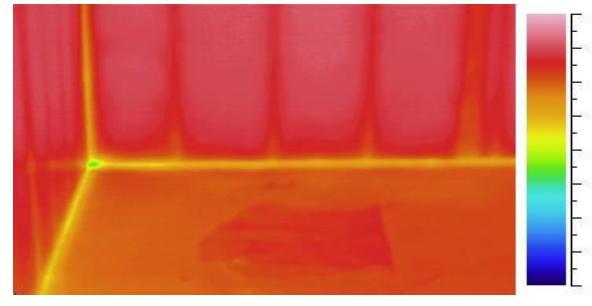
Figure 45: Inside Test Cell 2 with heater ON 2:55 PM 28/09/07

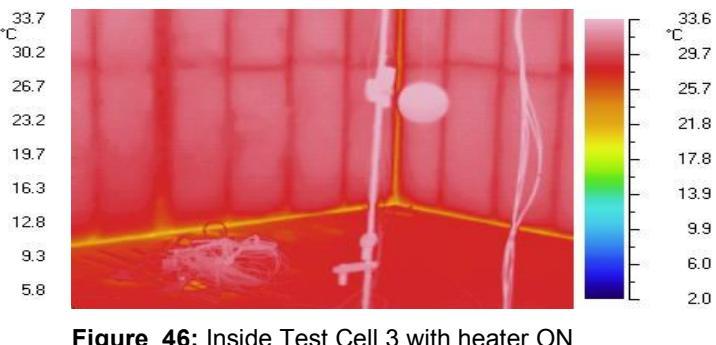
Figure 46: Inside Test Cell 3 with heater ON 2:58 PM 28/9/07

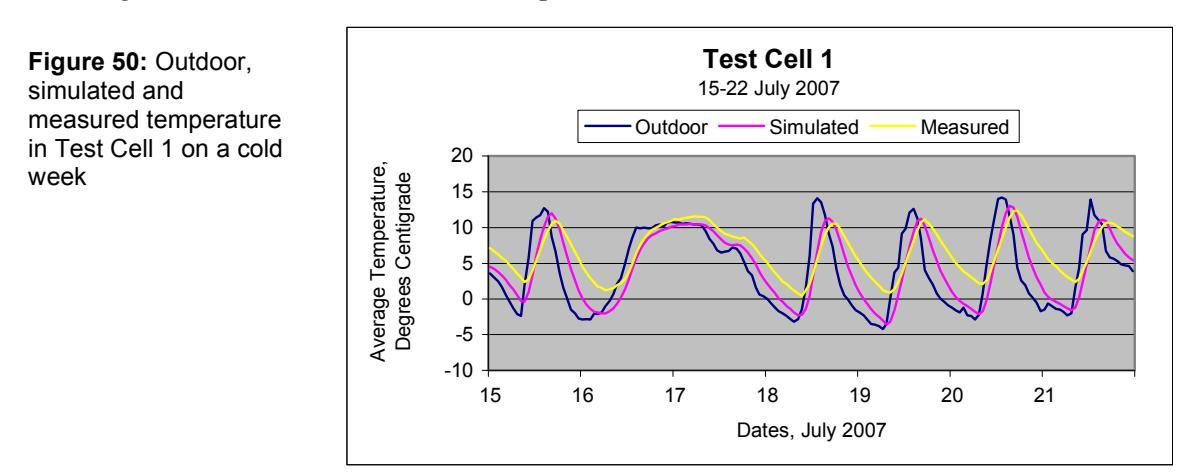
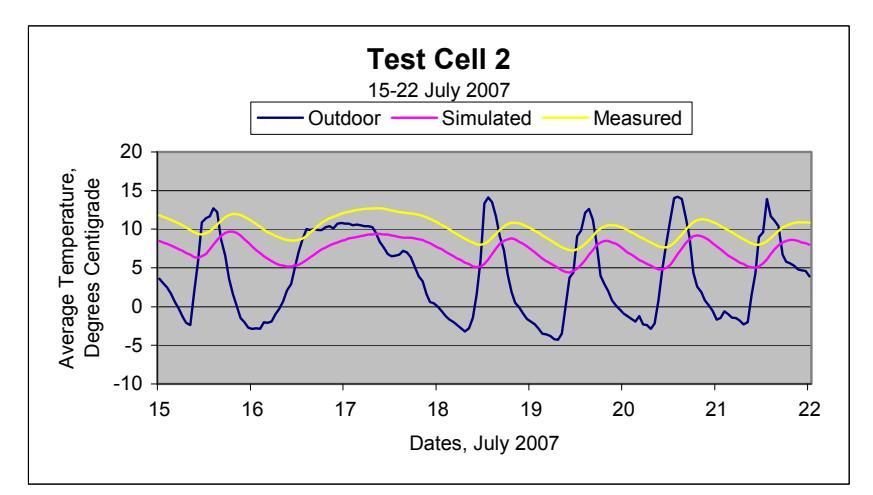
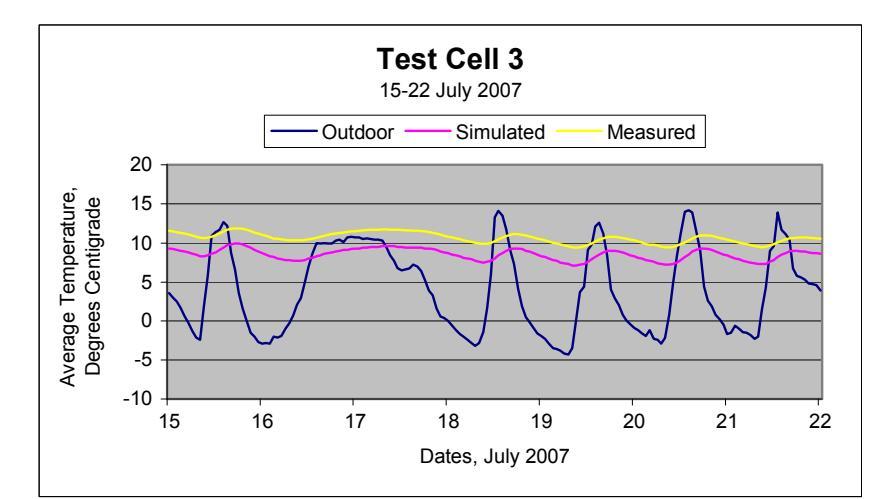
Measured temperature was always higher than simulated temperature in Test Cells 2 and 3, but not in Test Cell 1 (See Figures 50-52). Although the maximum values for both measured and simulated were very close in Test Cell 1, the minimum values for simulated temperature were significantly lower. Similar to the observation on peaks and time lags during the warm period, the simulated temperature wave in Test Cell 3 conforms closely with the measured one. This was also observed in Test Cell 2 but to a lesser extent. As in the warm week, the peaks, swings and ranges in measured and simulated temperatures in Test Cell 1 do not conform.
