MARKET ACCESS & DEVELOPMENT PROJECT NUMBER: PNA001-0405

Comparison of Test Cell Thermal Performance & The Empirical Validation of AccuRate in a Cool Temperate Climate

M. Dewsbury, F. Soriano, G. Nolan and R. Fay

#### Project No: PNA001-0405

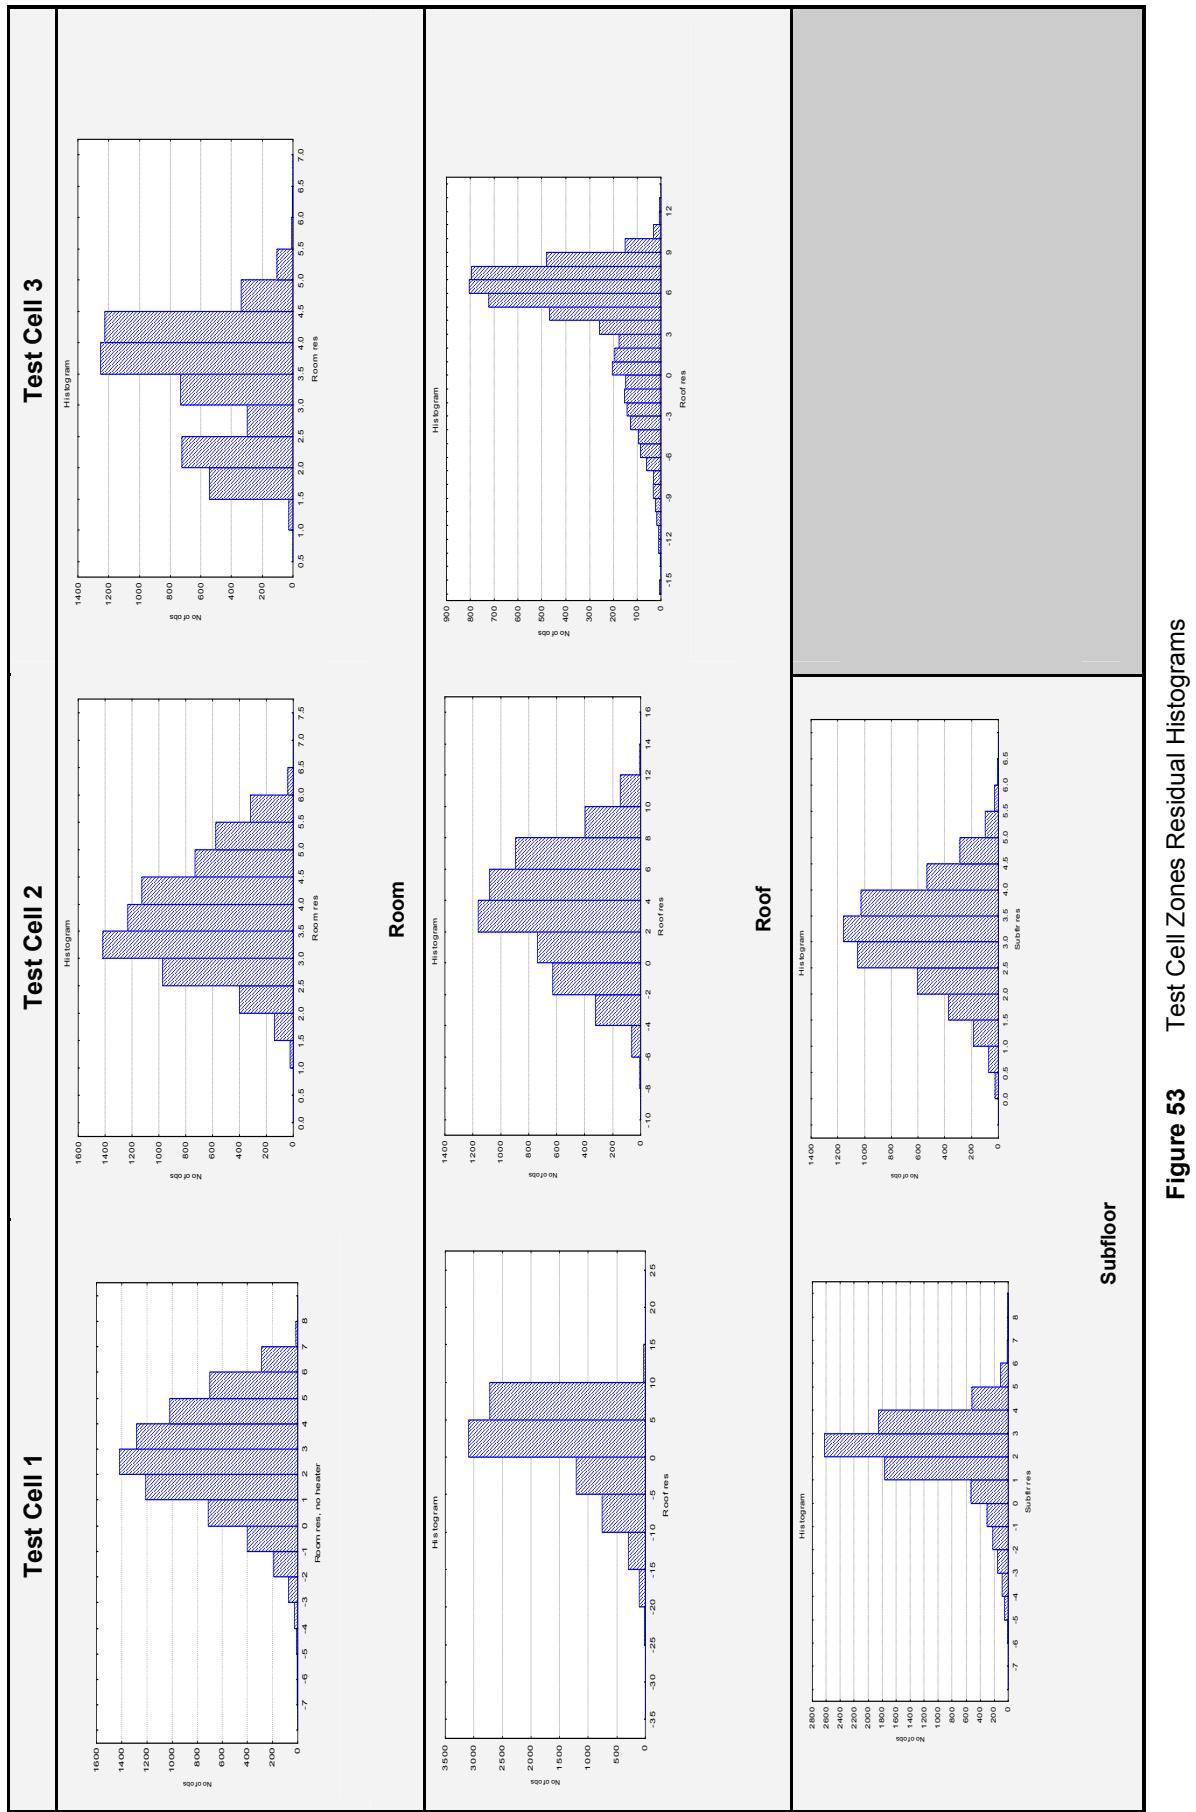
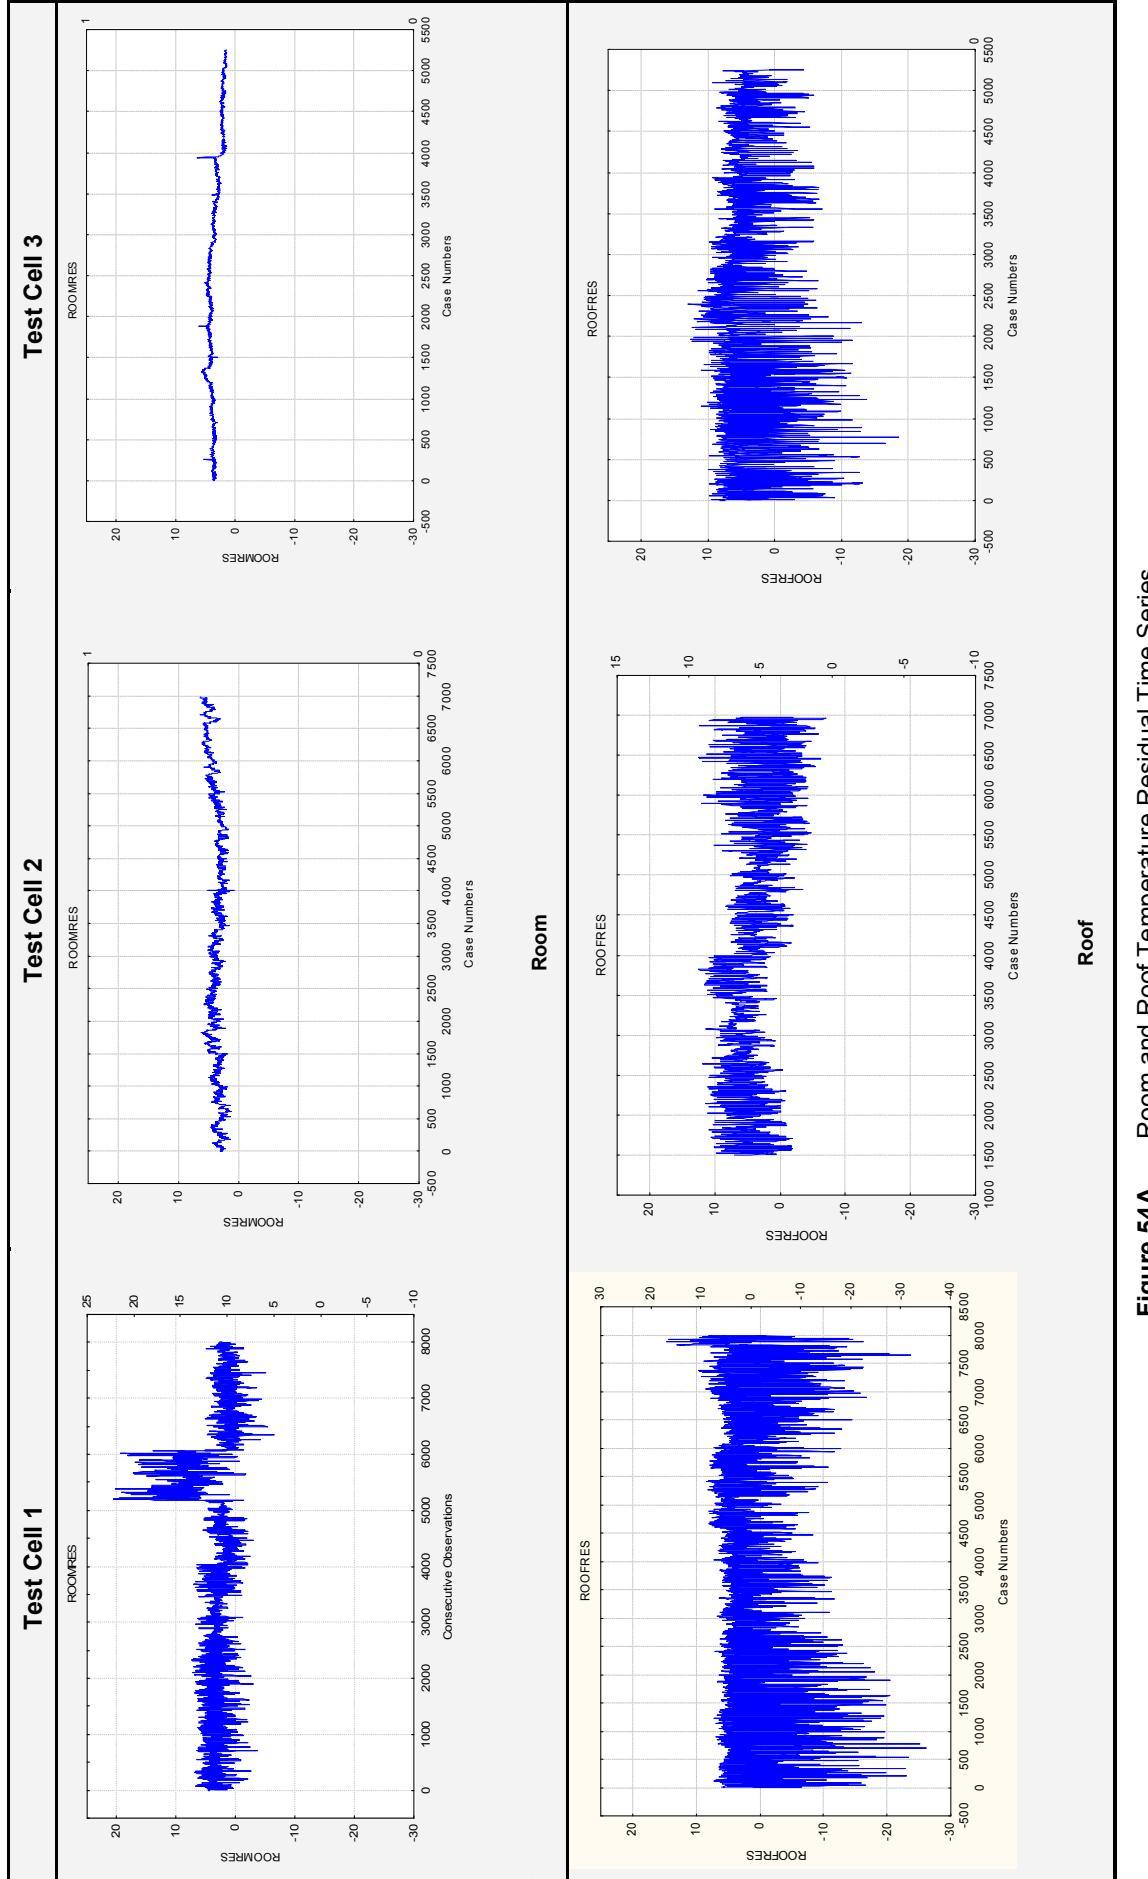
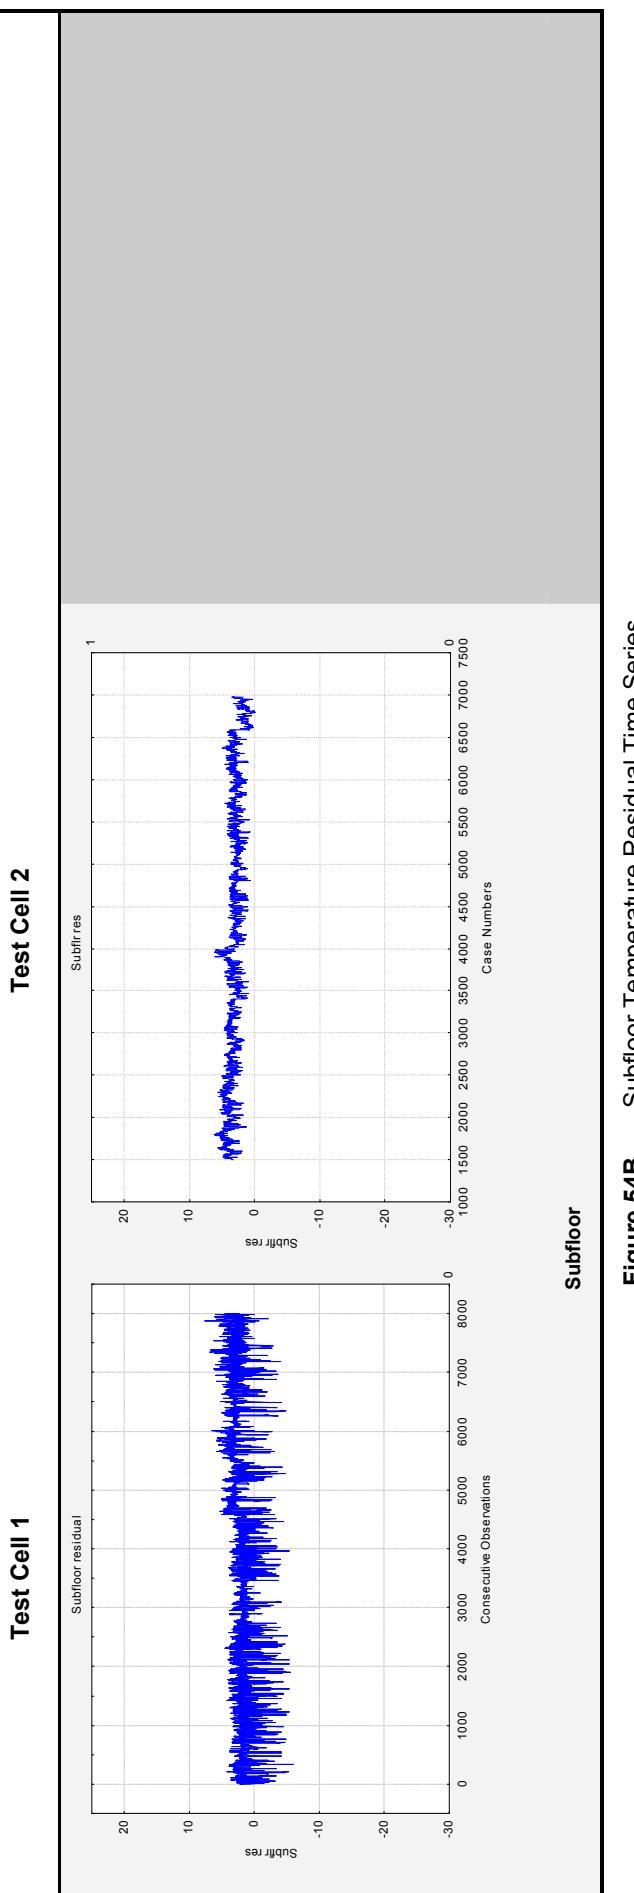
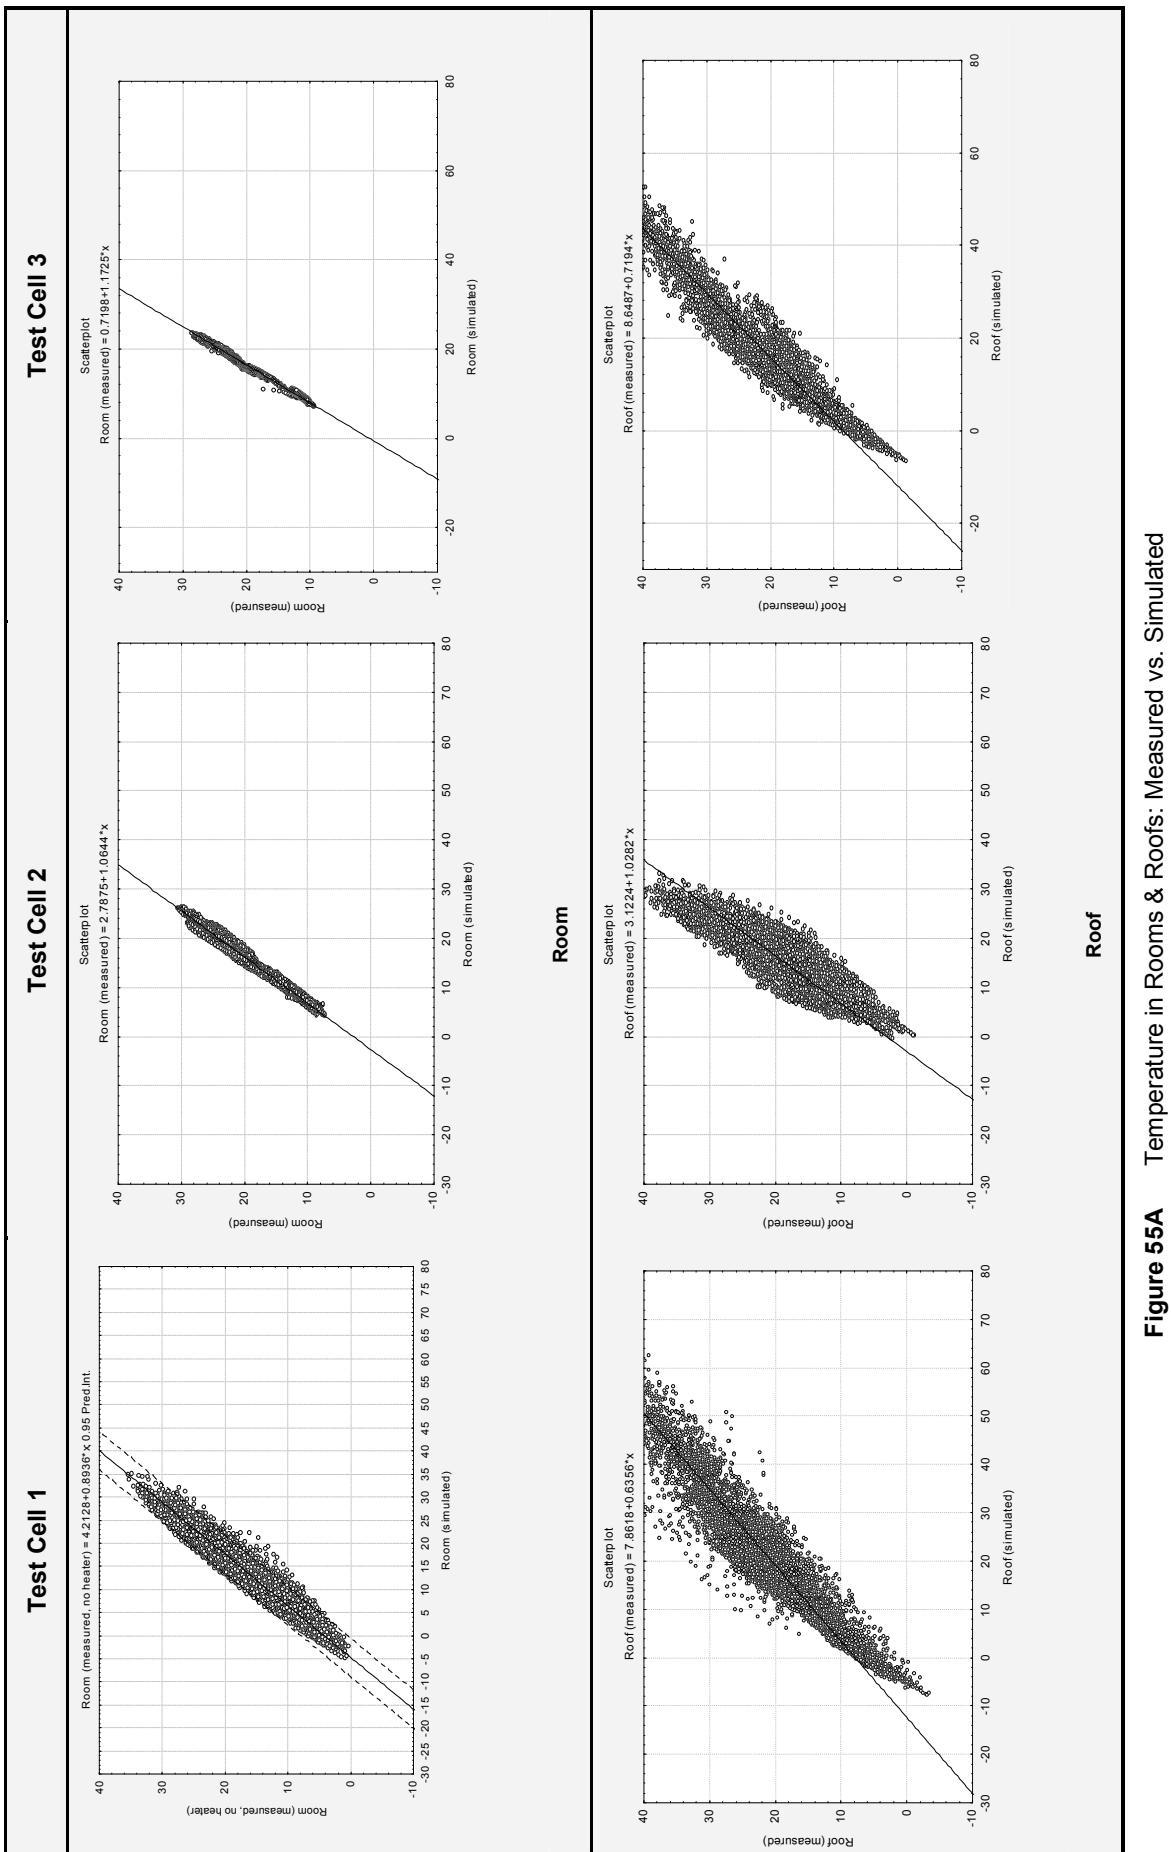
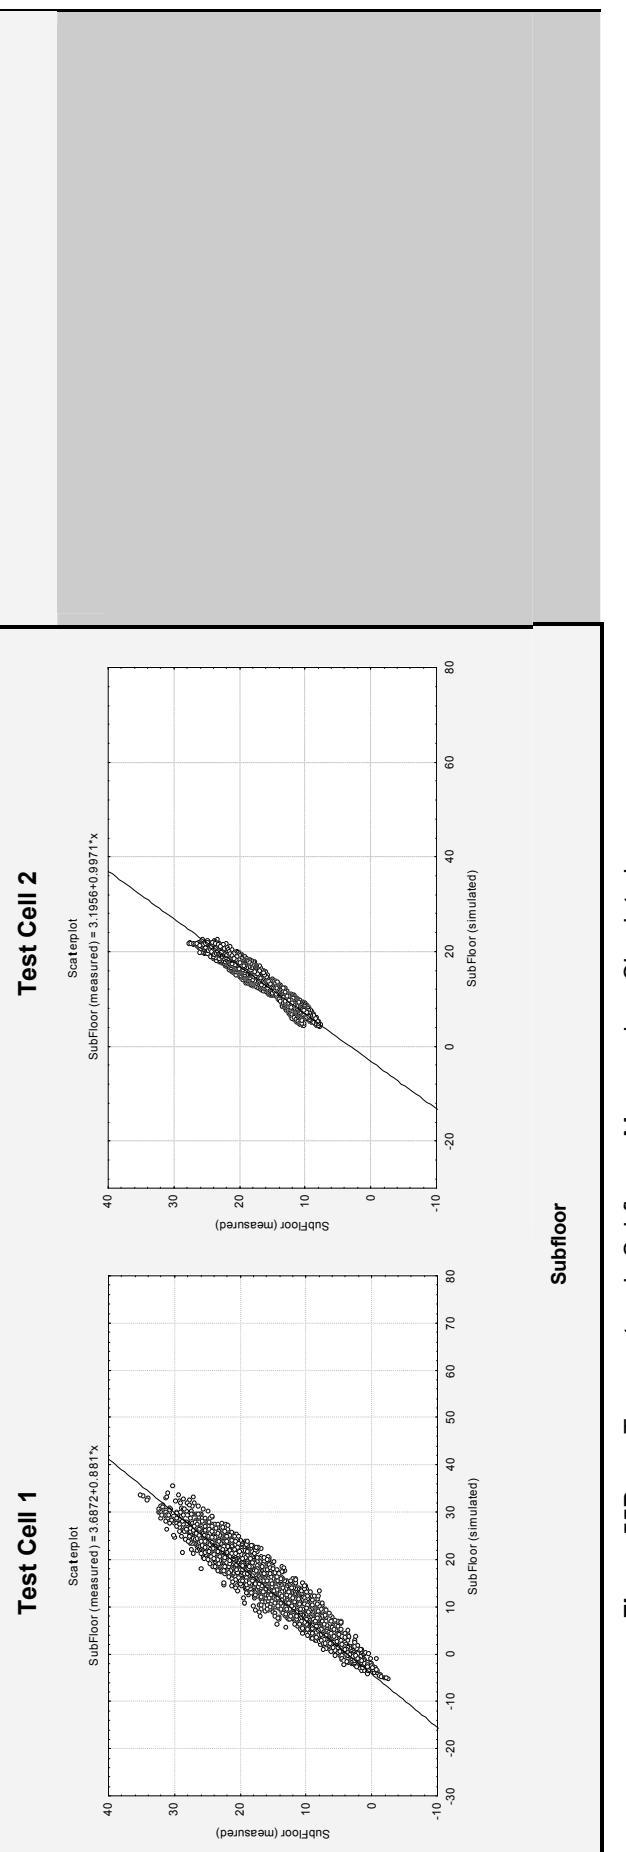
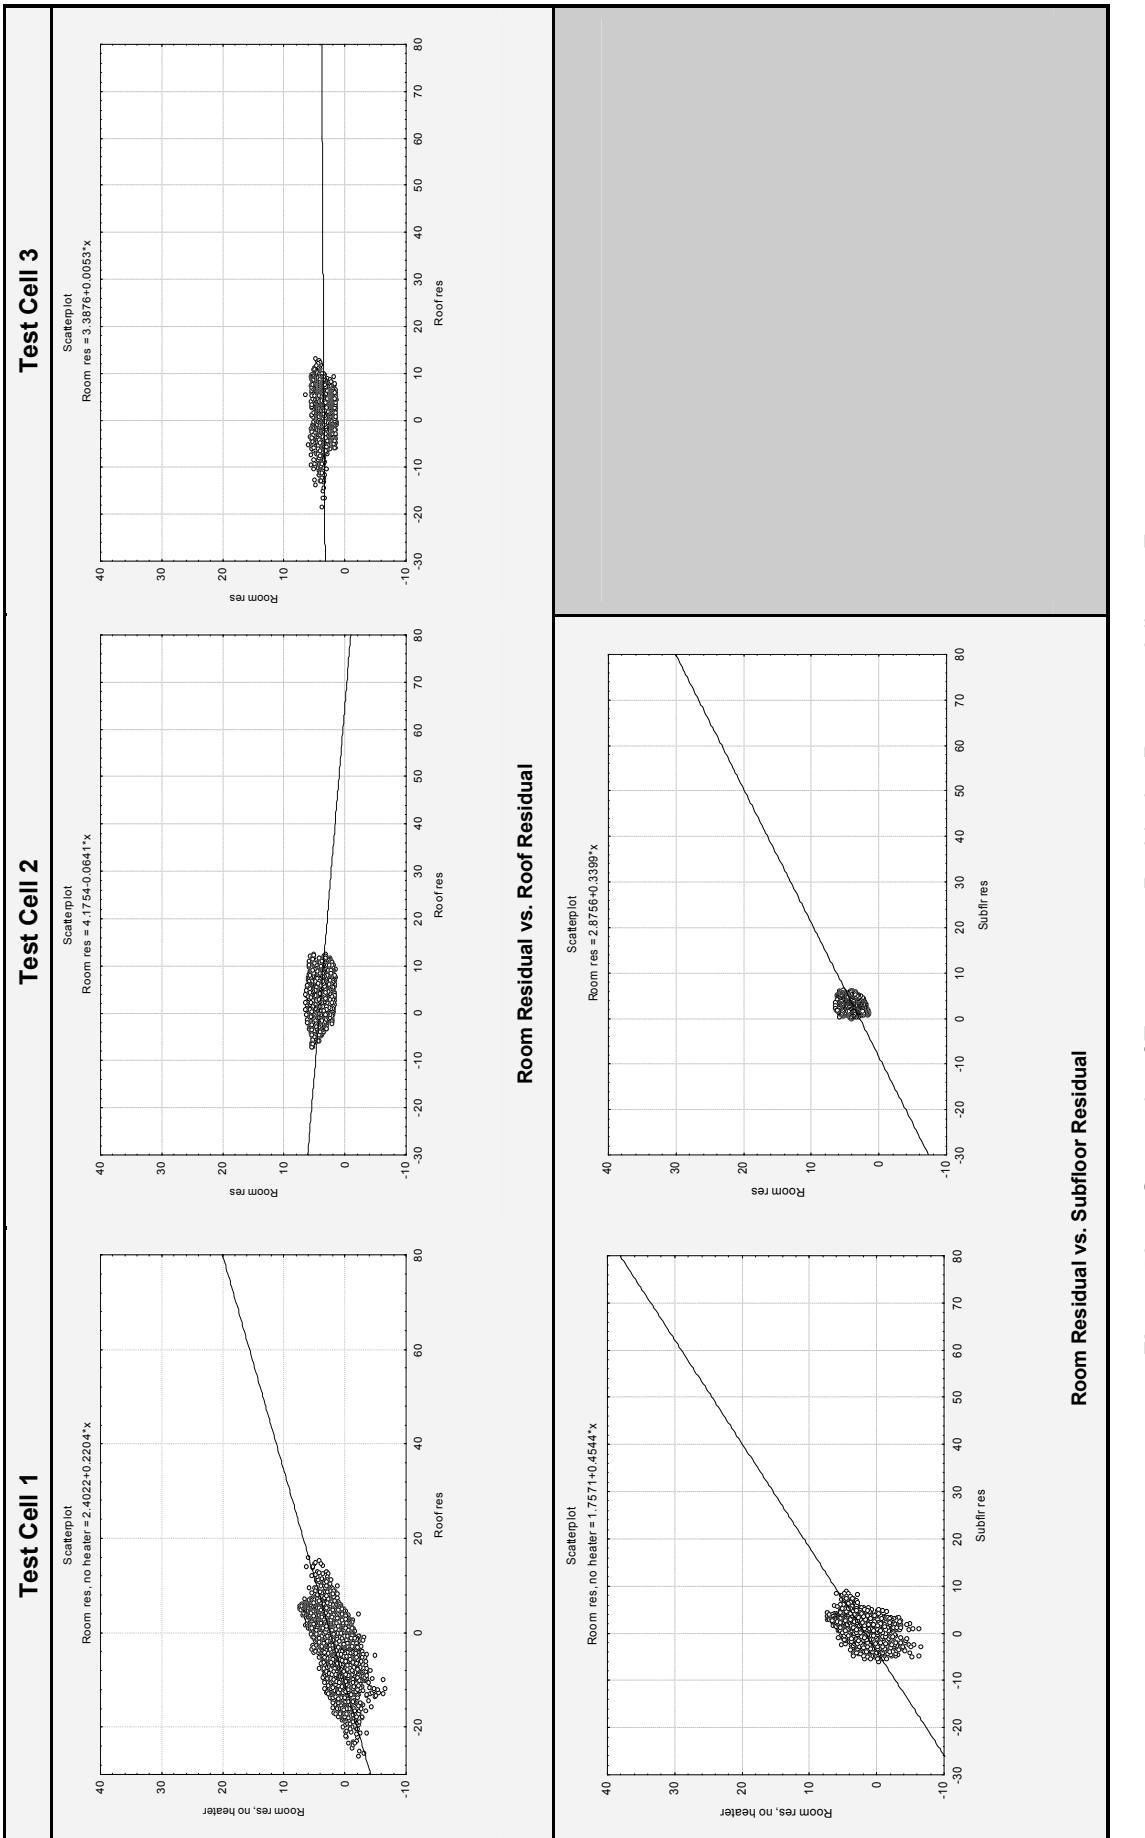
Test Cell Zones Residual Histograms

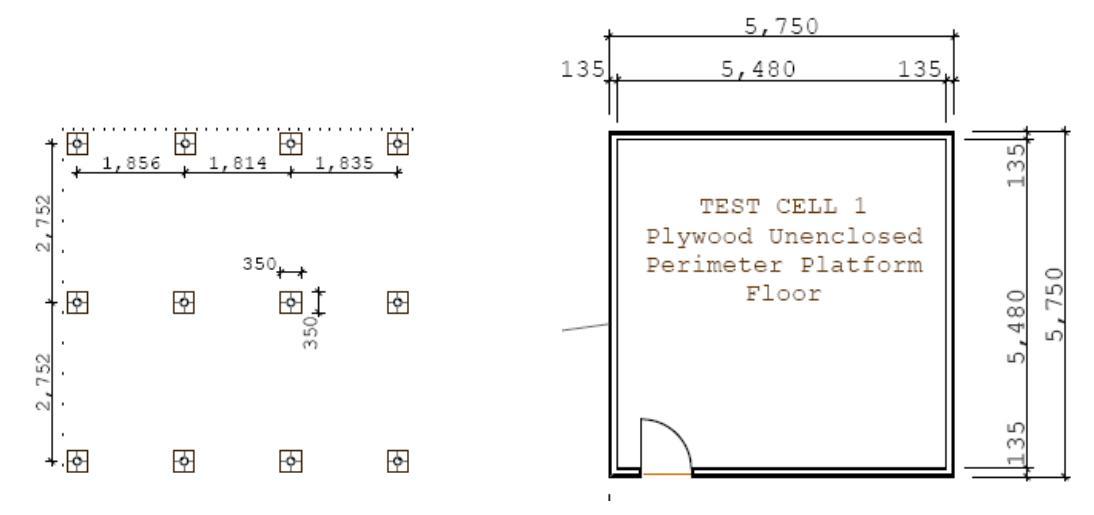
Item	Specification
Footings	Treated poles set in a concrete pier
Floor	19mm Particle board deck on timber bearer and joists
Walls	10mm Plasterboard, 90mm softwood stud framing, R2.5 rockwool wall batt insulation, reflective foil wrap, 21mm cavity, 12mm plywood lining
Ceiling	10mm Plasterboard, R4.0 Glass wool ceiling batt
Roof	Softwood truss, battens, reflective foil sarking, Colorbond sheet metal roofing

#### Figure 41: Test Cell 1 Footing Plan & Floor Plan

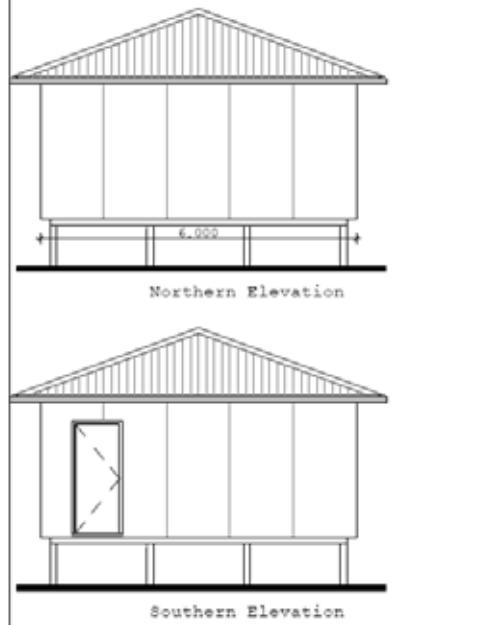
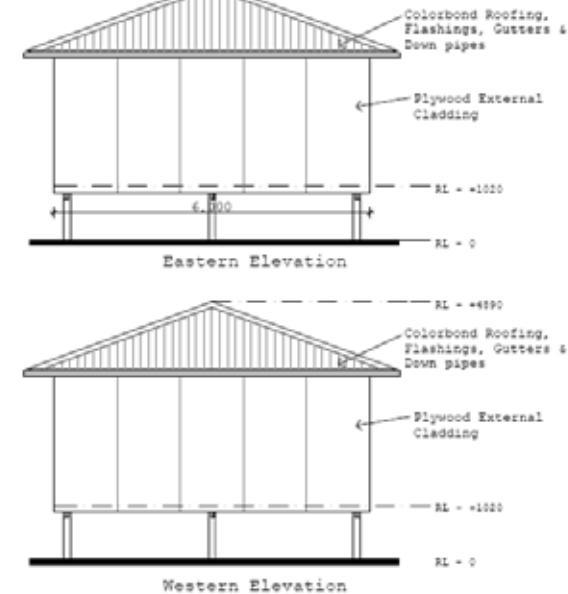
Figure 42: Test Cell 1 Elevations

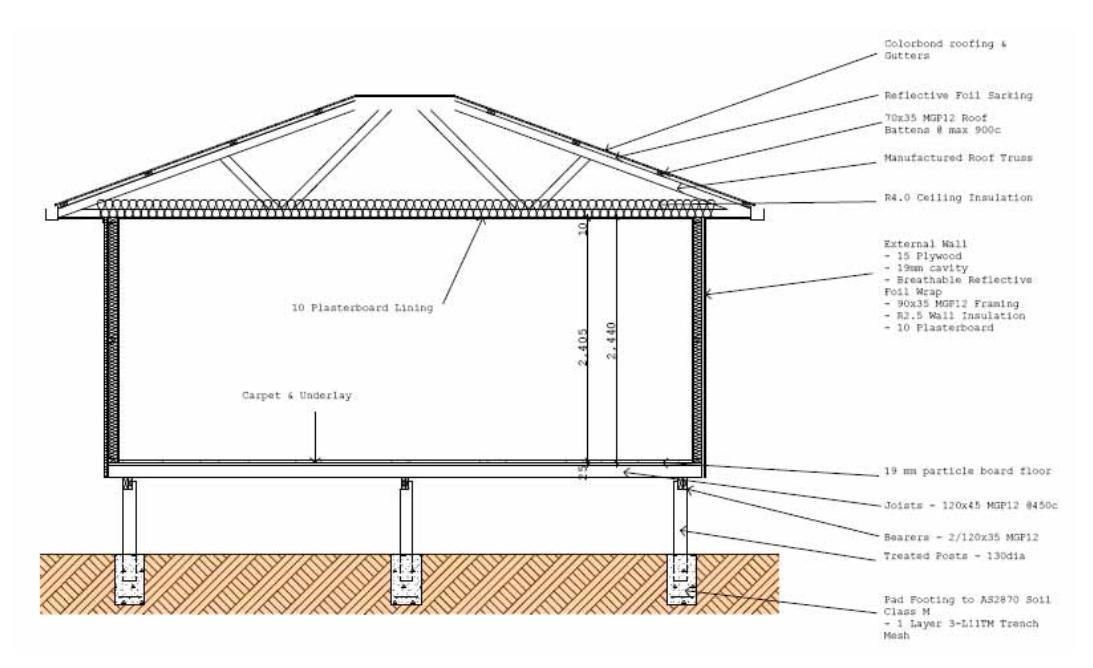
Figure 43: Test Cell 1 Section

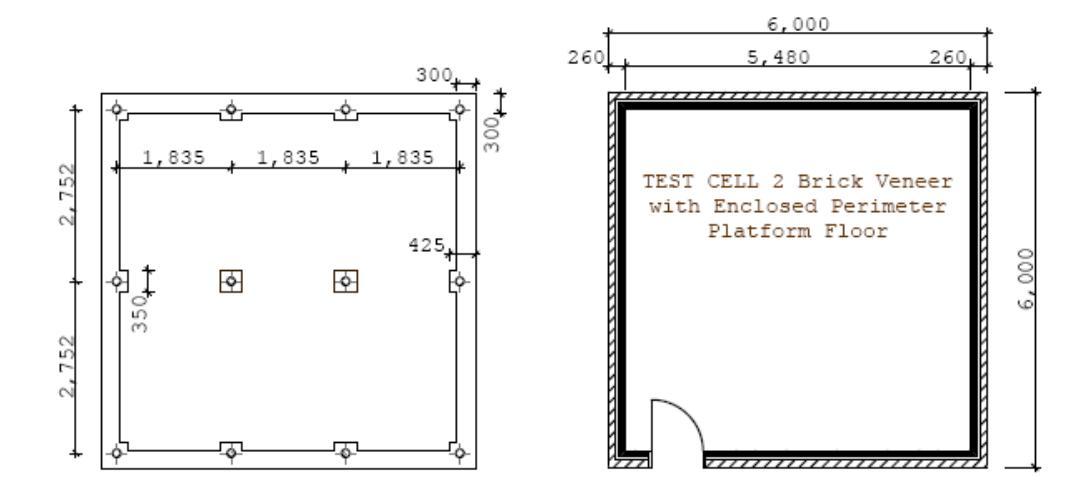
Item	Specification
Footings	Treated poles set in a concrete pier
Floor	19mm Particle board deck on timber bearer and joists
Walls	10mm Plasterboard, 90mm softwood stud framing, R2.5 rockwool wall batt insulation, reflective foil wrap, 50mm cavity, 110 clay brick
Ceiling	10mm Plasterboard, R4.0 Glass wool ceiling batt
Roof	Softwood truss, battens, reflective foil sarking, Colorbond sheet metal roofing

Figure 44: Test Cell 2 Footing Plan & Floor Plan

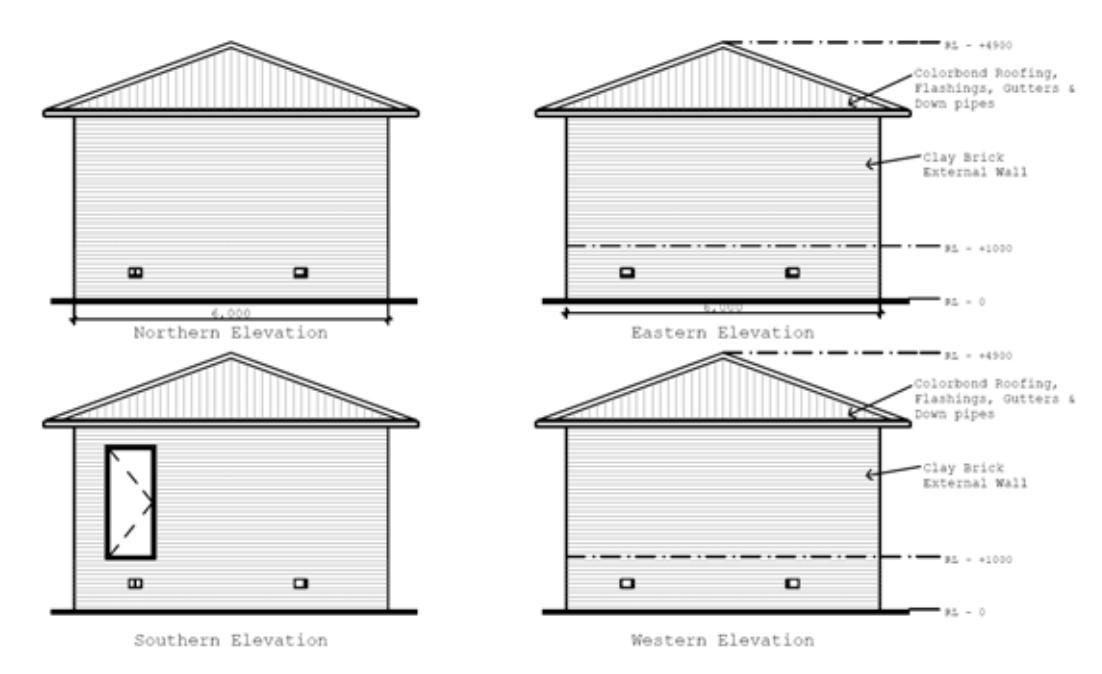
Figure 45: Test Cell 2 Elevations

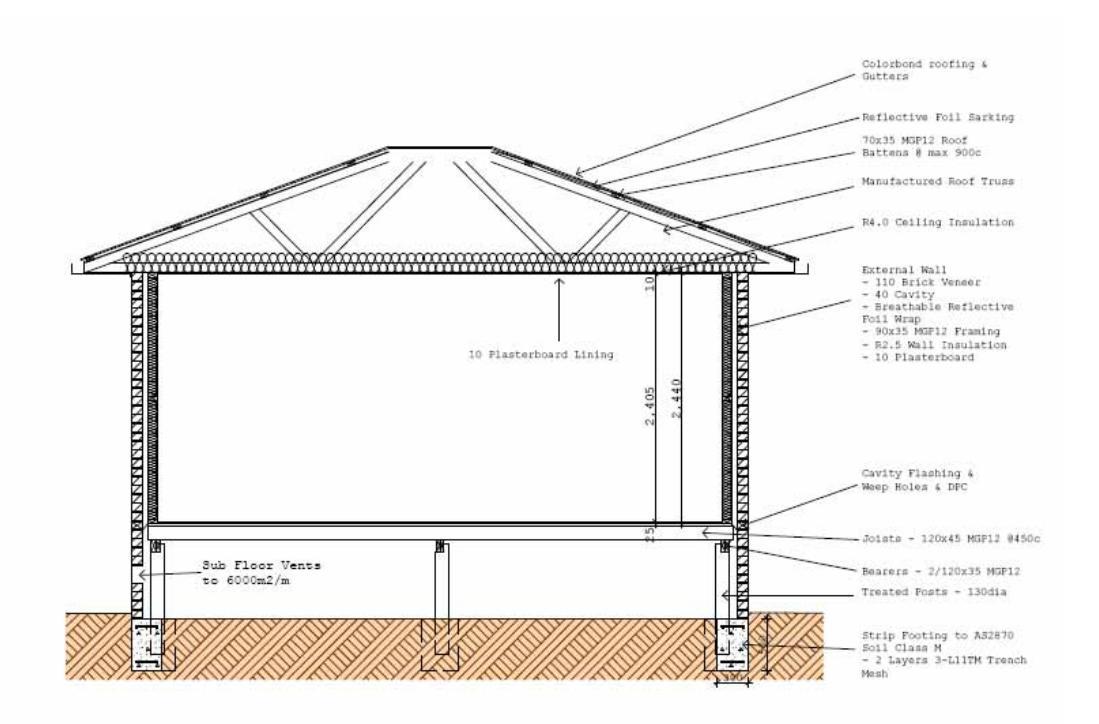
Figure 46: Test Cell 2 Section

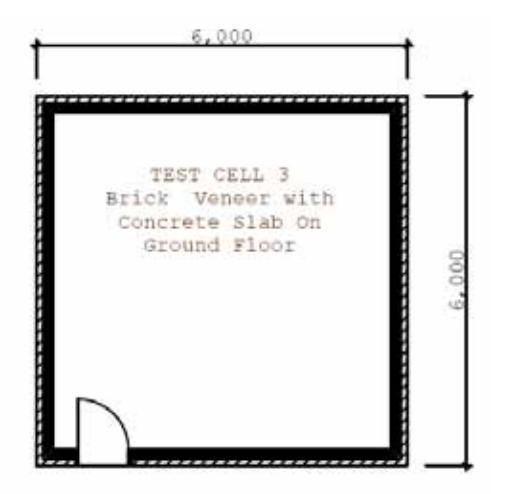
Item	Specification
Floor	100mm Concrete slab on ground
Walls	10mm Plasterboard, 90mm softwood stud framing, R2.5 rockwool wall batt insulation, reflective foil wrap, 50mm cavity, 110 clay brick
Ceiling	10mm Plasterboard, R4.0 Glass wool ceiling batt
Roof	Softwood truss, battens, reflective foil sarking, Colorbond sheet metal roofing

Figure 47: Test Cell 3 Floor Plan

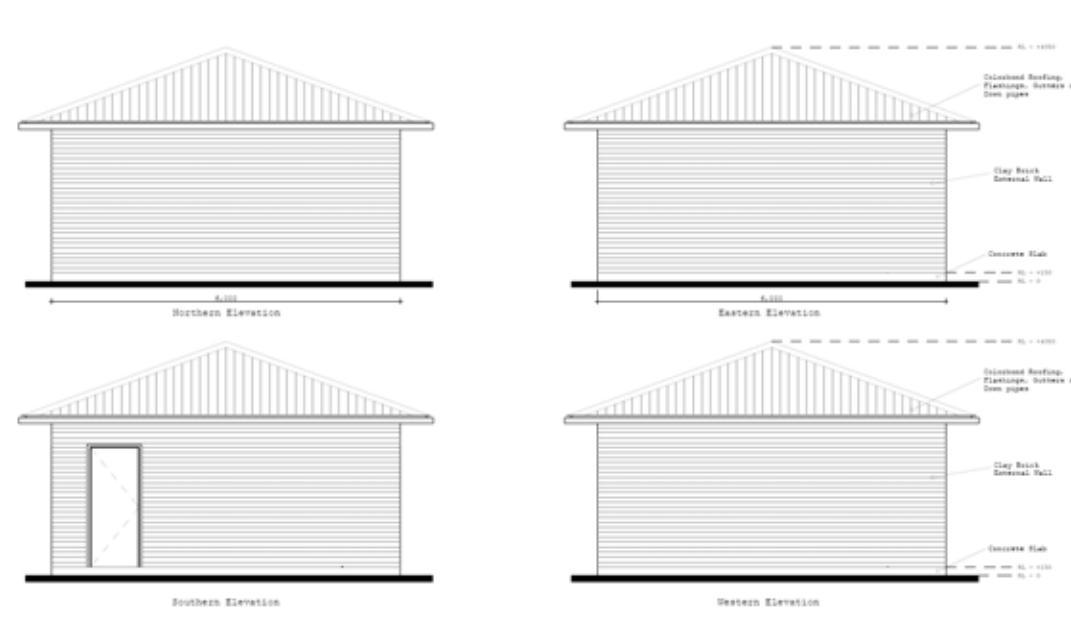
Figure 48: Test Cell 3 Elevations

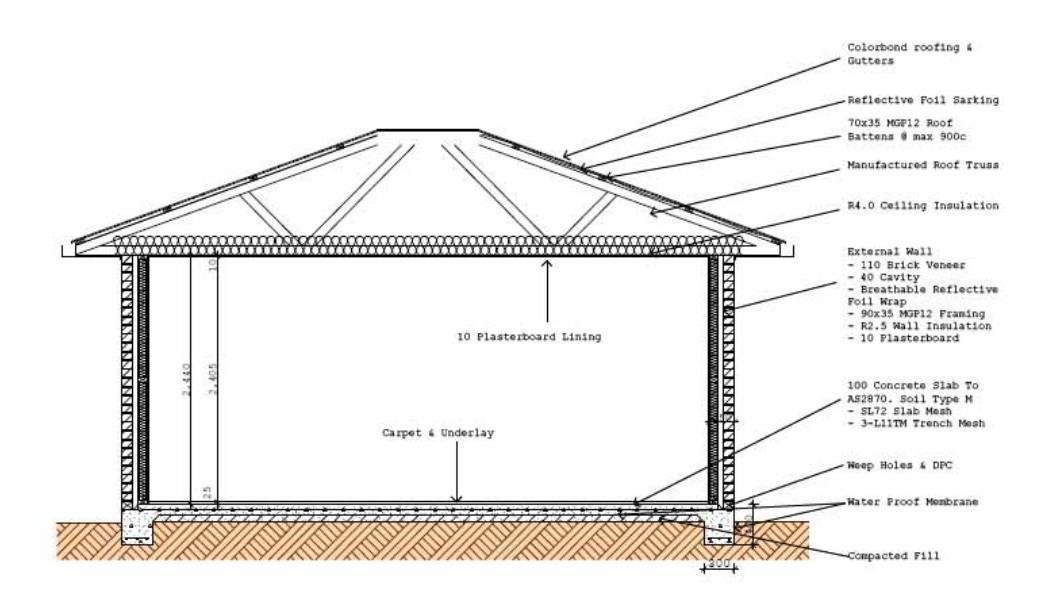
Figure 49: Test Cell 3 Section
